ARMSTRONG WEST EROSION CONTROL WORKS

2007-2008 Monitoring Report

September 2008

**Re: Armstrong West Erosion Control Works – 2008 Monitoring Program
TSH Project No. 54-22264**

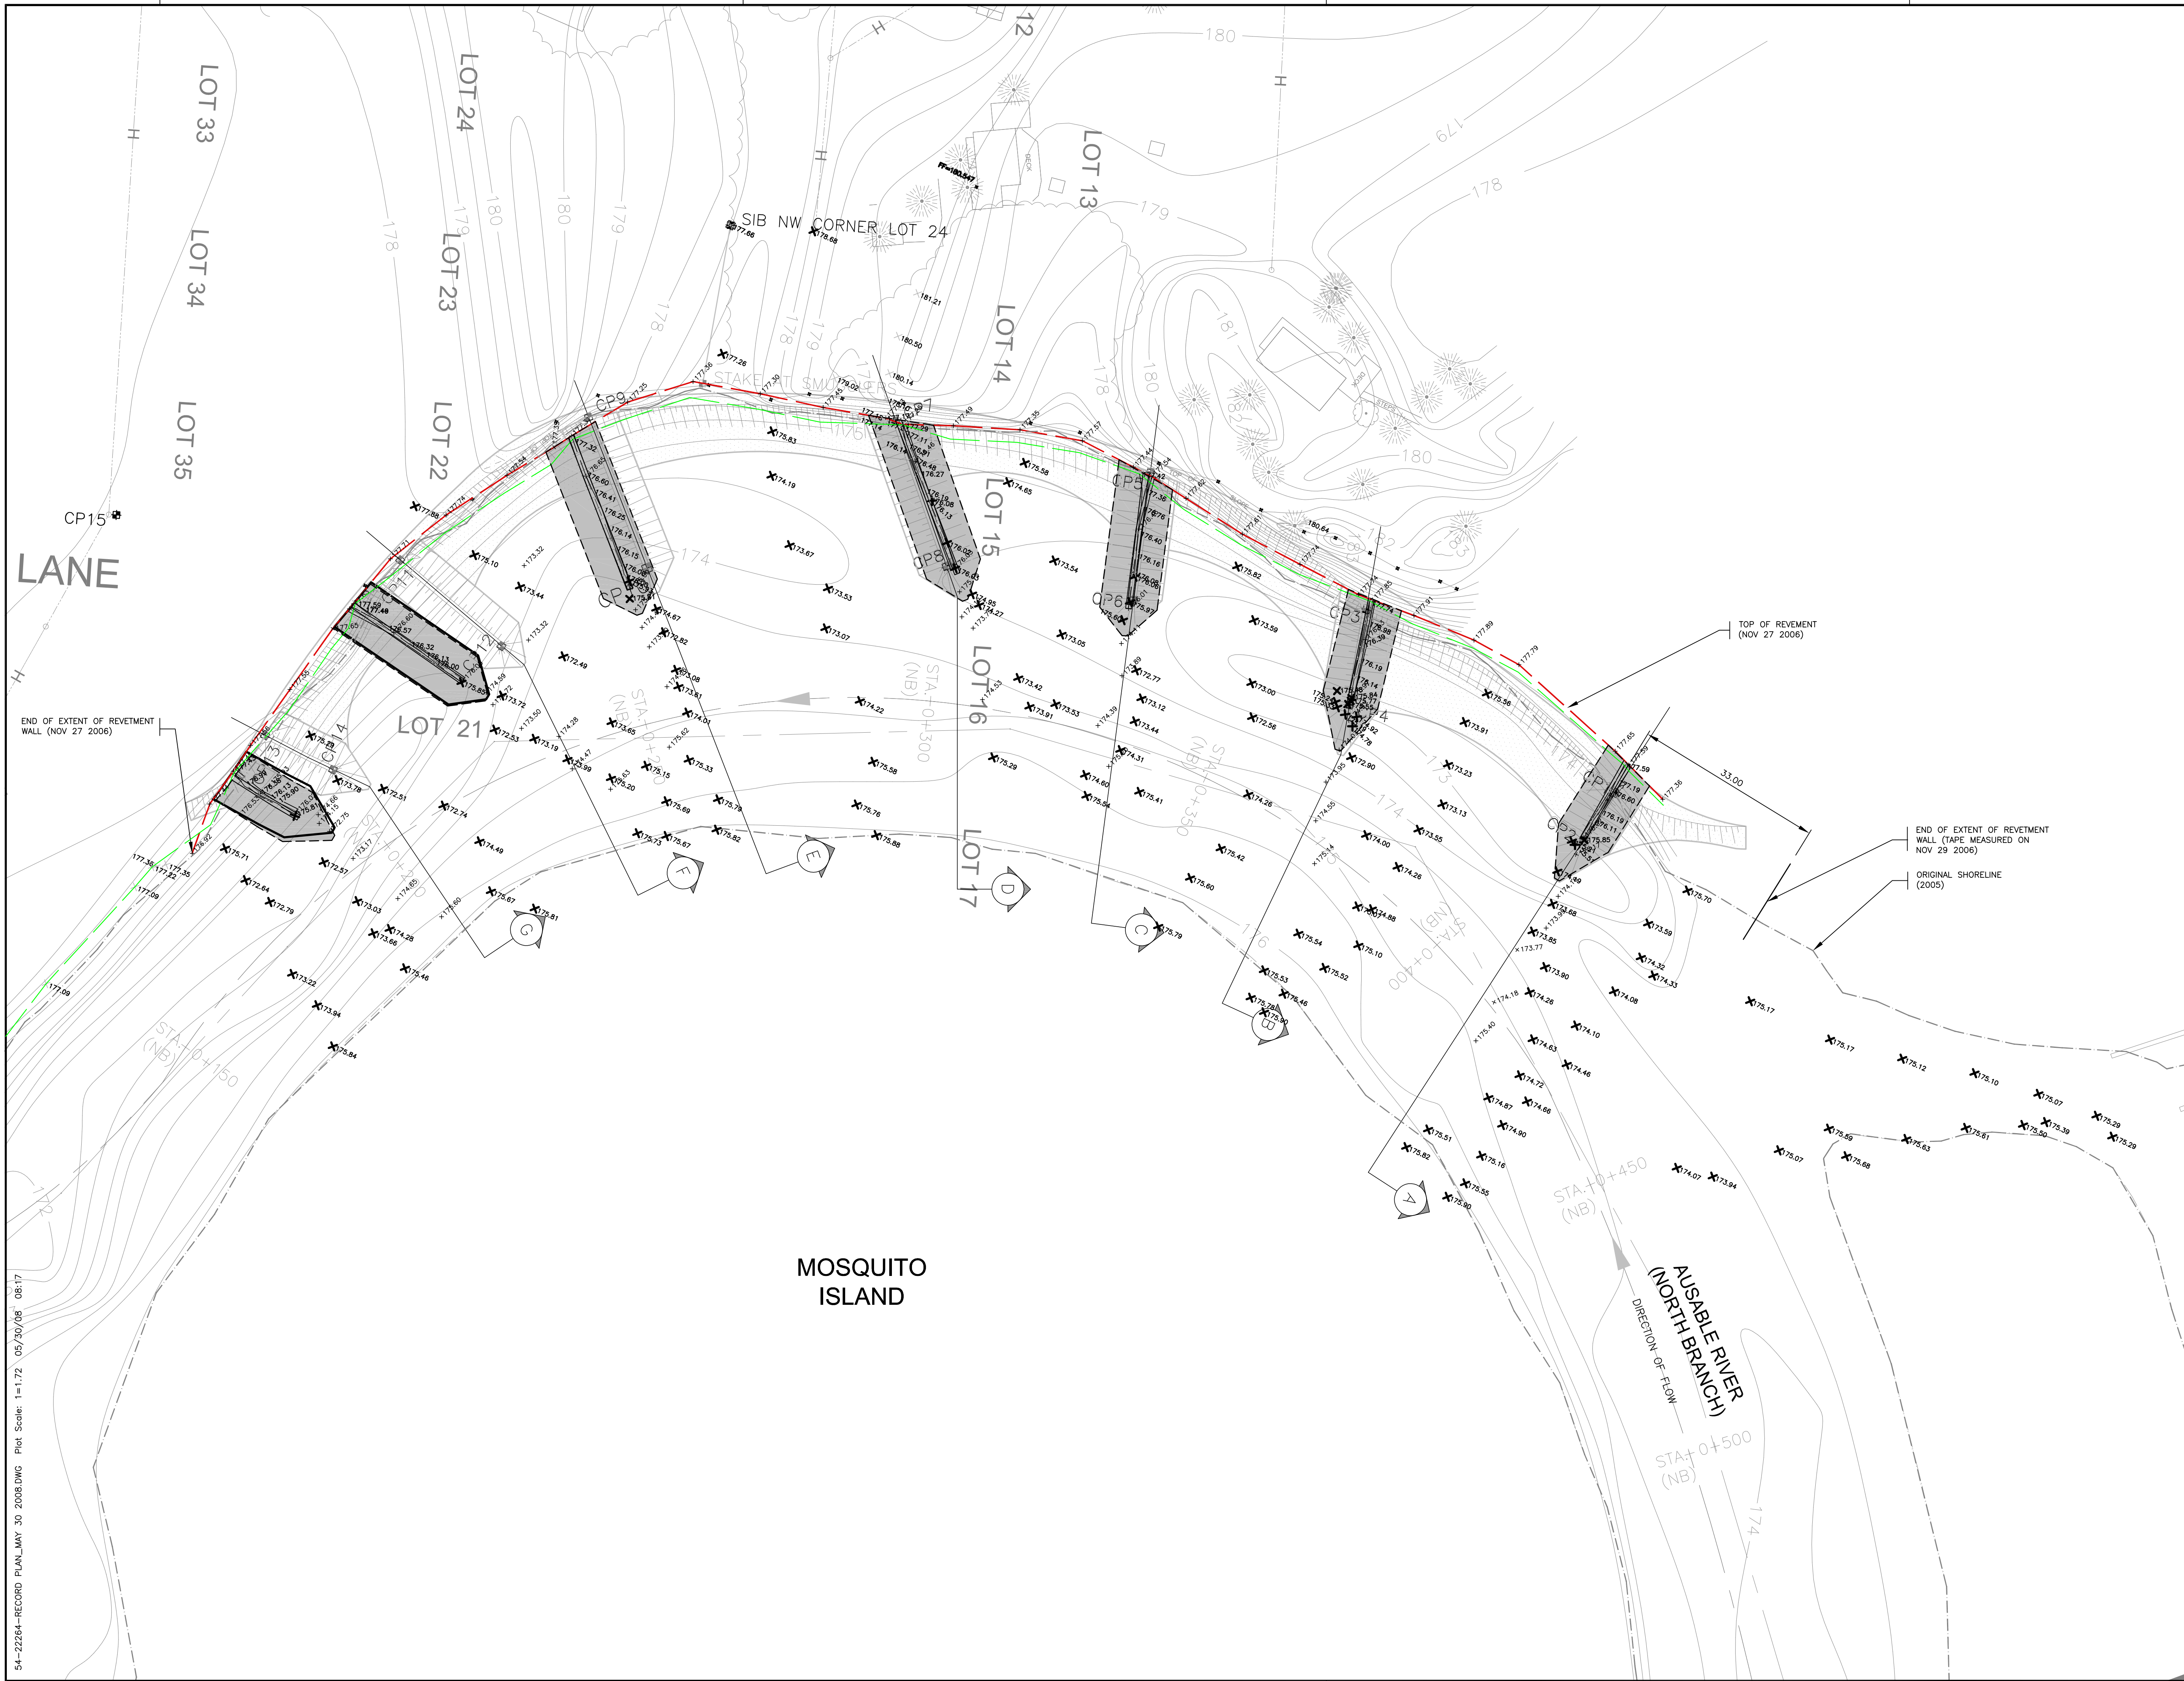
DRAWN BY: LCR/KV/MM	CHECKED BY: MG	PROJECT NO.: 54-22264-01
DESIGNED BY: HCCL/WW	APPROVED BY: RT	DRAWING NO. RP
SCALE: 1:500	DATE: MAY 2008

Following construction, a survey of the rock revetment shoreline and bendway weirs was conducted on November 27, 2006 and again on May 22, 2008 in order to produce record drawings for the project. **Drawing RP** shows the Record Plan of these erosion control works. The extent and centerline of the bendway weirs is shown under three scenarios: design conditions, November 2006 and May 2008 survey.

There has been some minor horizontal displacement of rock, most notably at Weir G, and therefore the November 2006 and May 2008 surveys show nearly coincident extent lines on the drawing. The drawing also shows the extent and top of revetment under the same scenarios, and with similar minor displacement since construction.

Some vertical settling of rock (i.e., less than 300 mm or 1ft) has occurred at all weirs. This initial settling is expected and should be monitored (i.e., re-surveyed in 2 years) to confirm further subsidence does not affect design performance. The greatest amount of settling occurred at Weir G.

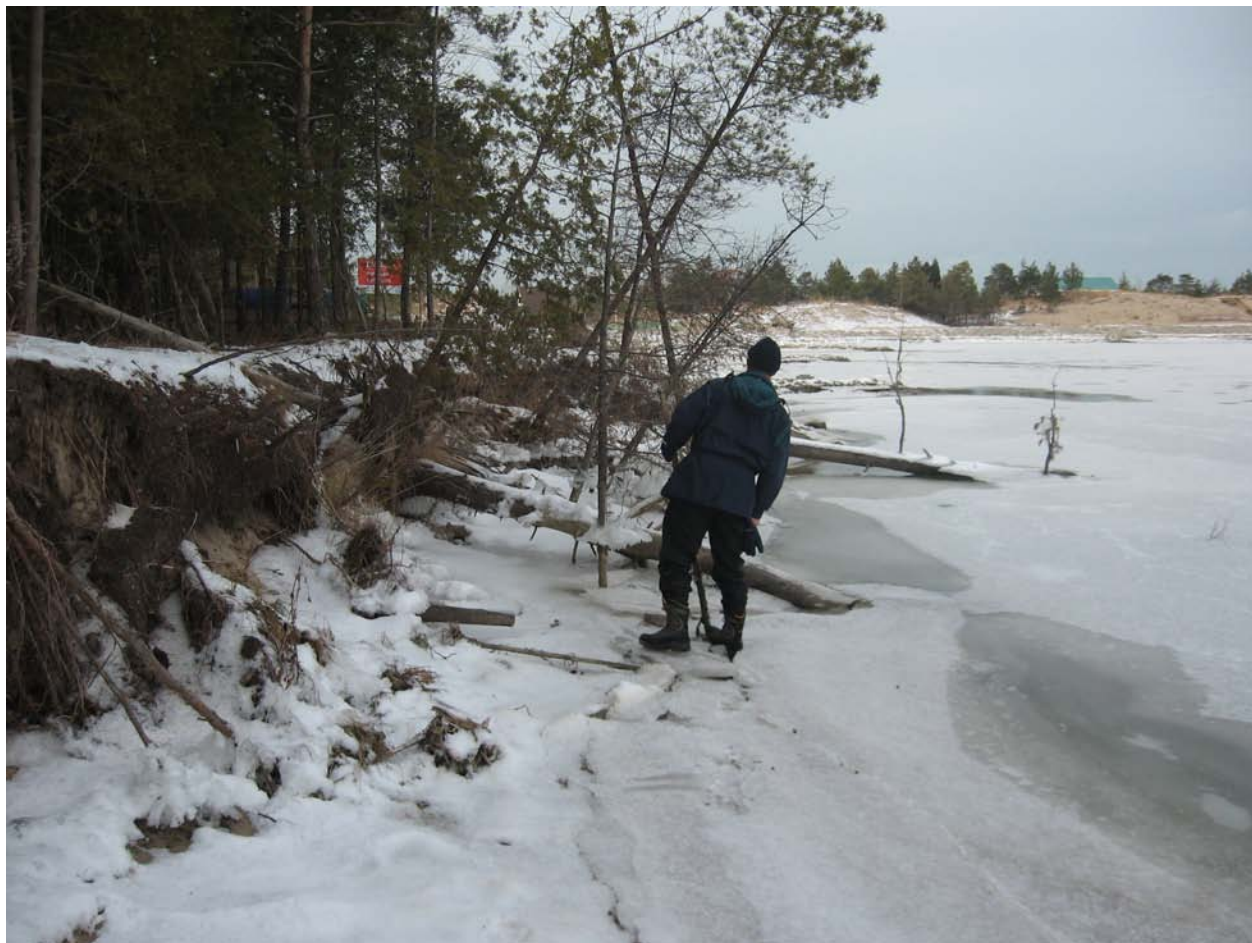
The final three photos highlight an area of concern downstream/south of the revetment. During the December 2007 inspection (see photo P45), there appeared to be excessive bank erosion at this location. However the July 2008 inspection (see photos P43 and P44) did not indicate the bank migration rate has accelerated beyond pre-construction conditions (i.e., greater than 0.5 m/year). Bank erosion and deep scour holes near the shoreline had been noted at this location for many years prior to construction.

**Figure 1 – Potential Bank Erosion (approx. 35 m downstream (south) of Weir G,
photo looking north)**

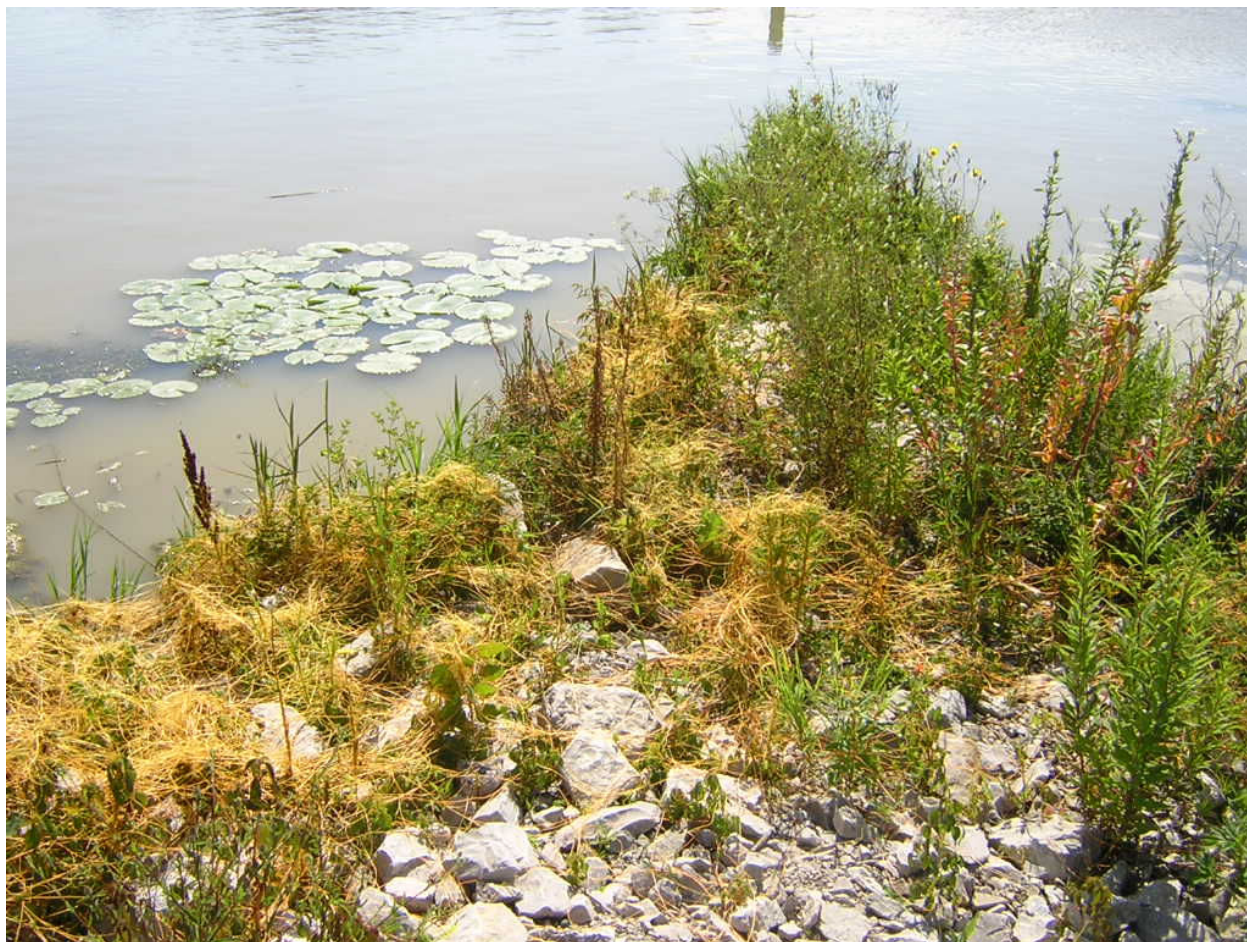
- An invasive vine was noted in a number of locations, most evident on Weirs C, E, and F and in each case has established itself on the upstream (north) side of the weirs. It has orange roots that are wrapping around and smothering other weeds and vegetation. New shoots are creeping across the rocks. It appears to have arrived within the past month or so. It is suspected to be Oriental Bittersweet (*Celastrus orbiculatus*) but not confirmed. **Figure 1** shows this vine on Weir C.

Figure 1 – Invasive vine on Weir C

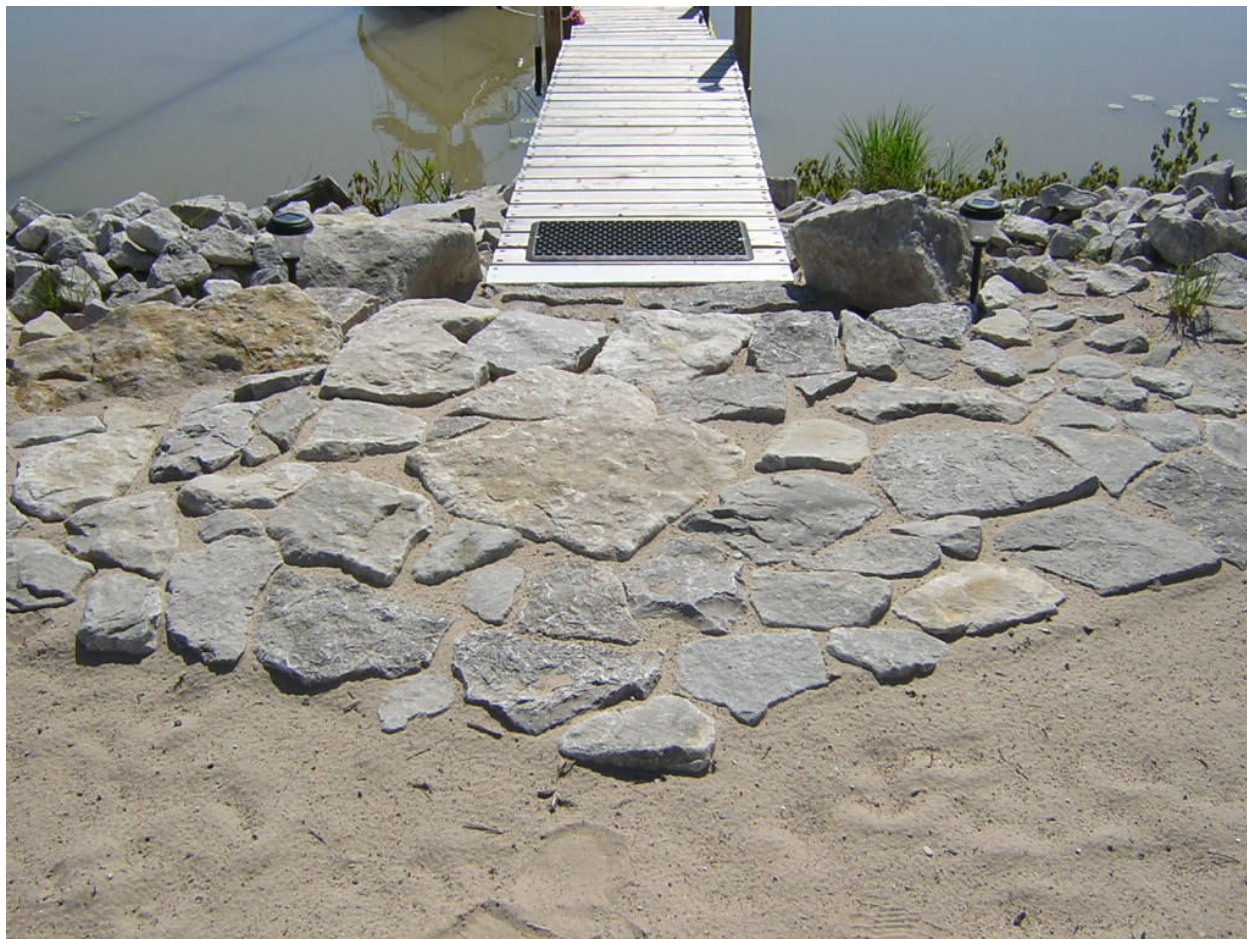
Figure 4 – Evidence of Rock Displacement by Local Residents (between Weir D and Weir E)

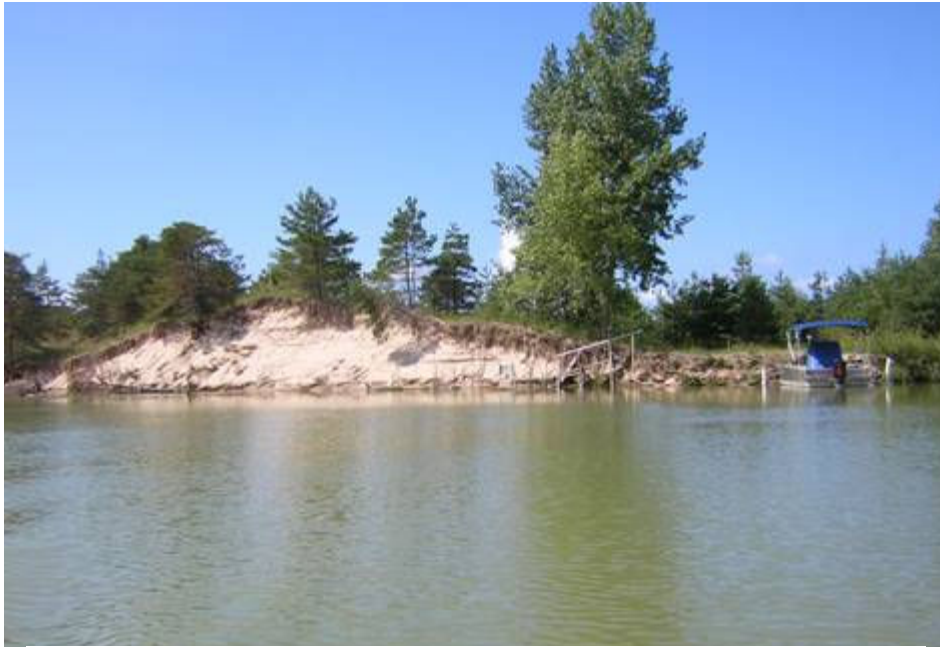
Photos E1 through E8 document pre-construction conditions and were taken in August 2005. These photos cover the length of the shoreline in the project site and indicate a highly unstable and eroding slope.

Photo E1 (23-Aug-05): Looking west at north end of project, proposed weir A.

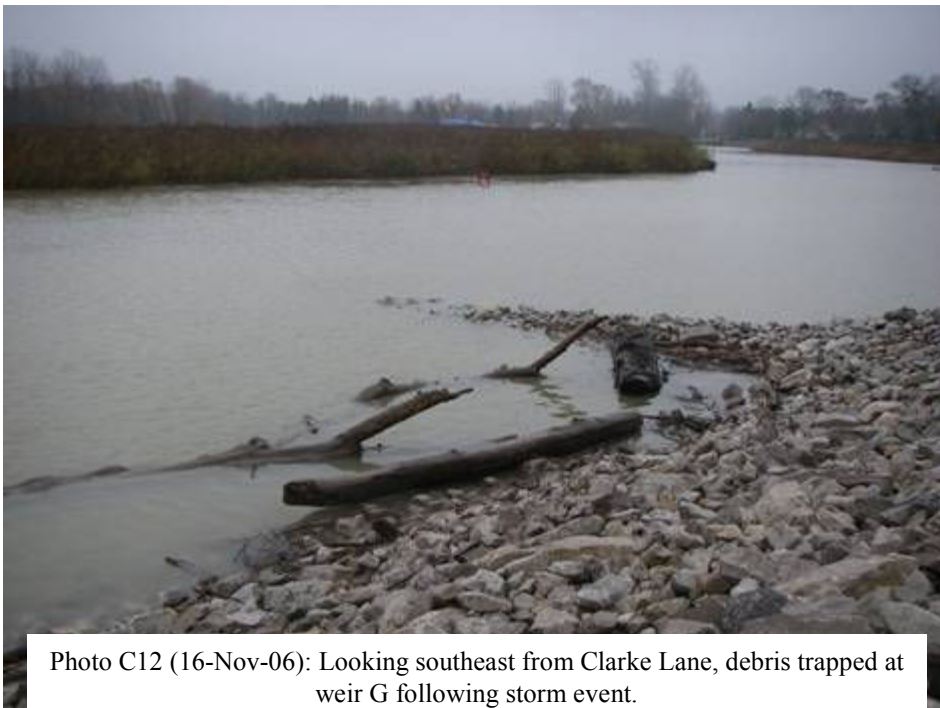
For safety reasons, construction operations were suspended during high flow conditions in the river. Only one such event occurred during the construction period. Photo C12 shows the high water level at weir G following this event in mid-November and gives evidence of the debris that was trapped. The collection of floating debris by the weirs is encouraged as it helps to re-establish bank and also prevents this debris from impacting boaters and property downstream.

Photo C12 (16-Nov-06): Looking southeast from Clarke Lane, debris trapped at weir G following storm event.

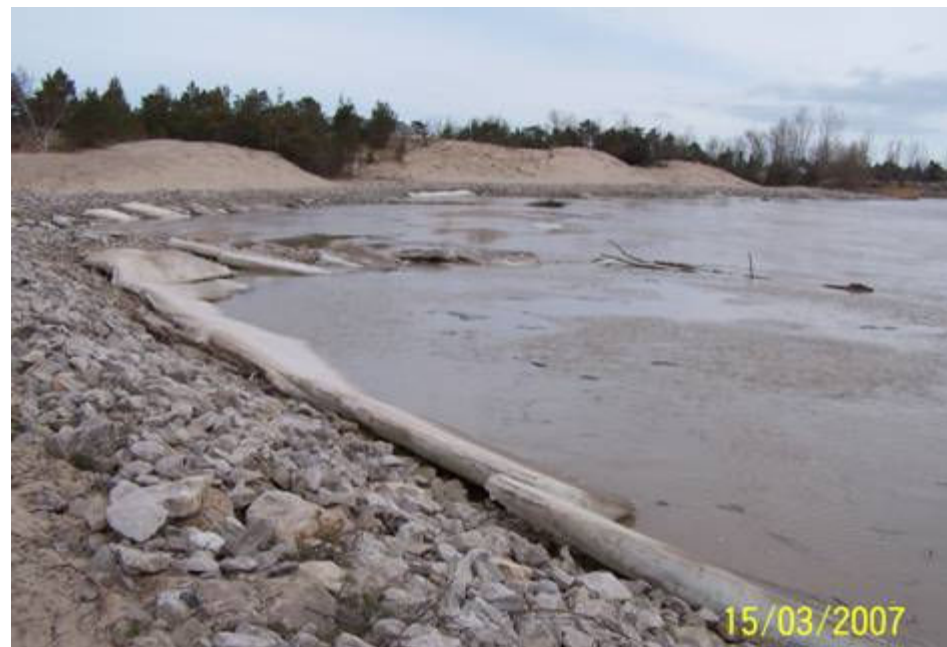
Photo P4 (15-Mar-07, ABCA): Looking north from Lot 22, note ice and debris.

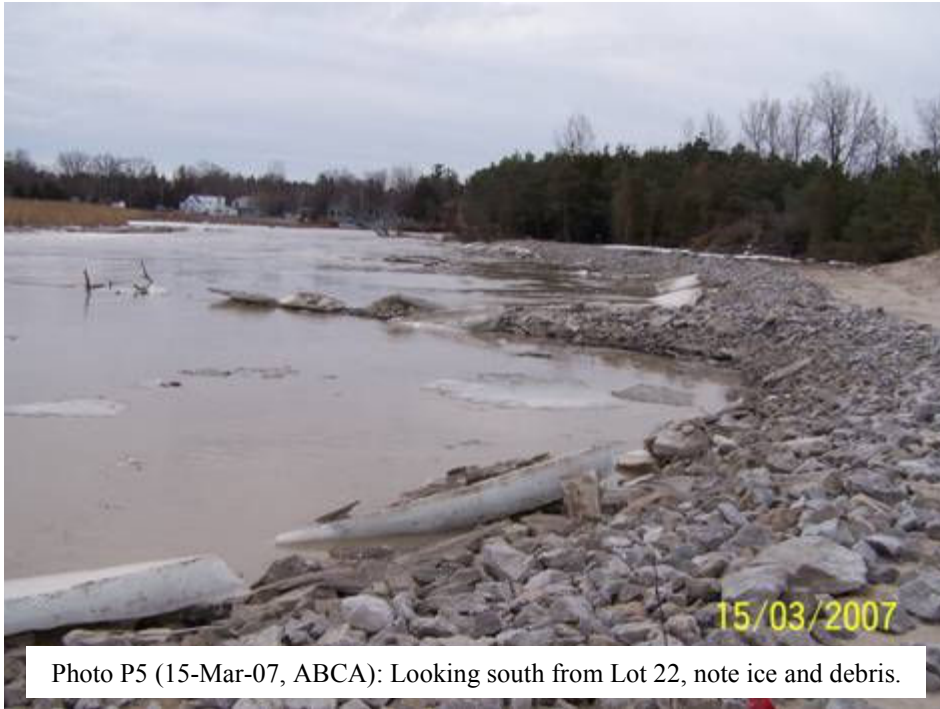
Photo P5 (15-Mar-07, ABCA): Looking south from Lot 22, note ice and debris.

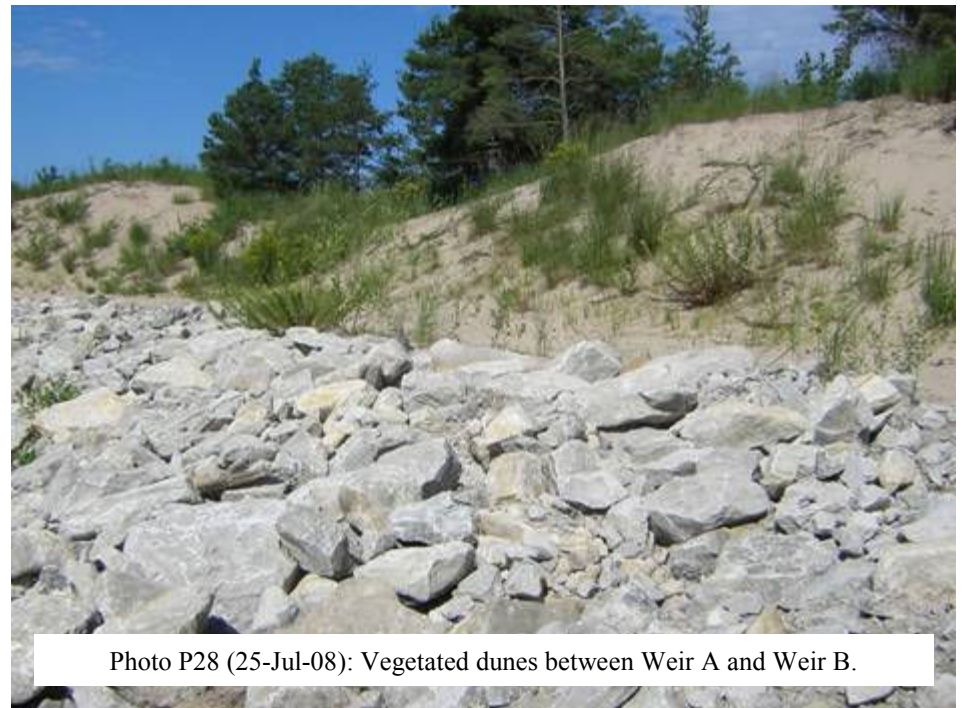
Further, the dune grass plugs that were planted in mid-November as well as other dune vegetation has grown well in the sand dunes between Weir A and Weir D (see photo P28). This gives an indication that the banks have been sufficiently stabilized to support such vegetation.

Photo P28 (25-Jul-08): Vegetated dunes between Weir A and Weir B.
