Considerations for Shoreline Protection Structures

December 7 2017 | 12646.101

Ausable Bayfield Conservation Authority
71108 Morrison Line
Exeter, ON N0M 1S5

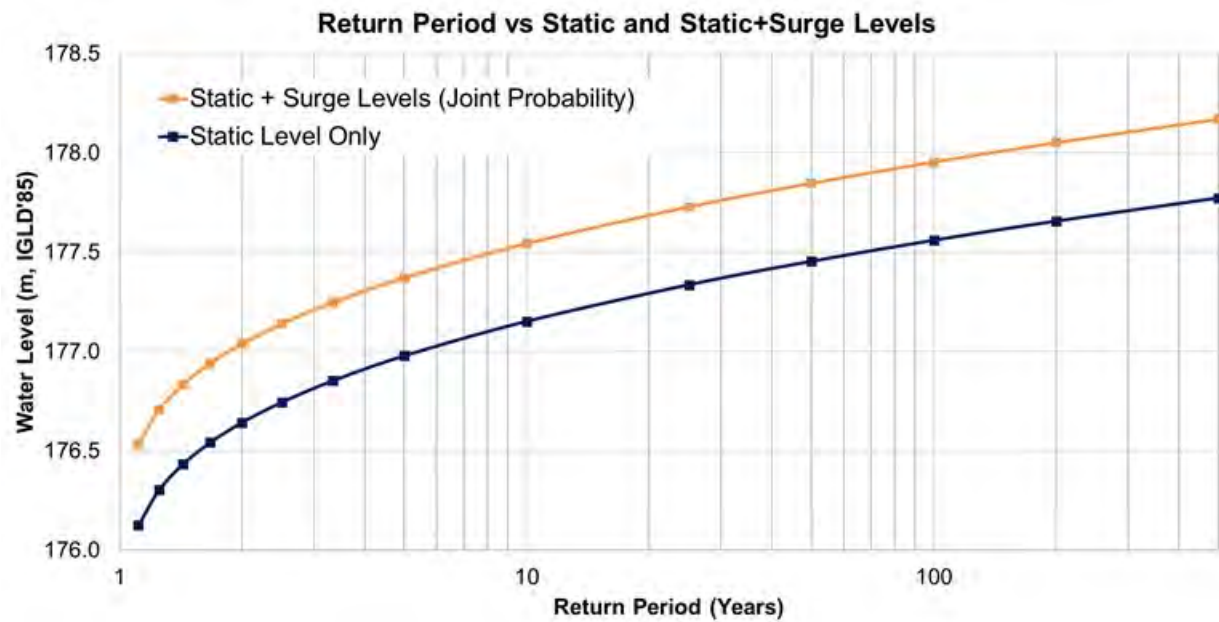
Figure B.1: Probability distributions of static lake level, joint static + surge level at Goderich

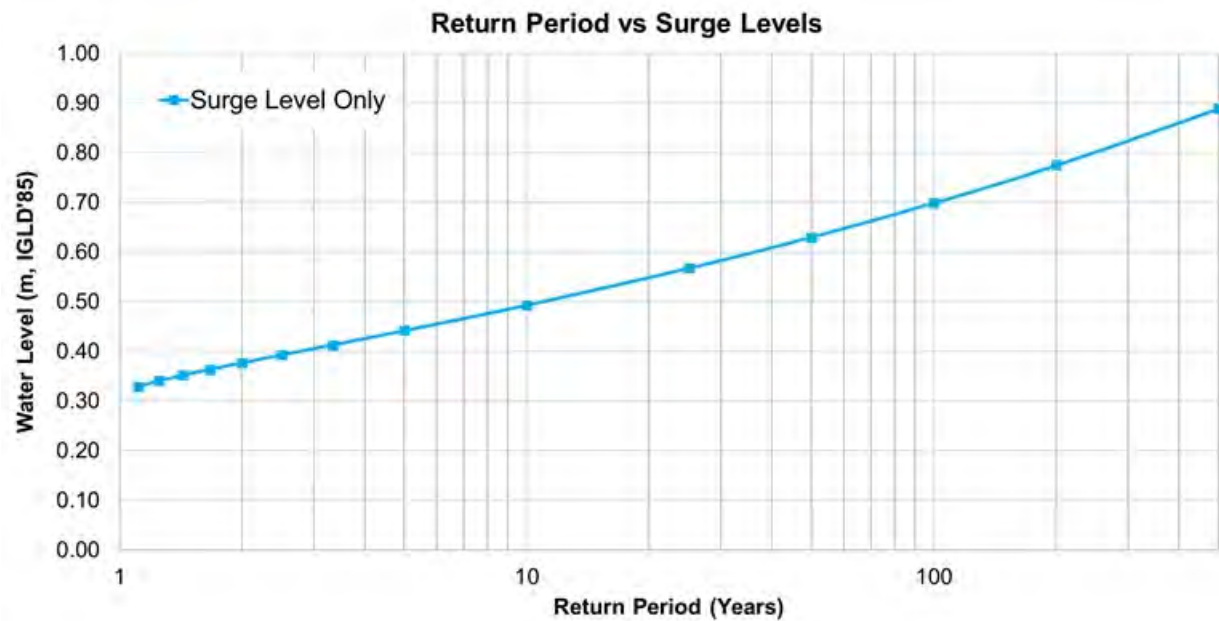
Figure B.2: Probability distributions of surge at Goderich
