Mosquito Control Study for Parkhill, Ontario, 2011

January 10, 2012

Angela Van Niekerk, Tom Prout

Ausable Bayfield Conservation Authority
71108 Morrison Line
RR 3, Exeter, Ontario, N0M 1S5, Canada

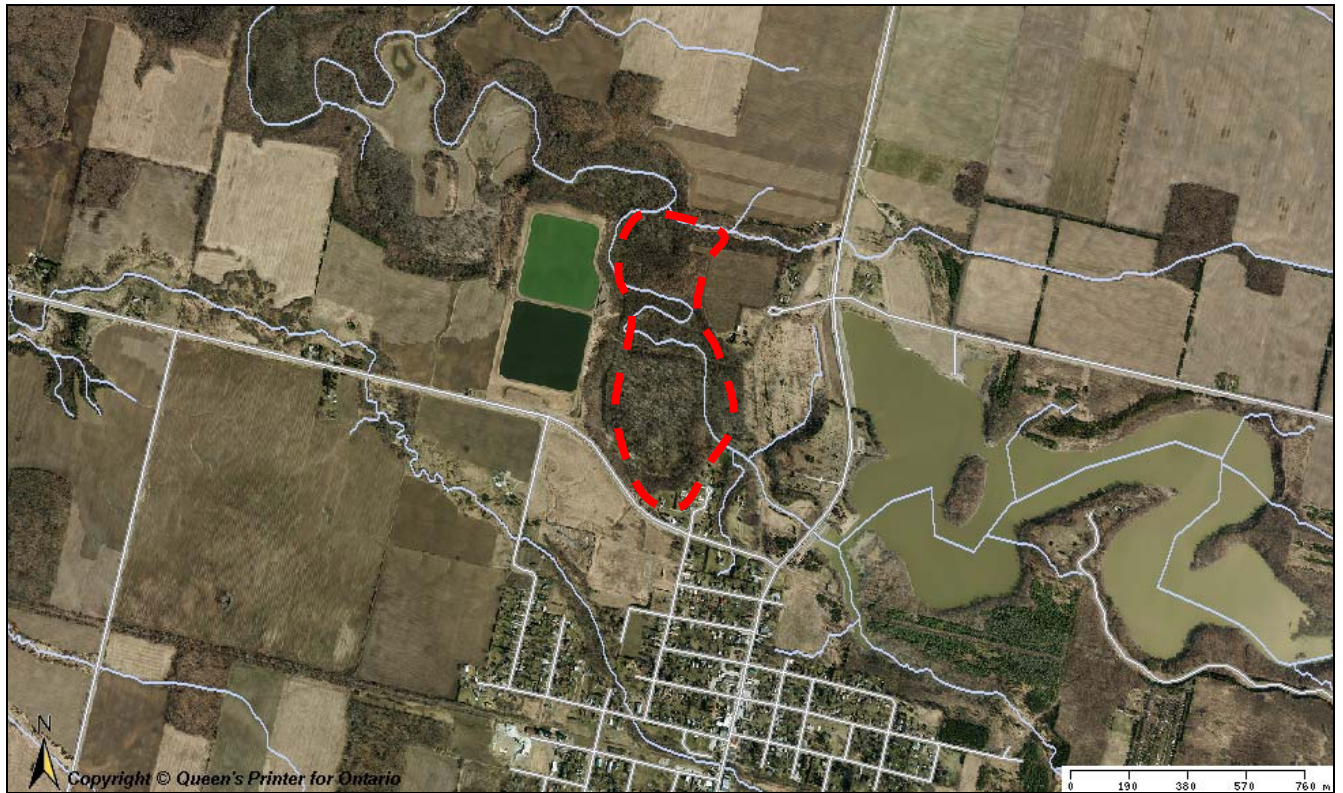
Figure 3: Parkhill Creek north of Parkhill, Ontario outlining the 25 hectare (62 acre) area of focus for mosquito habitat.

One of the mosquito breeding focus areas identified by the Municipality of North Middlesex, Pestalto, and Middlesex-London Health Unit includes two wetlands adjacent to Parkhill Creek downstream of the dam (Concession 5WCR, Lot 7, part Lot 6, McGillivray and part of Concession 20, Lot 6 & 7, West Williams) (Figure 3). The area is about 25 hectares or 62 acres in size. Property ownership in the area includes the Ausable Bayfield Conservation Authority, Municipality of North Middlesex and 19 per cent is privately owned. The Parkhill Creek meanders through this low area and flows between the south and north wetland which is part of the focus area. The south and north wetlands are low flat water storage areas or floodplains adjacent to Parkhill Creek.

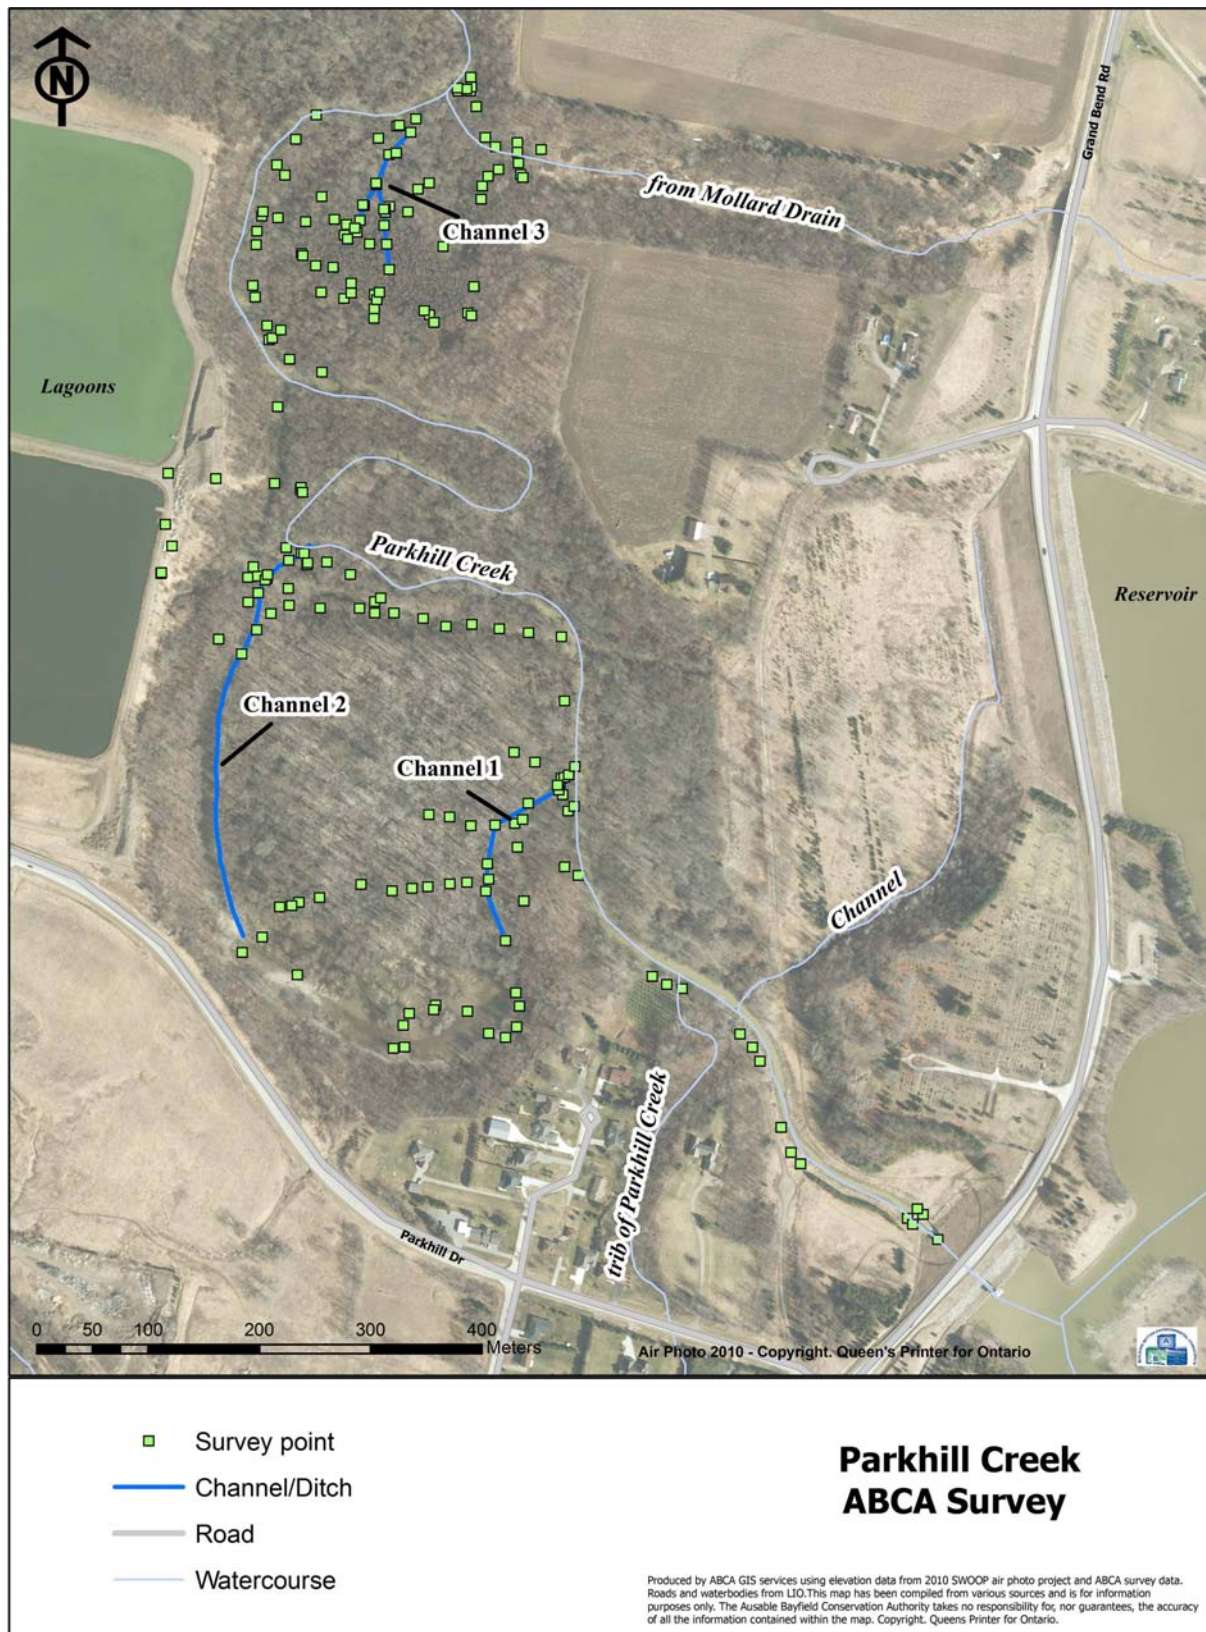
Figure 4: Parkhill Creek wetland survey indicating watercourses, dug channels and survey points within the area of focus.

The watershed boundary for Lower Parkhill Creek follows Parkhill Drive along the south border of the wetland area of focus. The area south of Parkhill Drive is in the Cameron-Gilles Drain watershed. However, there are two 24 inch culverts under Parkhill Drive that potentially transport water into the wetland area of focus.

Within this study area, drainage alterations have been made by adjacent landowners. The capacities of these drains are unknown. For example a tile was installed in the vicinity of Channel 2 (refer to Figure 4) in the 1970's. The function and capacity of this drain should be better understood.

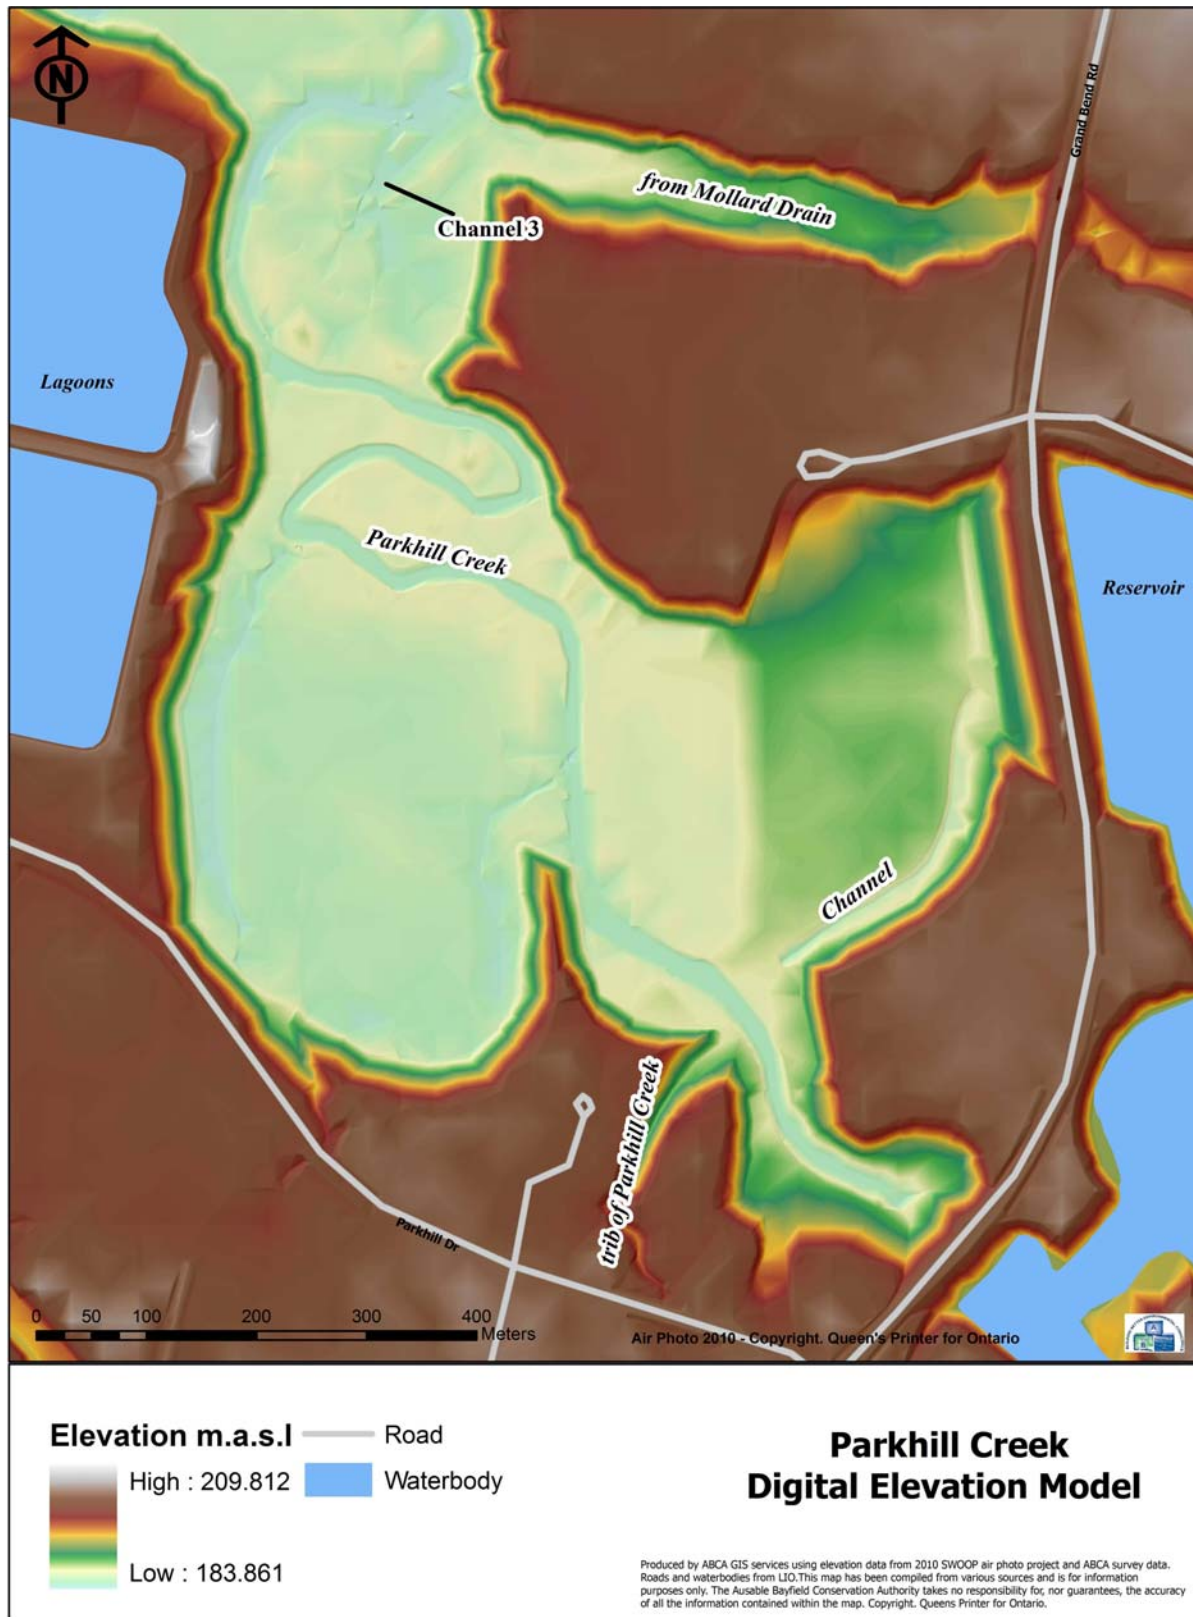
Figure 5: Parkhill Creek wetland digital elevation model using water elevations surveyed on November 8, 2011.

The ABCA has completed a detailed elevation survey and model of the wetland elevations to further investigate water levels in the focus area. This model can help to analyze elevations within the wetland area to see what happens during low and high water conditions in natural conditions and with regards to the channels that were created to manage water levels. It is the finding of this report that had the side channels not been excavated, flooding of the disconnected wetland areas would likely only have occurred during periods of significantly elevated flood stage within the Parkhill Creek to levels exceeding the bank

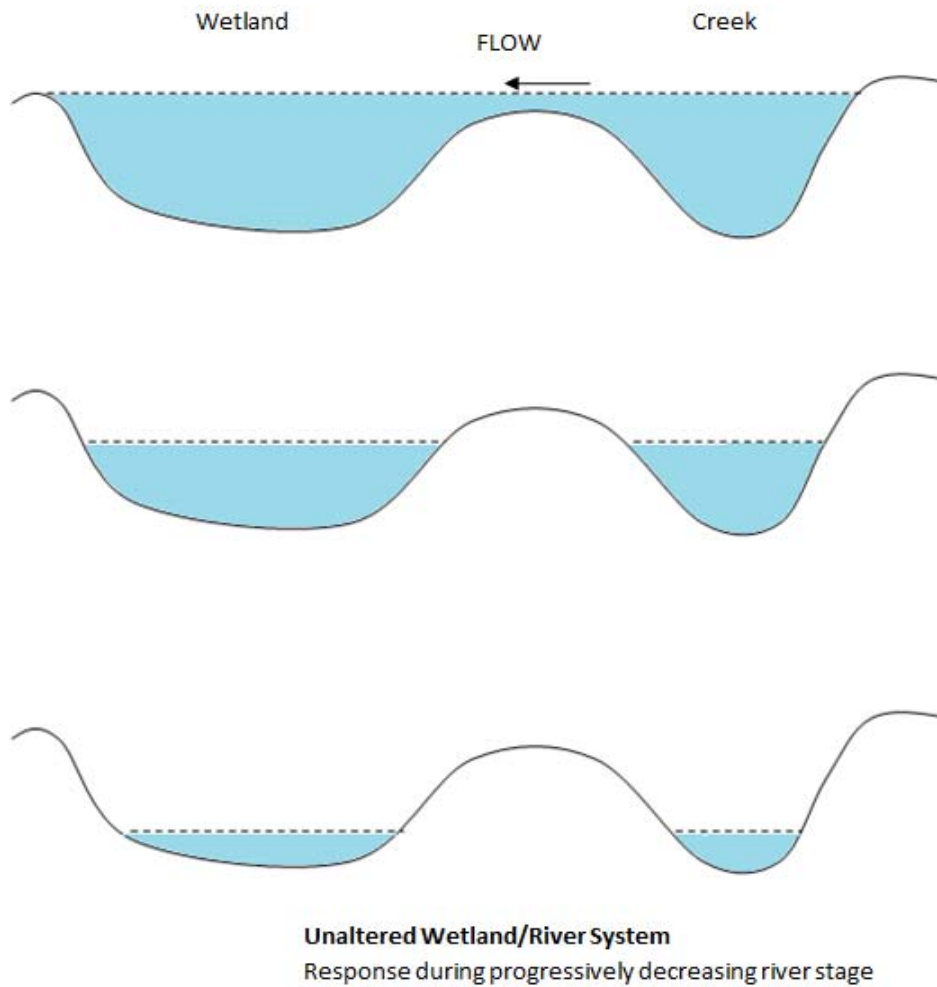
Figure 7: Unaltered wetland and creek system where the water in the creek levels decrease over time. The water levels in the wetland eventually decrease, slower than the creek water levels, after initially overflowing the top of the banks.

The “Unaltered” figures describe conceptually what would be occurring for a system which had not been artificially altered (*i.e.* if side channels as described had not been excavated). Under the “Unaltered” conditions, the flooding of the disconnected wetland areas would be expected to occur generally only during a condition when the Parkhill Creek flood level is on the rise and the level has exceeded the bank full condition and the Creek has spilled over the banks (Figure 6 and Figure 7).

full condition (Figures 6 and 7). This condition would generally occur infrequently throughout the year however would be expected to occur on a regular basis each spring during the period of thaw (spring freshet).

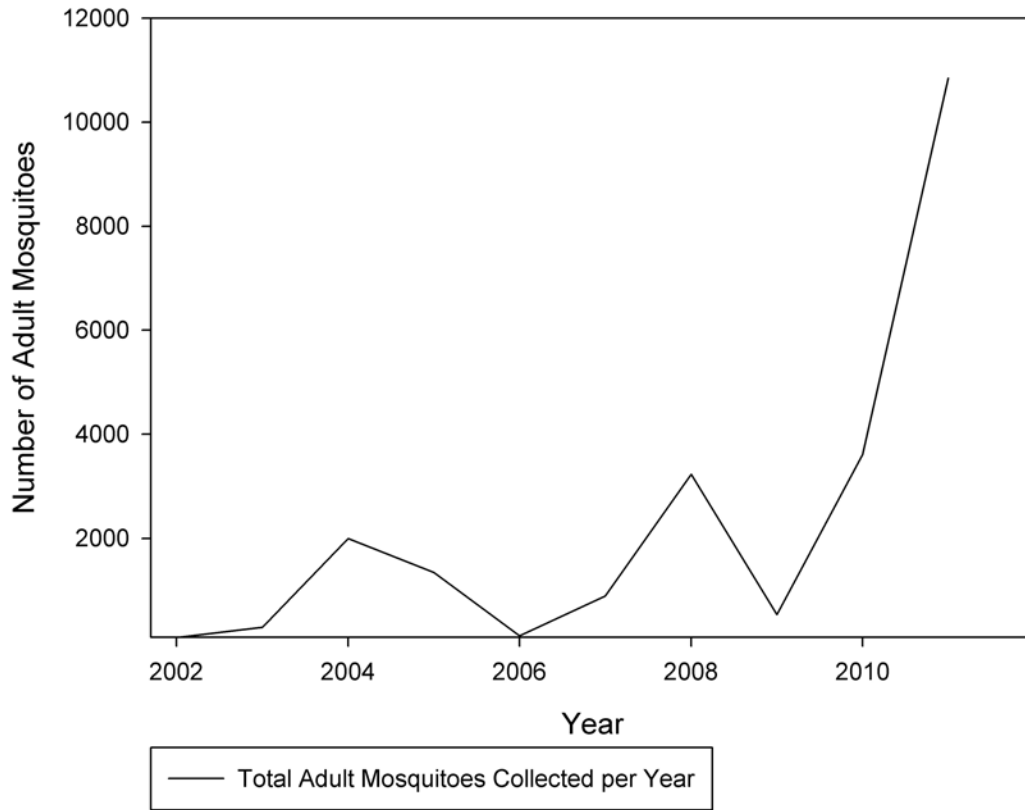
Yearly Total Adult Mosquitoes Collected in Parkhill

Figure 10: Yearly total adult mosquitoes collected in Parkhill from 2002 to 2011.

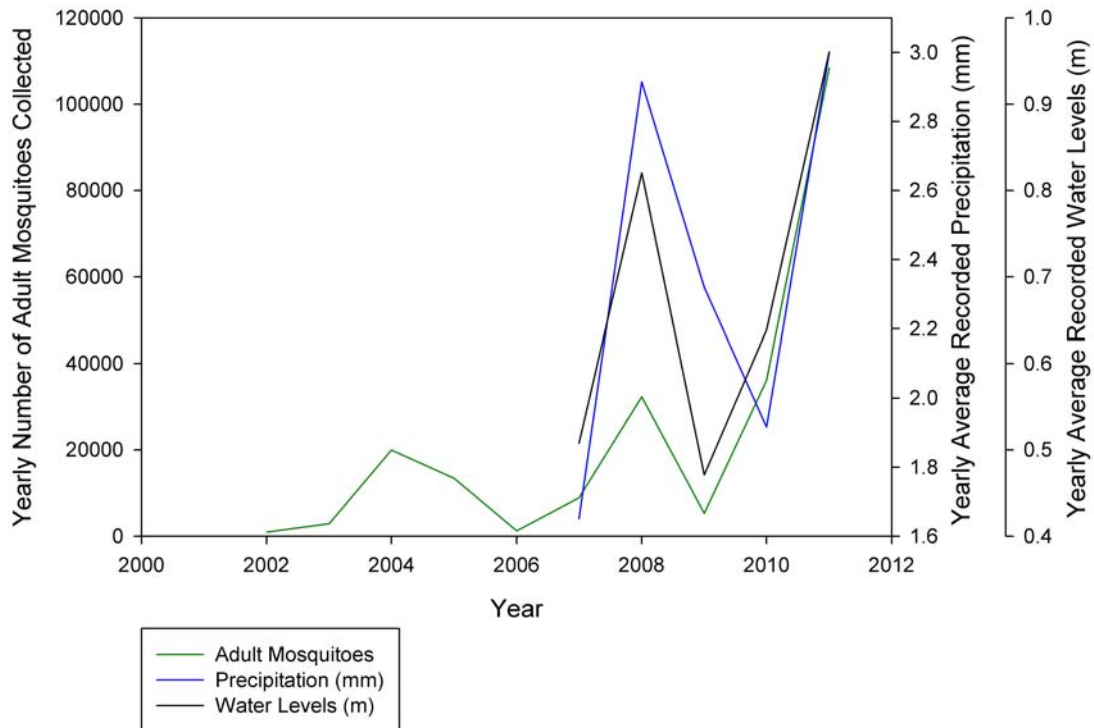
Yearly Total Adult Mosquitoes Collected and Yearly Average Precipitation and Water Levels

Figure 11: Yearly total adult mosquitoes trapped in Parkhill, and yearly average precipitation and yearly average water levels from 2007 to 2011.

The precipitation and water levels were compared with the total adult mosquitoes collected from Middlesex-London Health Unit surveillance data to see if there were any obvious relationships. The yearly total adult mosquitoes collected from 2002 to 2011 were compared to the yearly average precipitation (mm) in Parkhill and yearly average water levels (m) in Parkhill Creek from 2007 to 2011. Not surprisingly, the precipitation and water levels peaked during 2008 and 2011 and this corresponds well with peak mosquito population years (Figure 11).

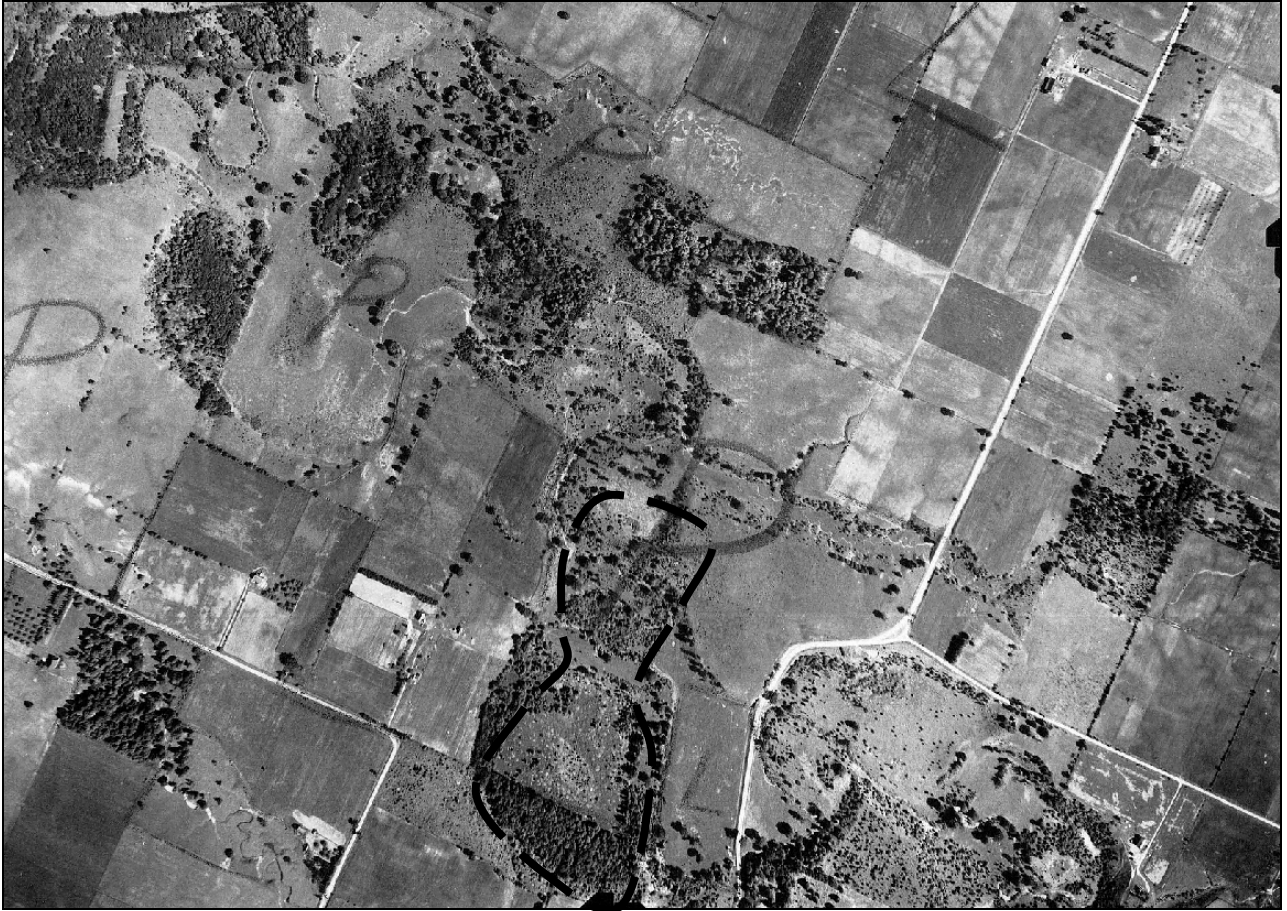
Figure 1: 1947 aerial photo of Parkhill wetland. Black dotted line marks area of focus.

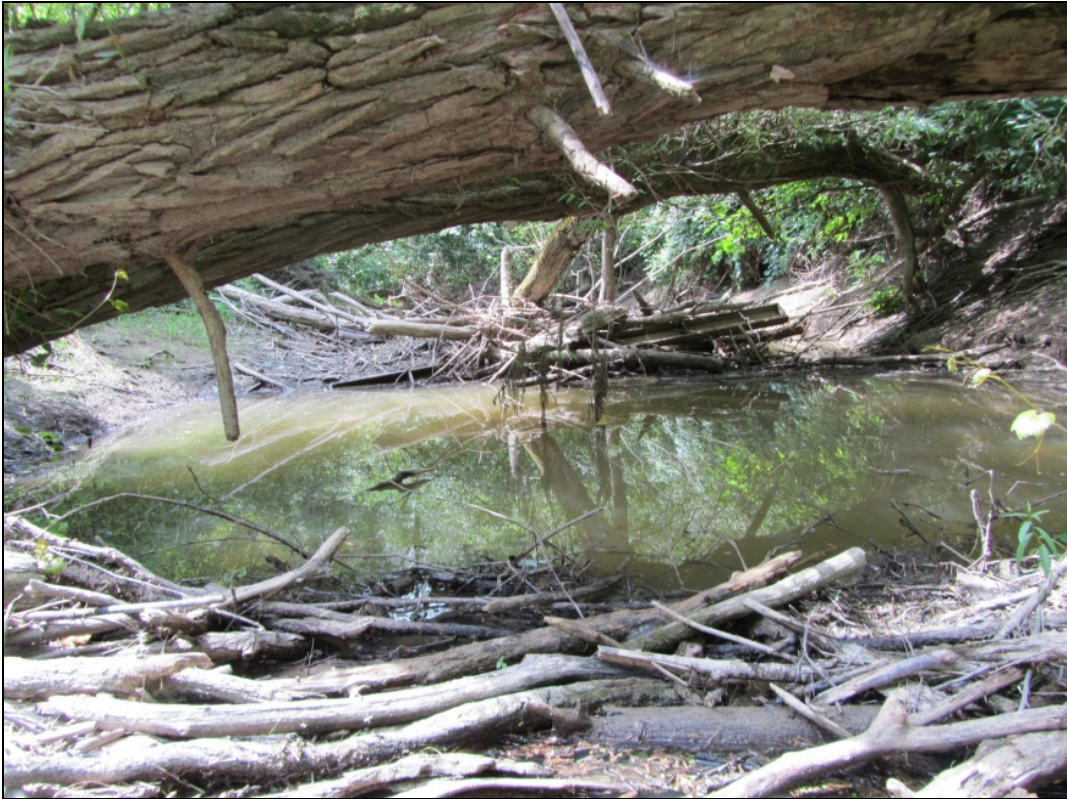
Figure 3: Photo of log jam in Parkhill Creek.

The ABCA has provided an in-depth investigation of the management area of focus and found many log jams in Parkhill Creek. The Municipality of North Middlesex has completed removal of those log jams in October, 2011 which has helped the Parkhill Creek to flow.

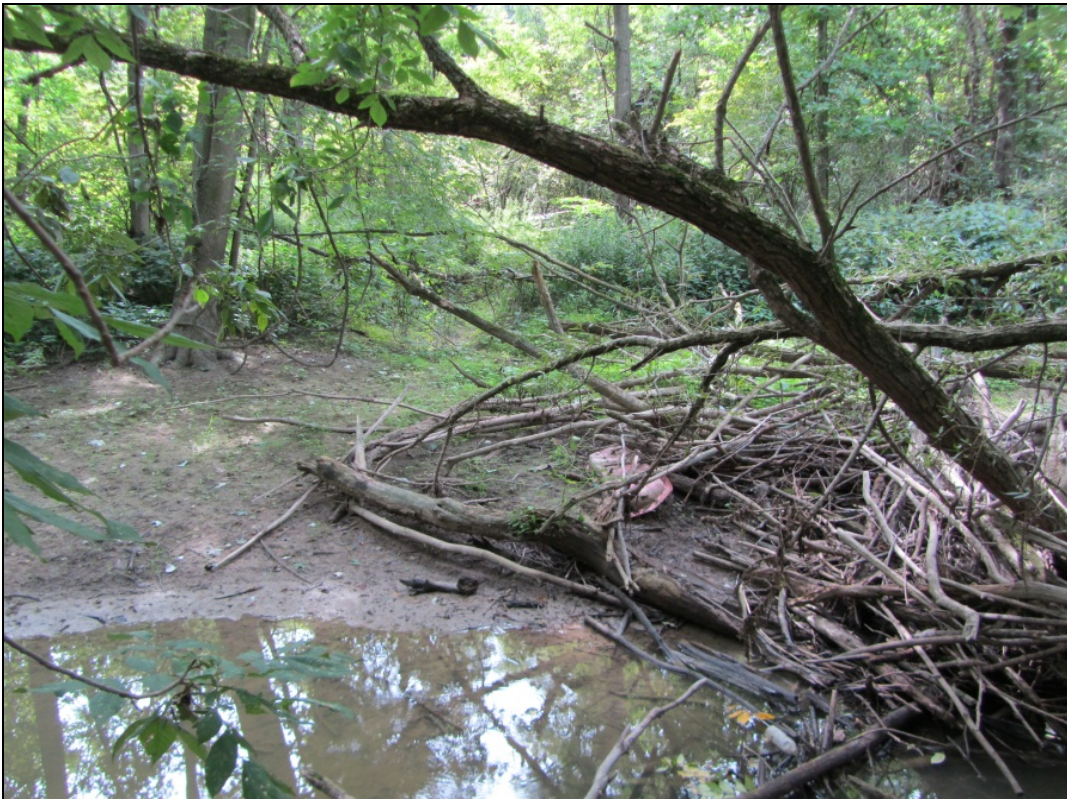
Figure 4: Photo of log jam in Parkhill Creek, facing outlet of Channel 2.

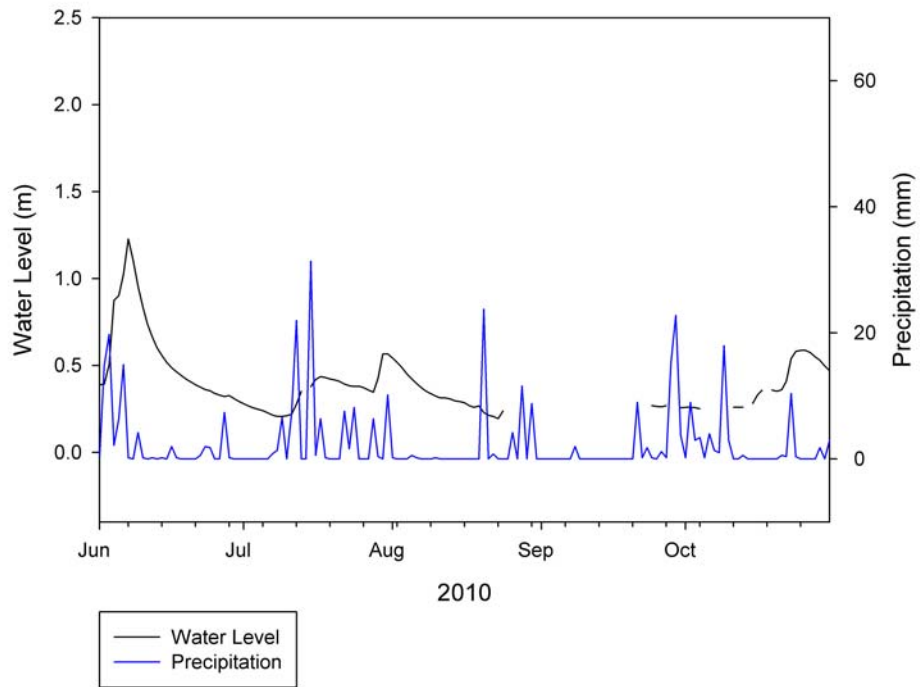
June to October 2010 Precipitation in Parkhill and Water Levels in Parkhill Creek

Figure 4: Precipitation (mm) recorded in Parkhill and Water Levels (m) recorded below dam in Parkhill Creek.

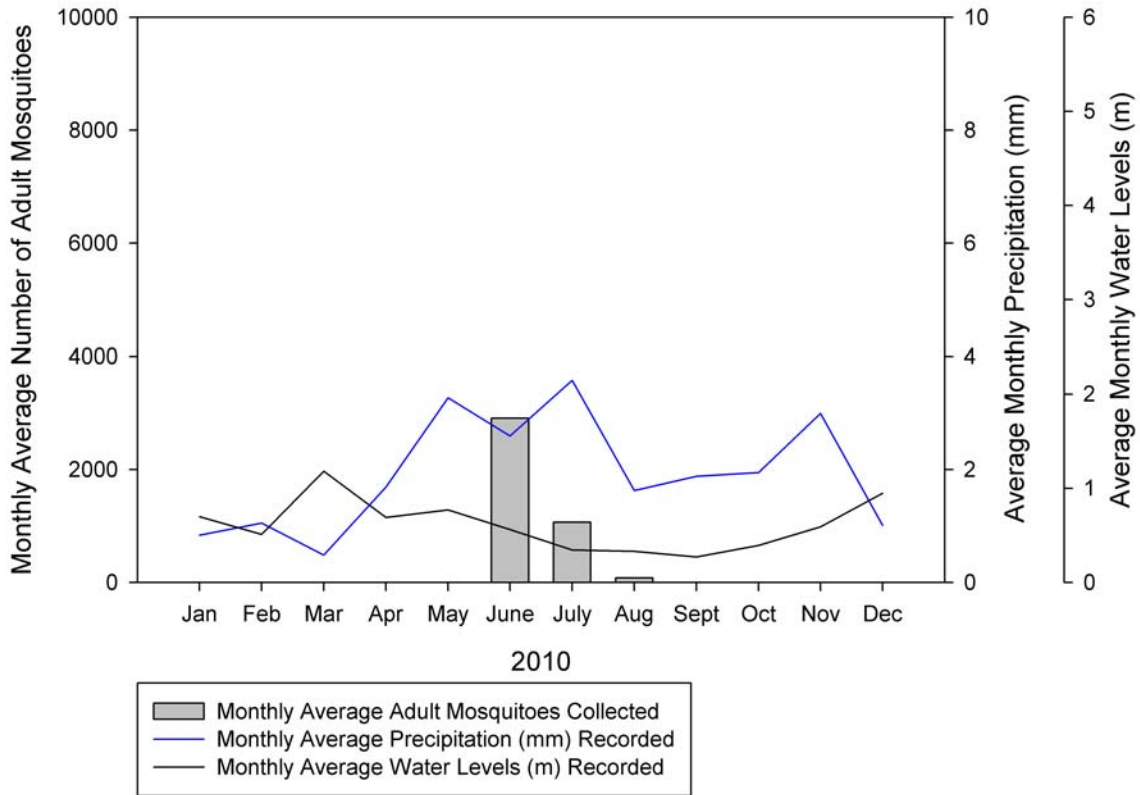
2010 Monthly Average Adult Mosquitoes Collected
and Average Precipitation (mm) and Water Levels (m)

Figure 3: 2010 monthly average of adult mosquitoes collected over the summer months and the average precipitation in Parkhill (mm) and average water levels (m) recorded in Parkhill Creek below the dam.

Figures 1 to 4 (Appendix E) provide the monthly average adult mosquitoes trapped compared to the average precipitation and water levels for each year, 2008 to 2011. Some of these graphs show a peak in mosquito numbers after a precipitation spike. It is likely that the rain events and large snow accumulations in the wetter years do increase mosquito populations. Daily precipitation was graphed with weekly mosquito totals to see if there were common spikes relating higher rainfall with higher mosquito population spikes a few weeks later after emerging as adults (Appendix F: Figures 1 to 4). It is hard to recognize specific relationships between the precipitation and mosquito populations from just the baseline data, but rainfall seem to be an important factor.

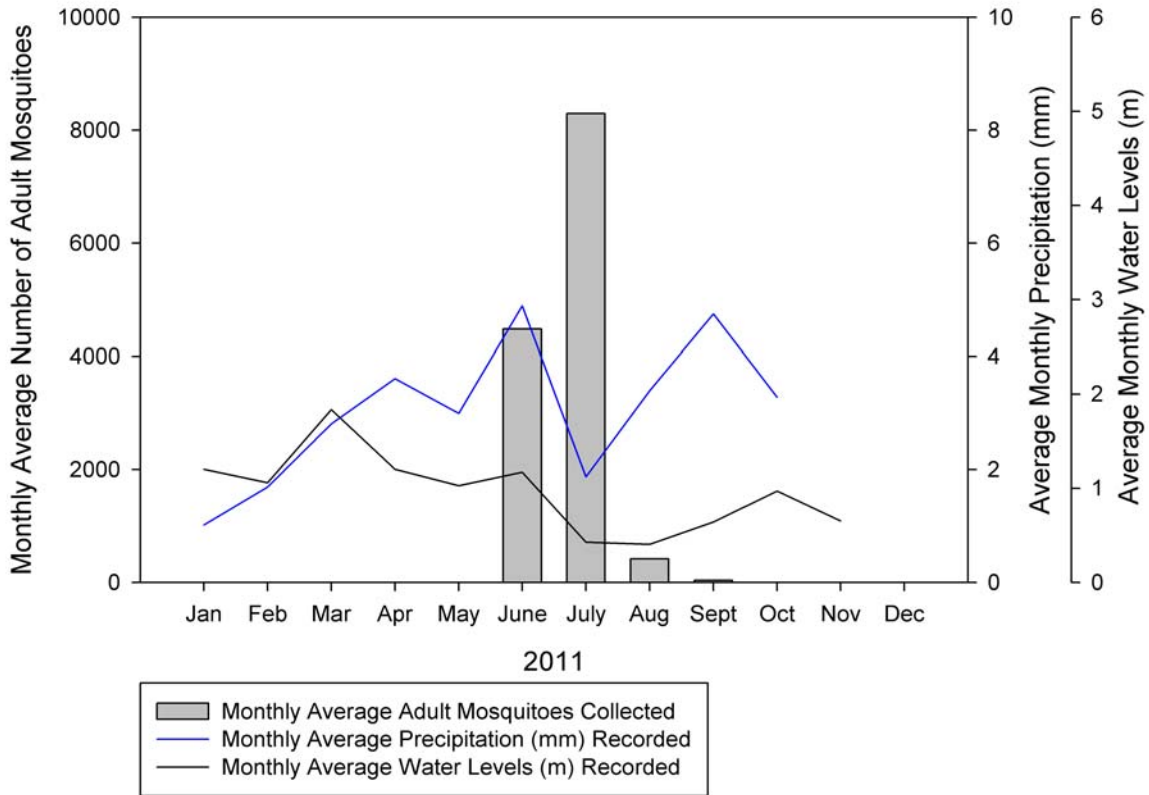
2011 Monthly Average Adult Mosquitoes Collected
and Average Precipitation (mm) and Water Levels (m)

Figure 4: 2011 monthly average of adult mosquitoes collected over the summer months and the average precipitation in Parkhill (mm) and average water levels (m) recorded in Parkhill Creek below the dam.

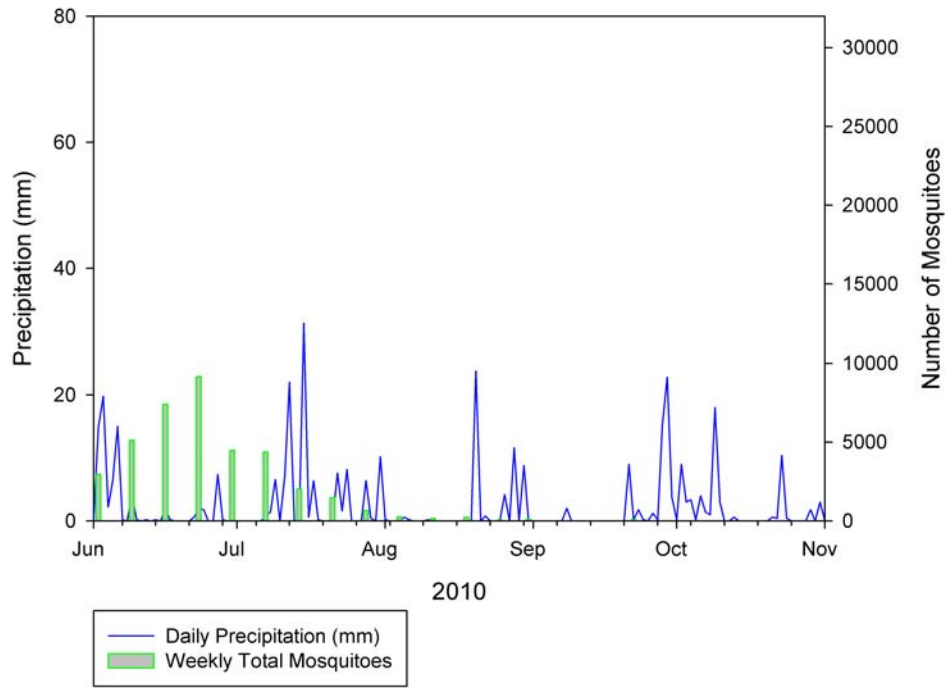
2010 Daily Precipitation (mm) recorded & Weekly Number of Mosquitoes Collected

Figure 3: Daily precipitation (mm) recorded in Parkhill and total weekly mosquitoes collected in traps throughout June to October in Parkhill for 2010.
