Ausable Bayfield Watershed Report Card

Part A: The Report Card Overview

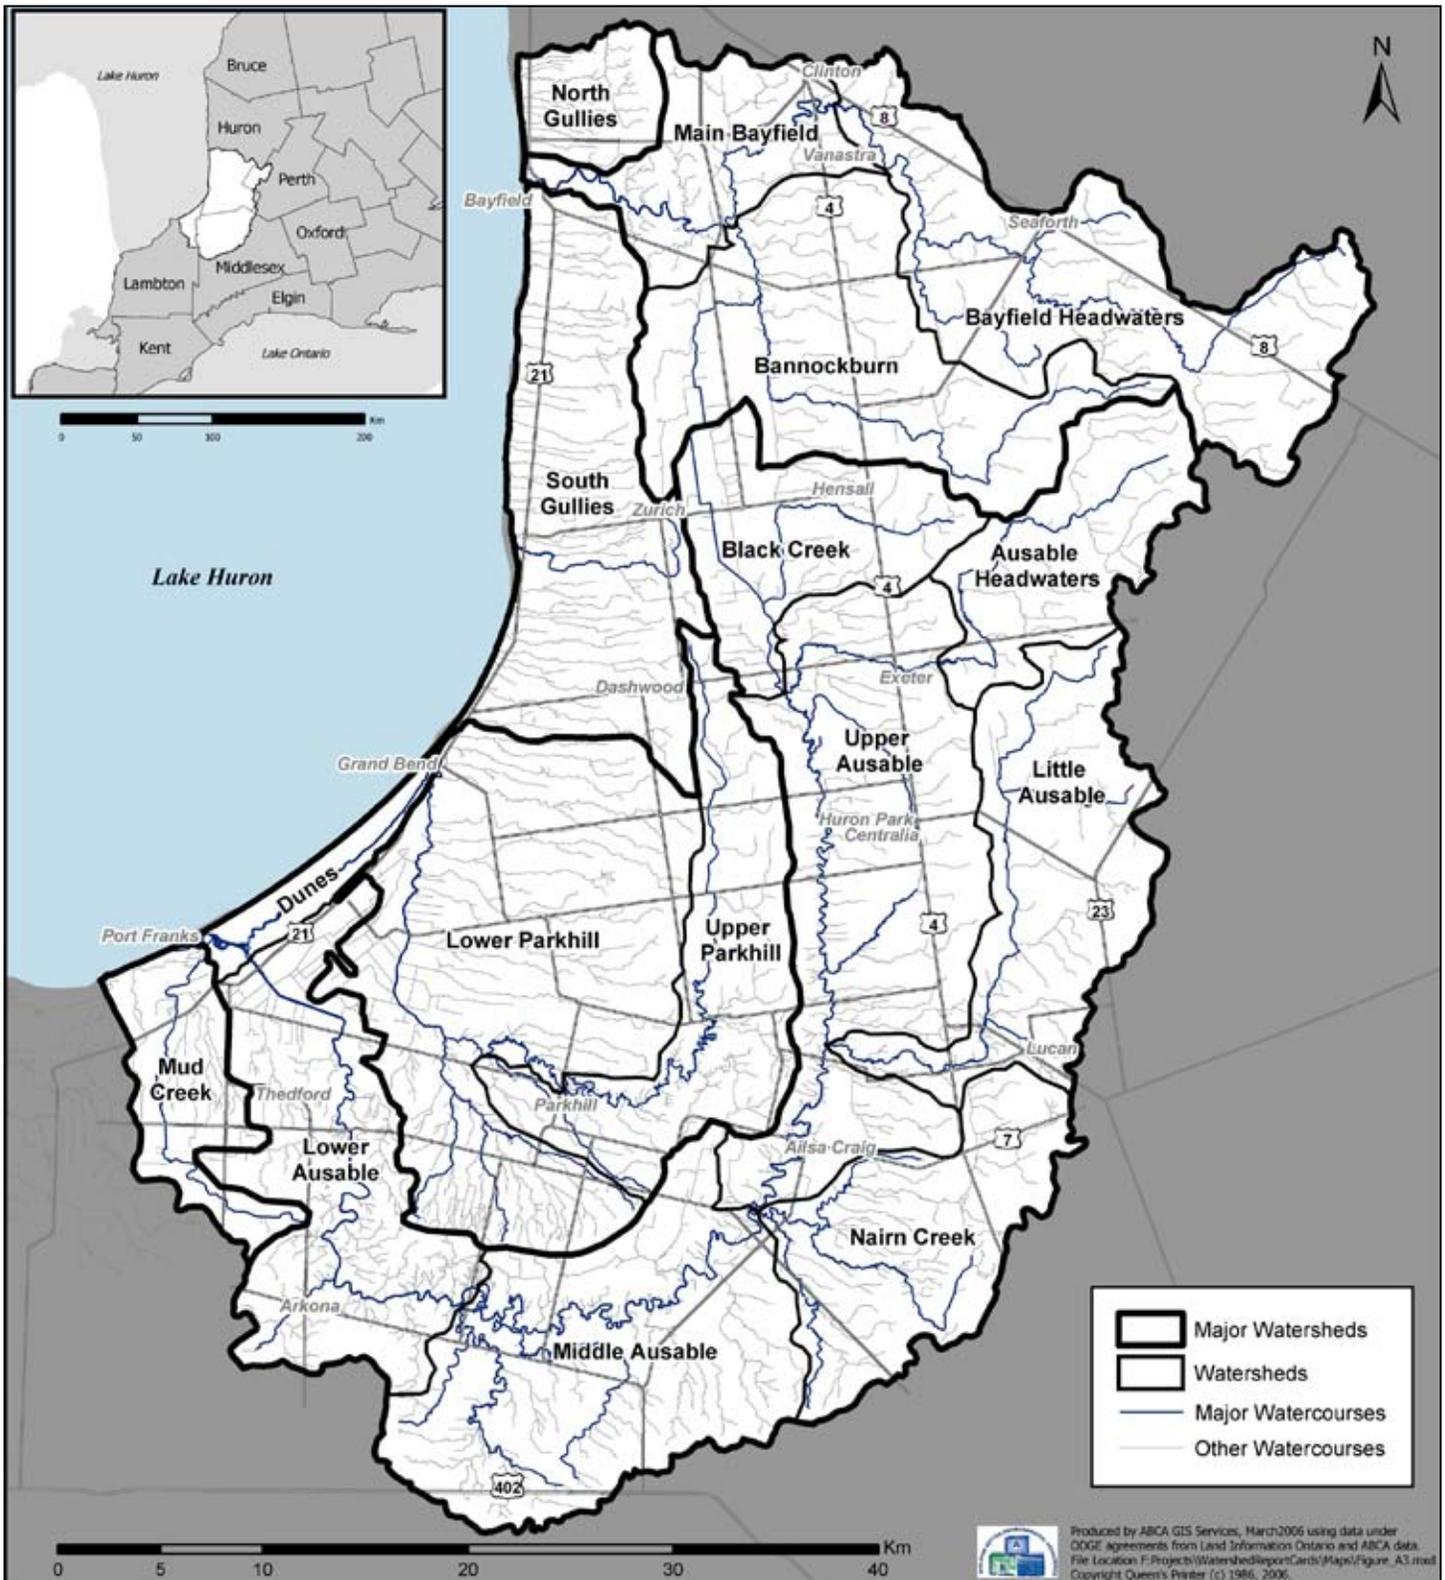
Figure A.3: Watershed boundaries within the Ausable Bayfield Conservation Authority jurisdiction

Watershed boundaries (Figure A.3) were determined as follows:

- sections of the main branch of the Ausable or Bayfield Rivers,
- major tributaries to the Ausable or Bayfield Rivers, or
- systems that drain directly to Lake Huron.

To complete the watershed report cards, the Ausable Bayfield Conservation Authority (ABCA) area was divided into 16 watersheds. These watersheds were first used for the ABCA Fish Habitat Management Plan (Veliz 2001) and represent the amalgamated smaller basins used in the ABCA Management Strategy (Snell et al. 1995). These watersheds represent an appropriately sized area with which the general public can relate and the ABCA can monitor.

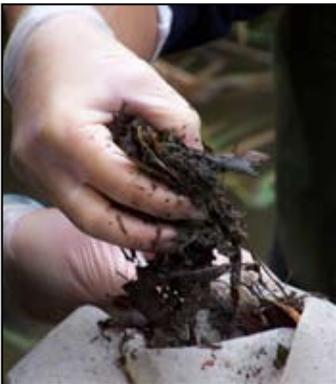
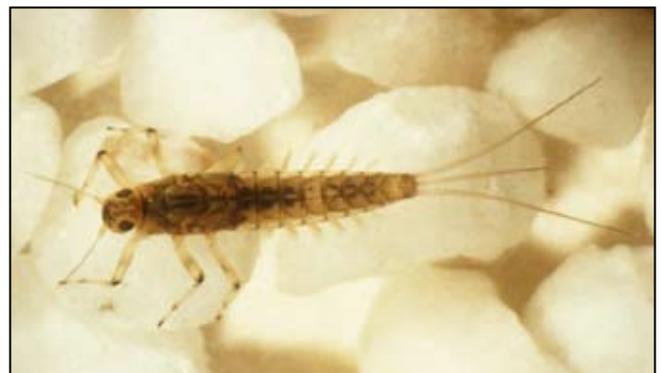
Photo at left shows ABCA staff sampling stream substrate where animals such as a mayfly (see photo at right, by Garry Scrimgeour) may be found. It is a member of the benthic invertebrate community, which provides an indicator of the health of our water.

‘Benthic’ refers to the bottom of lakes and rivers whereas ‘macro’ refers to the subset of larger or visible invertebrates: generally ¼ to ½ mm in length. Invertebrates are animals without backbones such as insects, crustaceans, molluscs, and worms. Benthic macroinvertebrates are commonly used as indicators of aquatic environmental quality.

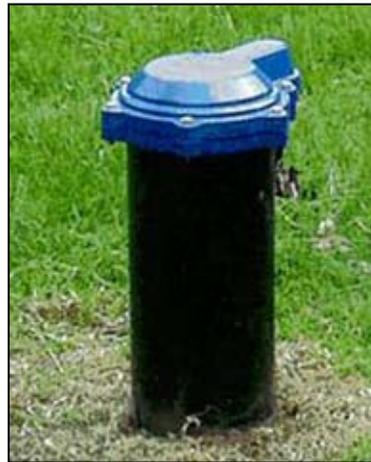
A properly-maintained wellhead can limit potential pathway for pollutants to reach groundwater sources.
