# **Ausable Bayfield Conservation Authority**

## Considerations for Shoreline Protection Structures

December 7 2017 | 12646.101

W.F. Baird & Associates Coastal Engineers Ltd.

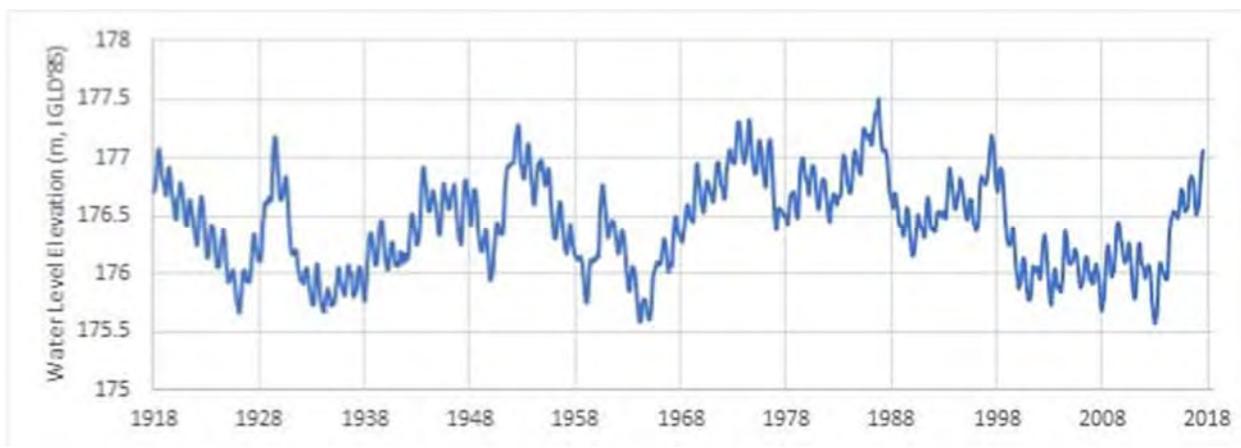
Figure 3.1: Lake Huron monthly mean lake levels (1918 to 2017)

Monthly mean lake levels for the period 1918 to 2017 are shown in Figure 3.1. The most recent period of high lake levels was 1985-86, and the highest monthly mean water level is 177.50 m International Great Lakes Datum (IGLD) 1985, in October 1986. Water levels in this report are referenced to IGLD 1985. Chart Datum is 176.0 m IGLD 1985. The lowest monthly mean water level was 175.58 m IGLD 1985, recorded in March 1964, giving a maximum range of close to 2 m. There was a sustained period of low water levels from 2000 to 2012, however the lowest monthly mean was marginally higher than the lowest value recorded in 1964. Studies have shown a lowering of water levels on Lake Huron in response to dredging in the St. Clair River in the late 1800’s and during periods in the 1900’s, see for example Baird (2005). The International Joint Commission (2009) concluded that lowering water levels due to increased conveyance in the St. Clair River is not ongoing and that climate is the main driver of lake level.

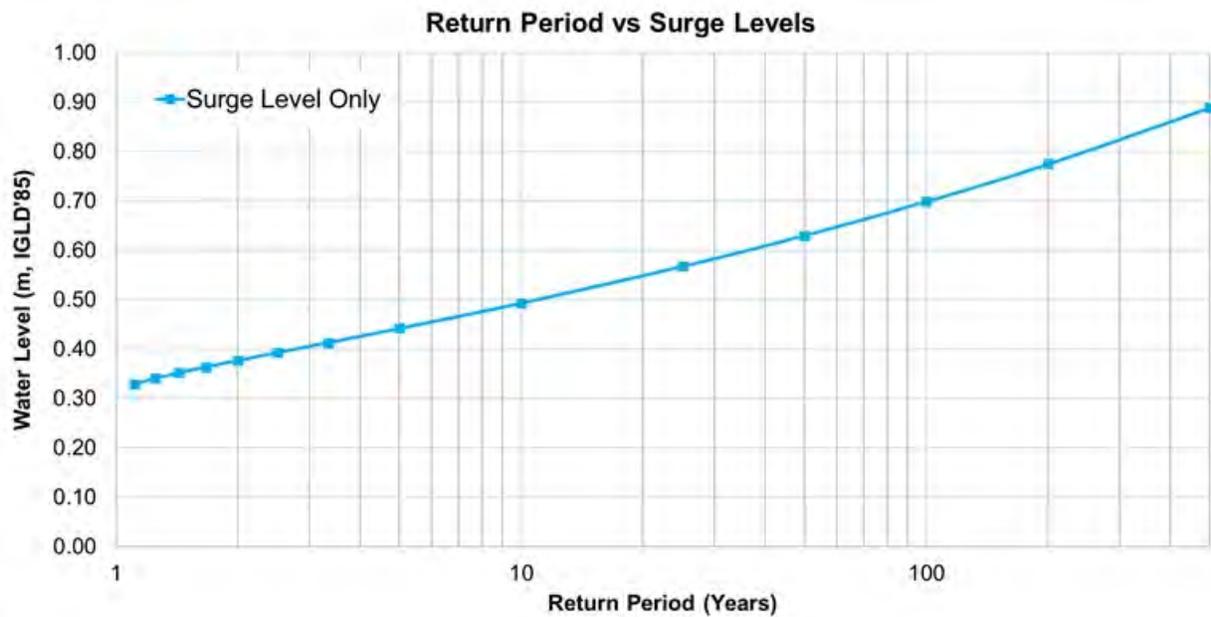
Figure B.2: Probability distributions of surge at Goderich
