Bayfield Beach Stormwater Monitoring 2015

Prepared for the Bluewater Beach Committee

by
Hope Brock and Mari Veliz
Ausable Bayfield Conservation Authority (ABC)
71108 Morrison Line, R.R. 3, Exeter, Ontario, N0M 1S5

April 22, 2016

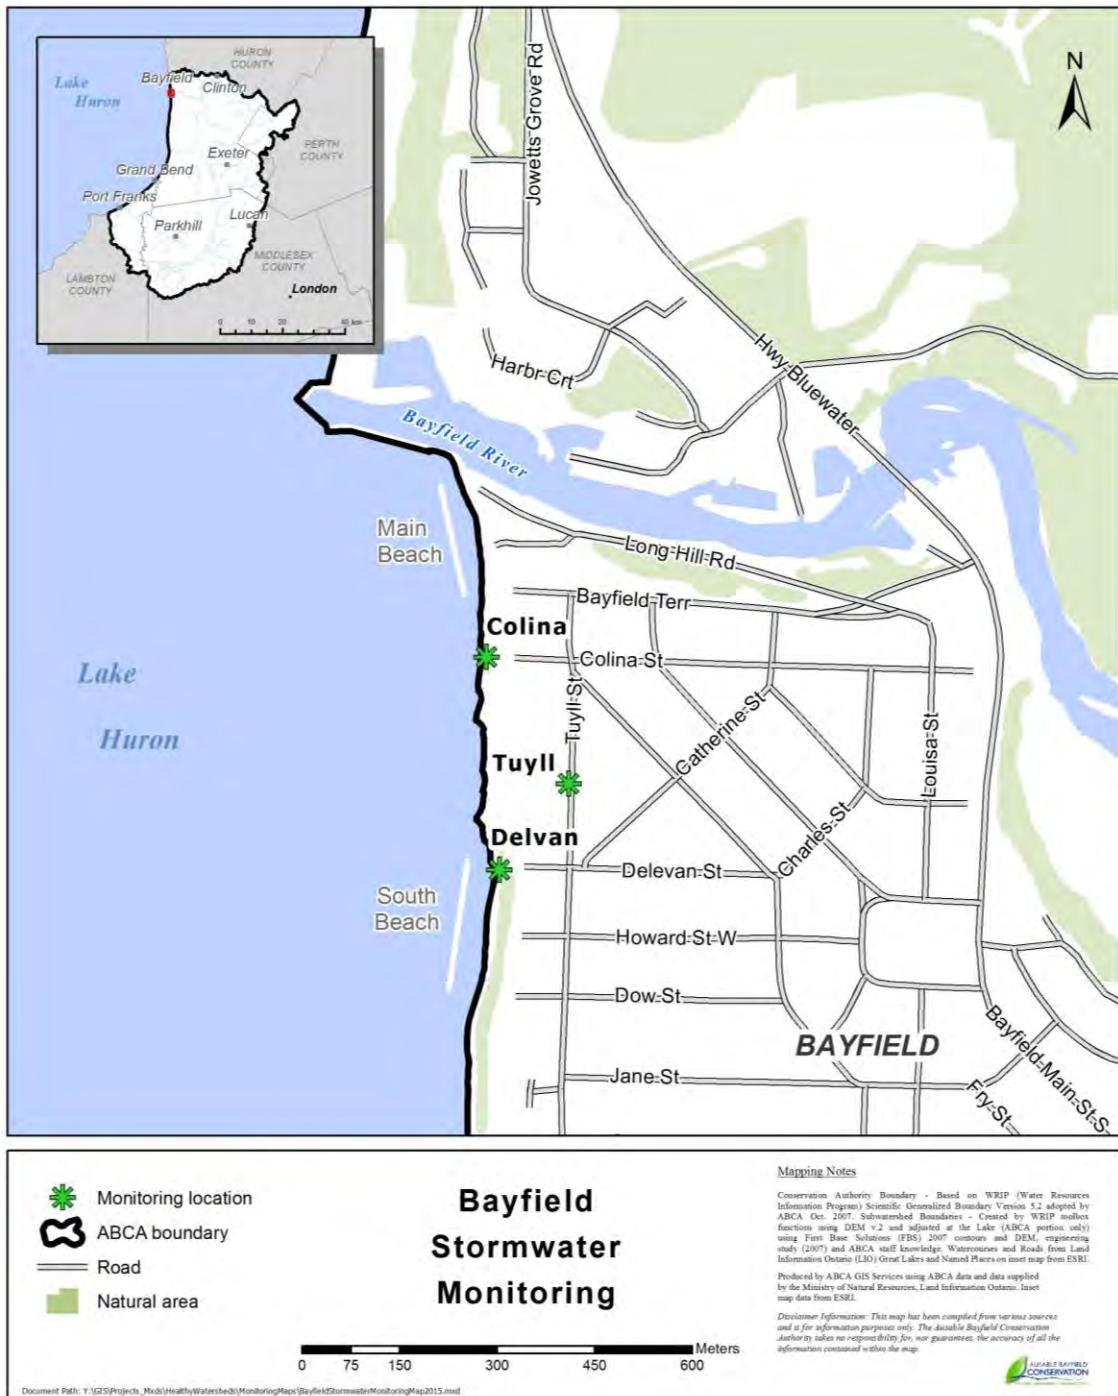
Figure 1. Approximate locations of three stormwater monitoring sites and public beaches along the Lake Huron shoreline in Bayfield, Ontario.

Water quality was monitored at two stormwater outfalls along the beach adjacent to the village of Bayfield, Ontario, and at one culvert along the road (Tuyl Street) adjacent to the shoreline (Figure 1). The Colina outfall (125 mm pipe) outletted at the top of the bank, while the Delevan outfall (750 mm) extended down the bank. Both were designated stormwater outlets for the village of Bayfield (BM Ross 2014). The Tuyl site was a culvert (~610 mm in diameter) running perpendicular to the shoreline at which overland flow had been observed. According to a report on storm drainage for the village of Bayfield (BM Ross 1985), existing tile drainage for the most developed portion of the village is directed towards the Delevan outfall or an open water course that discharges at the top of the bank (i.e., Tuyl).

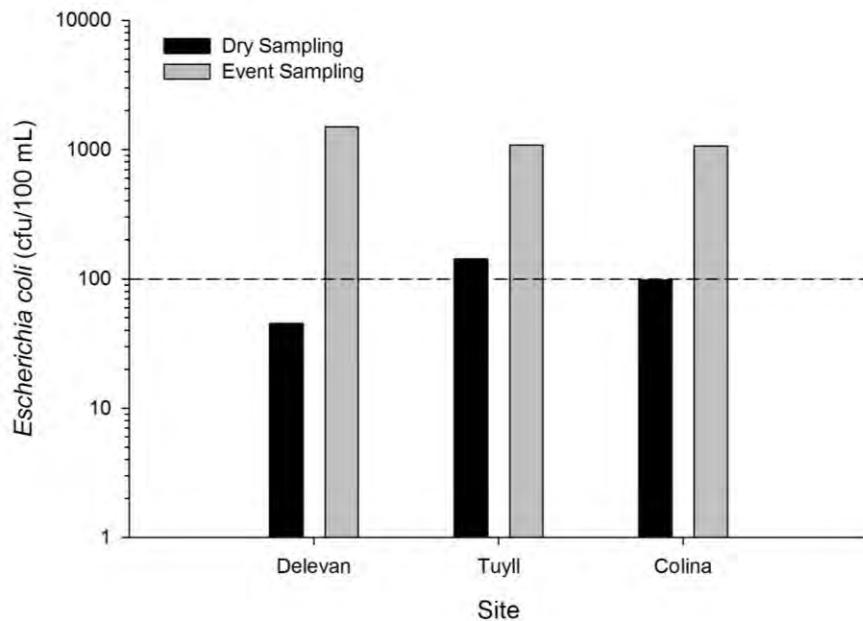
Figure 2. Dry (n=7)* and event (n=6)** sampling geometric mean *Escherichia coli* concentrations in colony forming units per 100 mL at three stormwater monitoring sites draining into Lake Huron along the shoreline of Bayfield, Ontario in 2015. Dashed line indicates Ontario Ministry of Health and Long-term Care guideline of 100 cfu/100 mL. (*n=4 for dry sampling geometric mean *Escherichia coli* concentration for Colina as the outfall was dry on three sampling dates; **n=6 for event sampling geometric mean as *Escherichia coli* concentrations from June 12 were not included as the holding time for these samples was exceeded.)

Geometric mean *E. coli* concentrations at the outfalls ranged from 45 cfu/100 mL at Delevan to 143 cfu/100 mL at Tuyl for dry sampling, and increased to 1064 cfu/100 mL at Colina to 1495 cfu/100 mL at Delevan following rain events (event sampling) (Figure 2). Geometric mean *E. coli* concentrations at all three sites exceeded the provincial water quality guideline following rain events. This guideline, however, was also exceeded at Tuyl for dry sampling, which may indicate a more constant source of contamination.

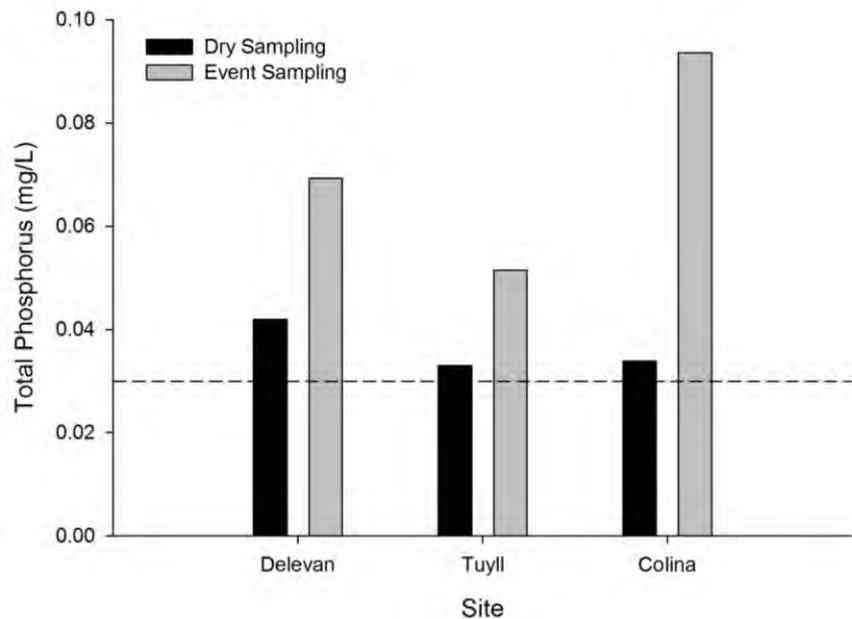
Figure 3. Dry (n=7)* and event (n=7) sampling geometric mean total phosphorus concentrations in mg/L at three stormwater monitoring sites draining into Lake Huron along the shoreline of Bayfield, Ontario in 2015. Dashed line indicates Provincial Water Quality Objective of 0.030 mg/L. (*n=4 for dry sampling geometric mean TP concentration for Colina as the outfall was dry on three sampling dates.)

Dry sampling geometric mean TP concentrations varied from concentrations of 0.033 mg/L at Tuyll to 0.042 mg/L at Delevan. Event sampling concentrations were higher across all sites and ranged from 0.052 mg/L at Tuyll to 0.094 mg/L at Colina (Figure 3). All dry and event sampling geometric mean TP concentrations exceeded the water quality objective.

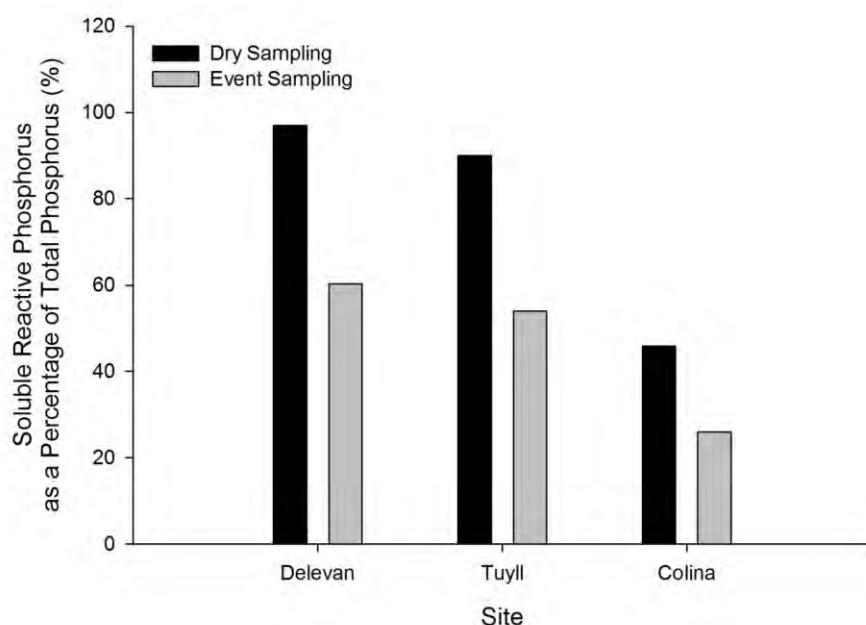
Figure 4. Soluble reactive phosphorus as a percentage of total phosphorus at three stormwater monitoring sites draining into Lake Huron along the shoreline of Bayfield, Ontario in 2015.

SRP varied from 0.005 mg/L at Tuyll (June 9) to 0.100 mg/L at Tuyll (July 14) (Table 2). SRP as a percentage of TP ranged from 46 percent at Colina to 97 percent at Delevan for dry event sampling dates (Figure 4). All outfalls had decreased percentages of SRP following rain events (event sampling), which varied between 26 percent at Colina to 60 percent at Delevan. The decrease in the percentage of SRP following rain events may be due to an increase in the proportion of particulate phosphorus delivered to the outfall as result of erosion and runoff. These SRP percentages indicate there is potential for eutrophication and algal blooms to occur along the shoreline if other required conditions (e.g., temperature) are also met.

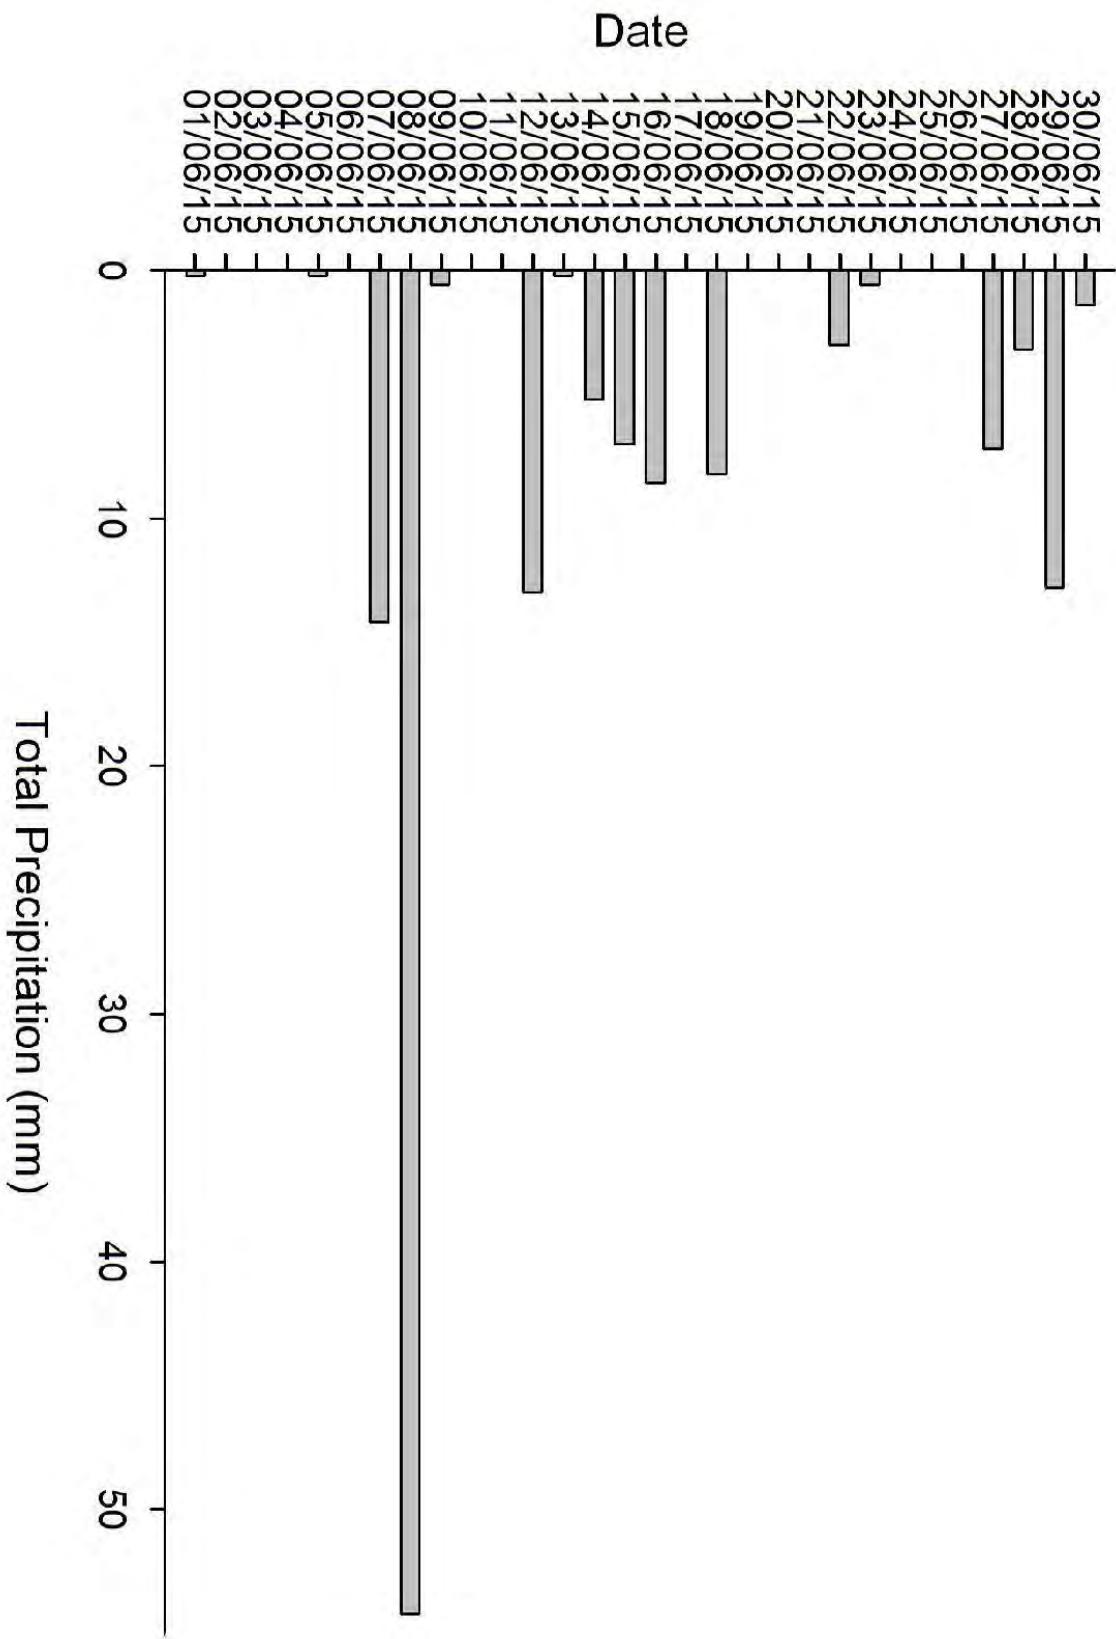
Figure A1. Total daily precipitation at Bayfield, Ontario during June 2015.

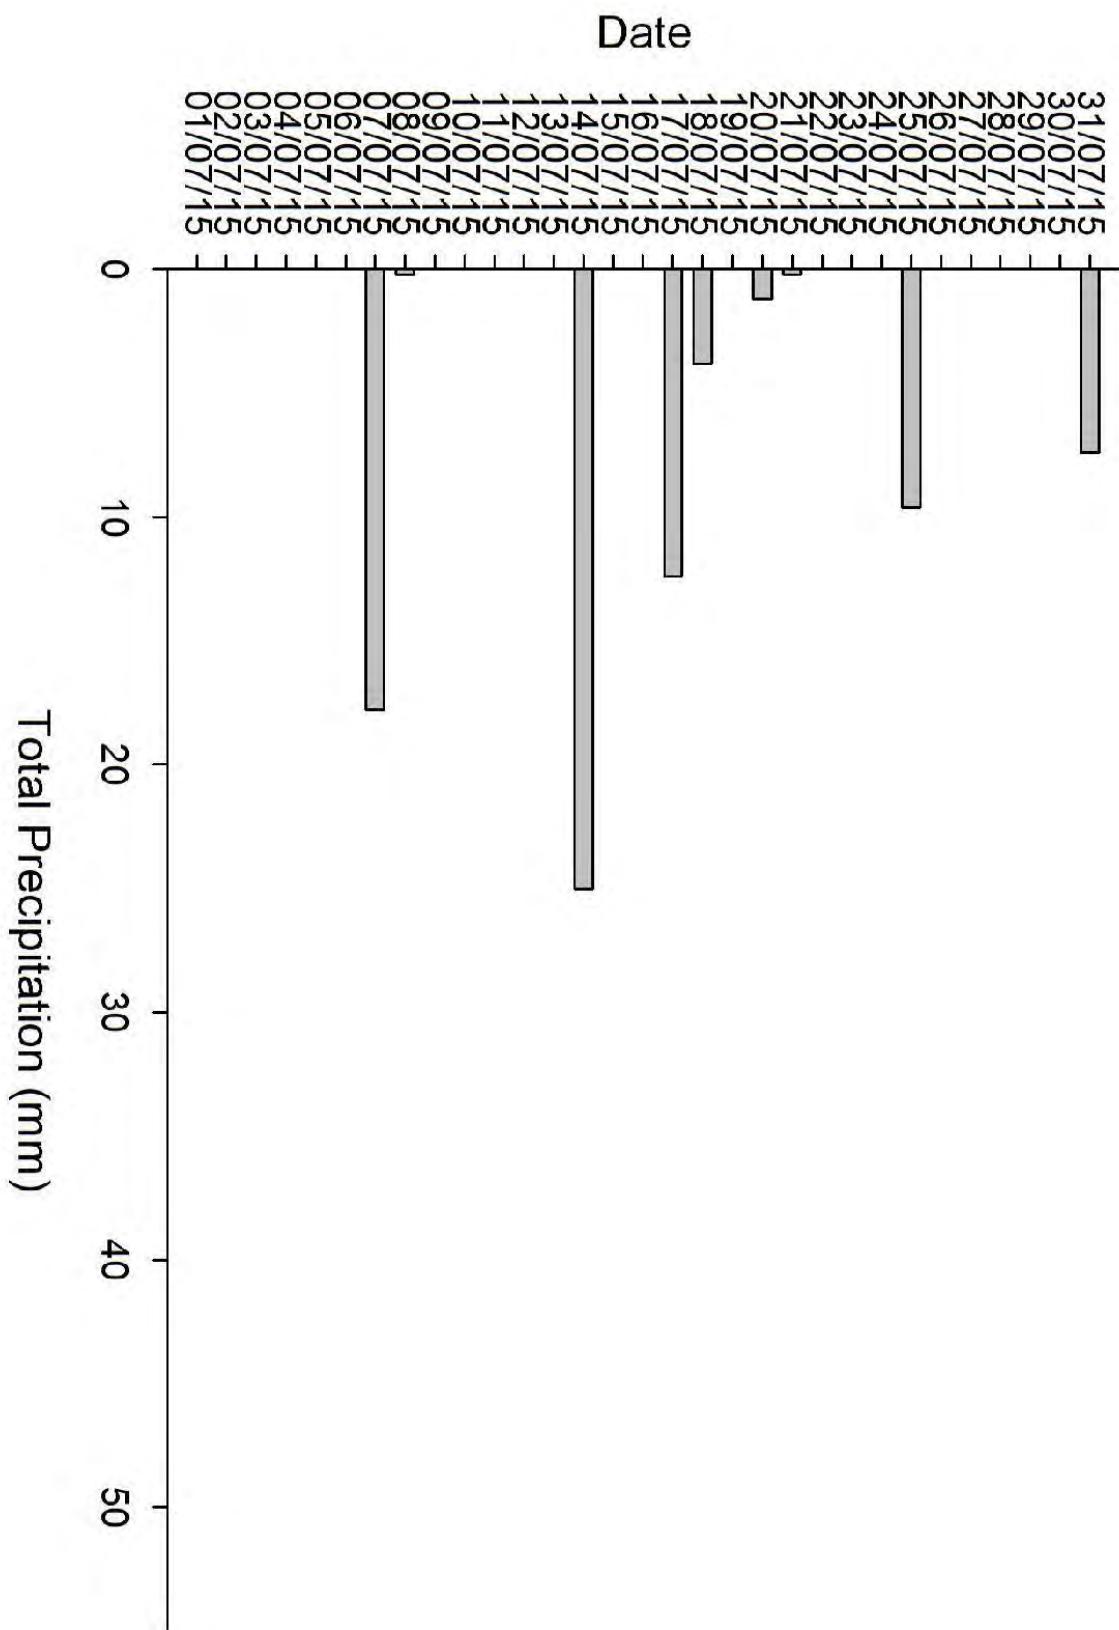
Figure A2. Total daily precipitation at Bayfield, Ontario during July 2015.

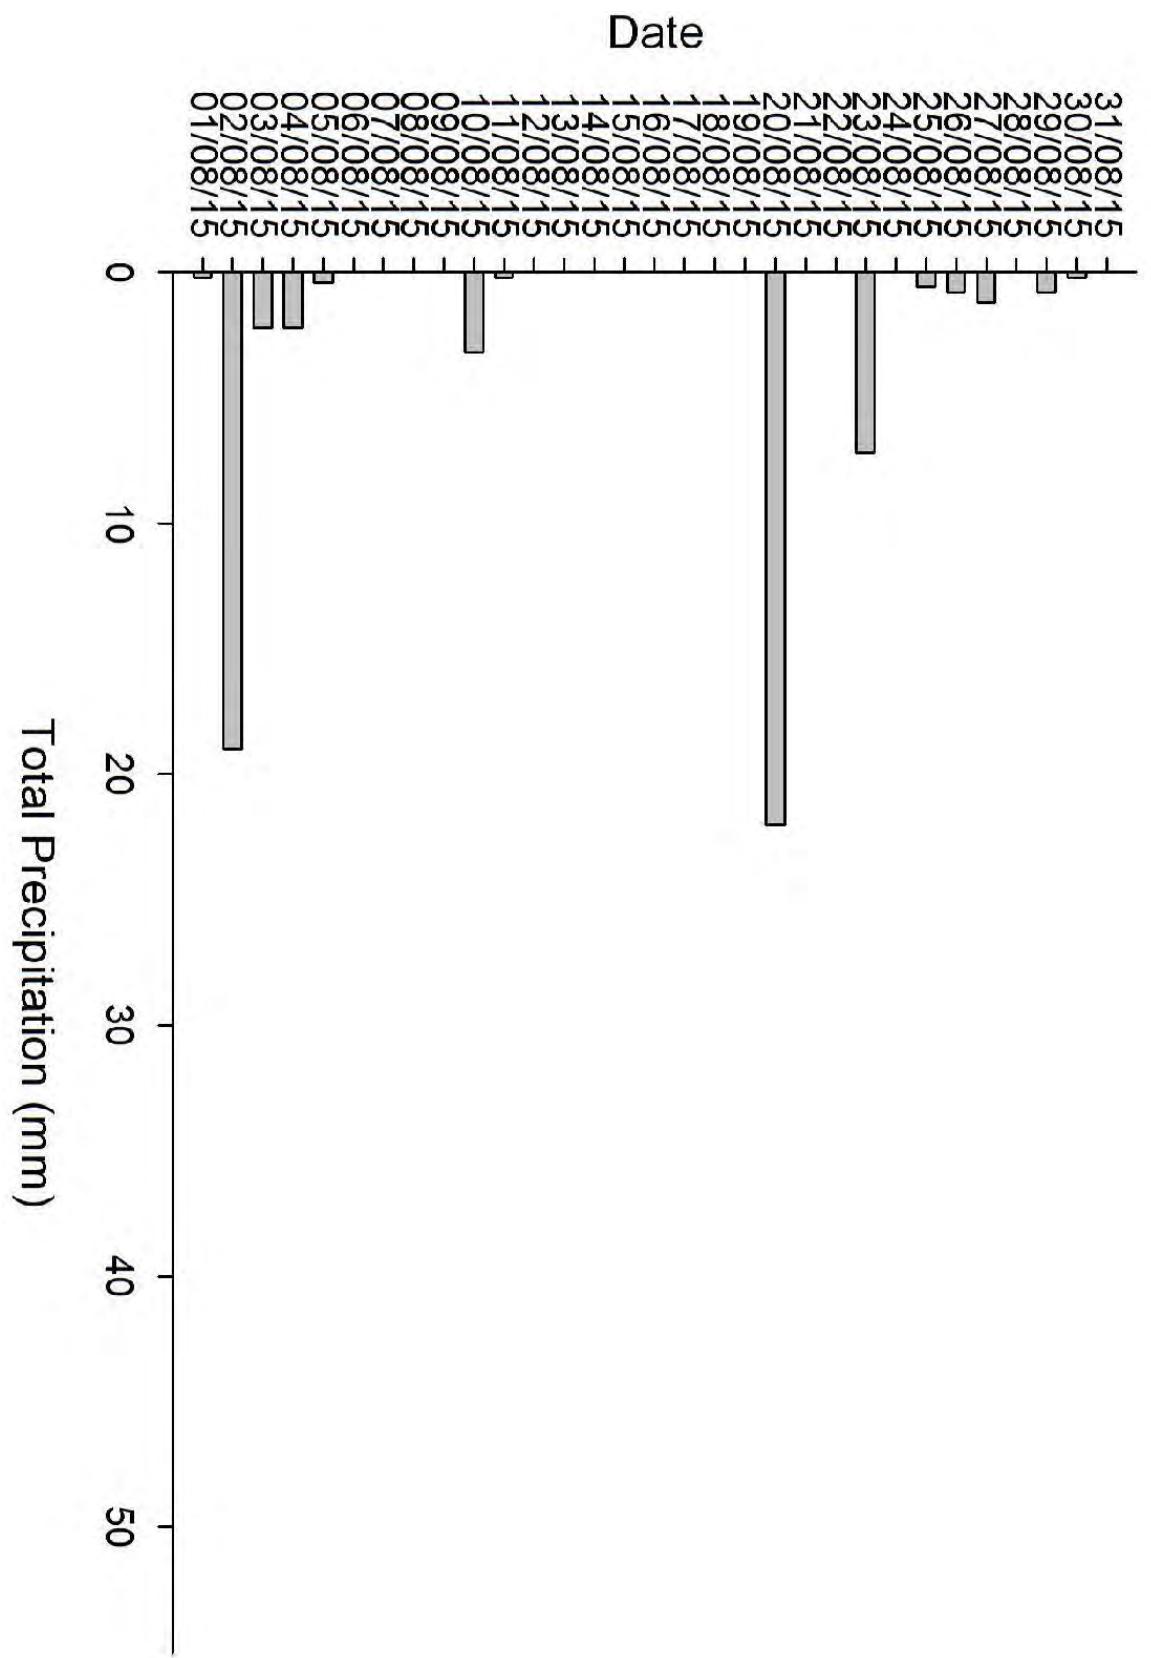
Figure A3. Total daily precipitation at Bayfield, Ontario during August 2015.
