Bayfield Beach Stormwater Monitoring 2014

Prepared for the Bluewater Beach Committee

Hope Brock and Mari Veliz

March 30, 2015

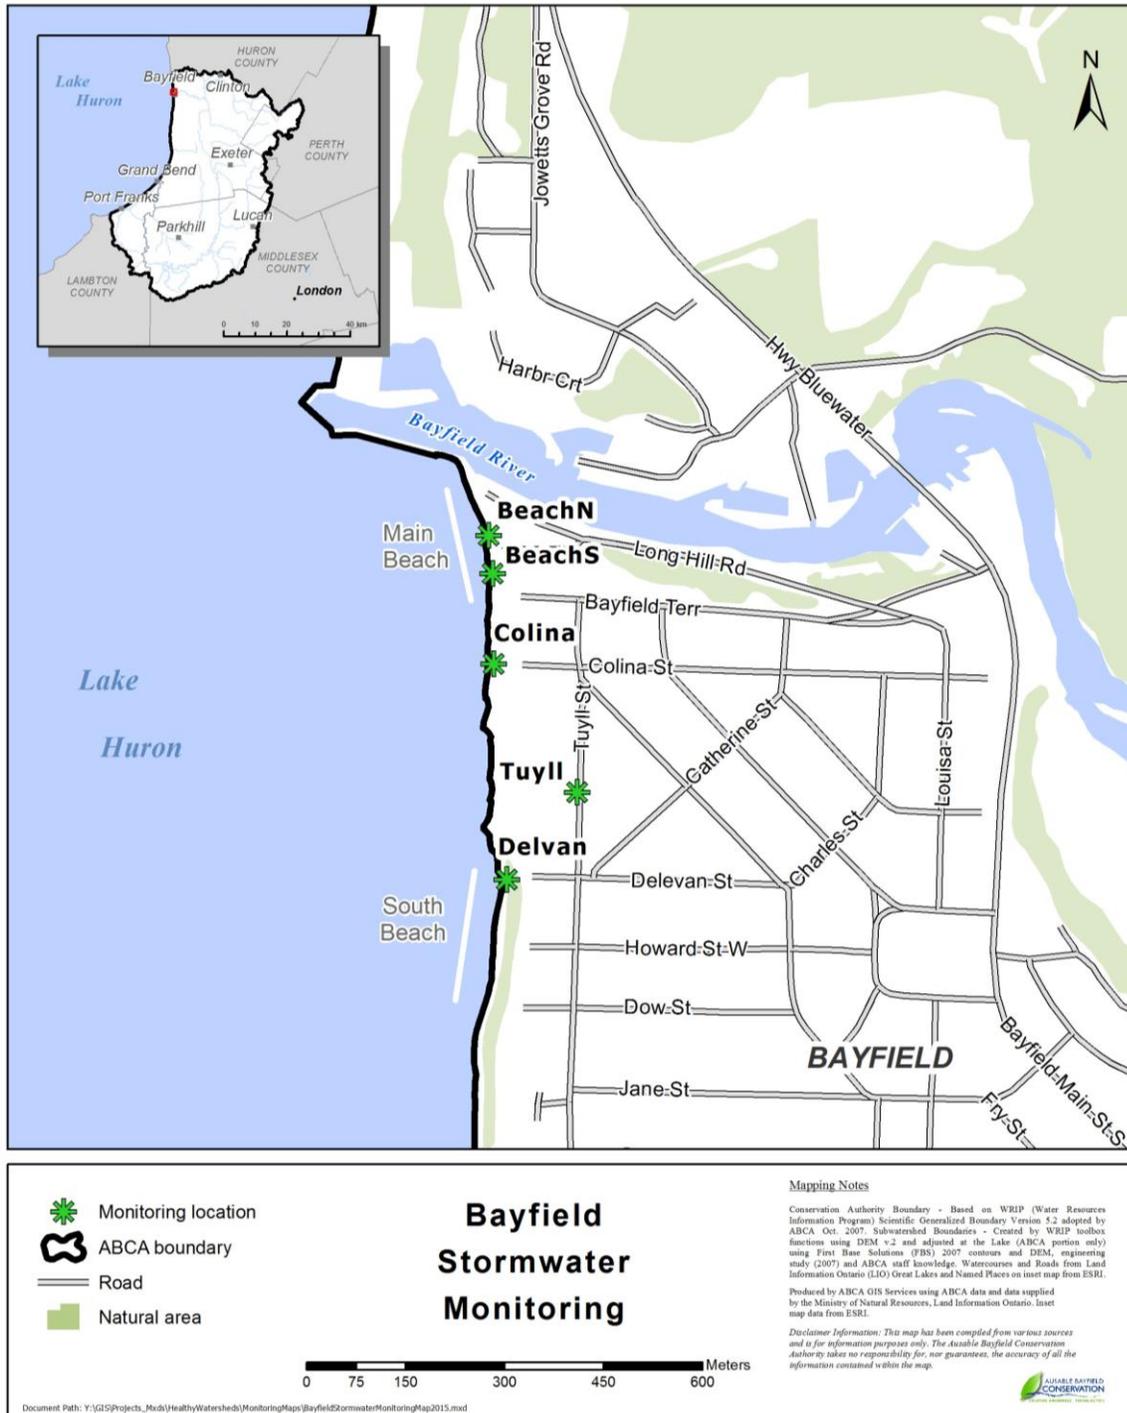
Figure 1. Approximate locations of five stormwater monitoring sites and public beaches along the Lake Huron shoreline in Bayfield, Ontario.

Water quality was monitored at four stormwater outfalls along the beach adjacent to the village of Bayfield, Ontario, and at one culvert along the road (Tuyll Street) adjacent to the shoreline (Figure 1). Two of the four outfalls (BeachN and BeachS) were located along the beach adjacent to shoreline residences. BeachN consisted of two small pipes (approximately 102 mm each), and BeachS consisted of sheet flow from the base of a rock retaining wall. The Colina outfall (125 mm pipe) outletted at the top of the bank, while the Delevan outfall (750 mm) extended down the bank. Both were designated stormwater outlets for the village of Bayfield (BM Ross 2014). The Tuyll site was a culvert (~610 mm in diameter) running perpendicular to the shoreline at which overland flow had been observed. According to a report on storm drainage for the village of Bayfield (BM Ross 1985), existing tile drainage for the most developed portion of the village is directed towards the Delevan outfall or an open water course that discharges at the top of the bank (*i.e.*, Tuyll).
