Watershed Planning for the Ridgeway Drain Background Document

Prepared for: Bluewater Shoreline Resident's Association (BSRA)

Date: January 9, 2009

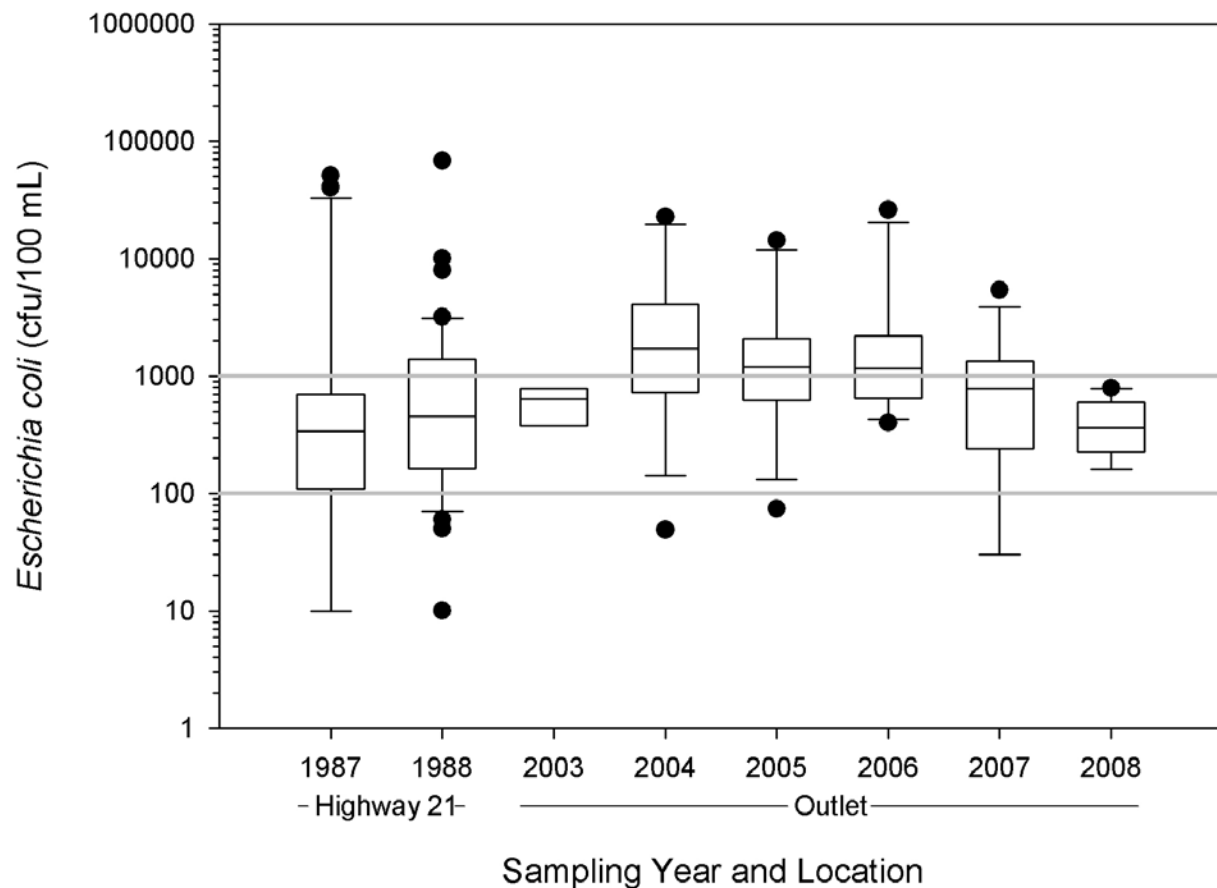
Figure 4. Median *Escherichia coli* concentrations in the Ridgeway Drain during 1987 to 1988 and 2003 to 2008. Box represents 50 % of the concentrations and whiskers represent 80 %. All outliers (*i.e.*, observations that are far outside the range of the rest of the data) are presented as circles. Light grey lines mark the 100 cfu/100 mL Ontario recreational guideline and 1000 cfu/100 mL.

E. coli is a bacterium that is found in the intestinal tract of warm-blooded animals. While *E. coli* itself is not a threat to the environment, its presence in water collected from drains may indicate contamination by other harmful bacteria, viruses, or parasites that are associated with animal wastes (*i.e.*, sewage or manure). The Ontario Ministry of Health and Long-term Care established a recreational guideline for *E. coli* of 100 colony forming units (cfu) per 100 mL (MOEE, 1994). Average (geometric mean and median) *E. coli* concentrations from the Ridgeway Drain exceeded the guideline during all years when sampling took place (Table 3, Figure 4). At least three quarters of the samples collected in each year exceeded the 100 cfu/100 mL guideline. *E. coli* was particularly abundant between 2004 and 2006, when average concentrations also exceeded 1000 cfu/100 mL. Other years sampled during the 2000 decade had average concentrations that were consistent with those from the 1980s. The 90th percentile of *E. coli* concentrations (Table 3) is the concentration below which 90 % of the samples for a given year occur. For all years except 2003 and 2008, the 90th percentile exceeded 1000 cfu/100 mL in the Ridgeway Drain. The magnitude of fluctuations in *E. coli* concentrations was lower during the 2000s than in the 1980s (Figure 4).
