Ausable Bayfield Conservation Authority (ABCA)

Shoreline Slope Stability Risks and Hazards

Fact Sheet for Property Owners

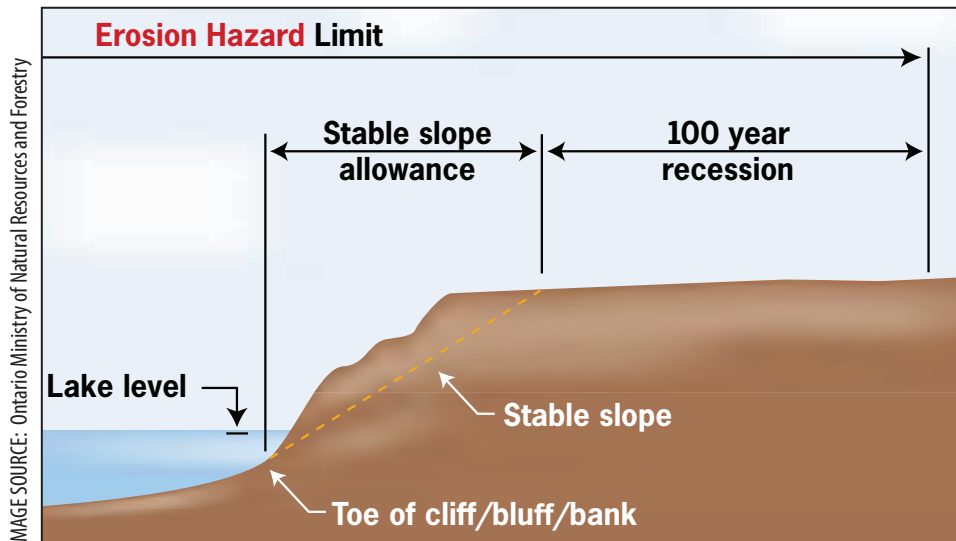
Erosion Hazard Limit and New Development

The Erosion Hazard Limit is established based on Stable Slope Allowance, Average Annual Recession, and Erosion Allowance as described below:

1. Stable Slope Allowance (Stable Slope Inclination Setback) is a horizontal allowance measured landward from the toe of the shoreline cliff, bluff, or bank. It is:

- Dependent on slope soil types, soil strengths, and groundwater conditions
- Assumed to be three times the height of cliff/bluff in absence of site-specific study, or, is determined by a detailed site investigation (boreholes) and analysis (typically minimum Factor of Safety of 1.5 required)

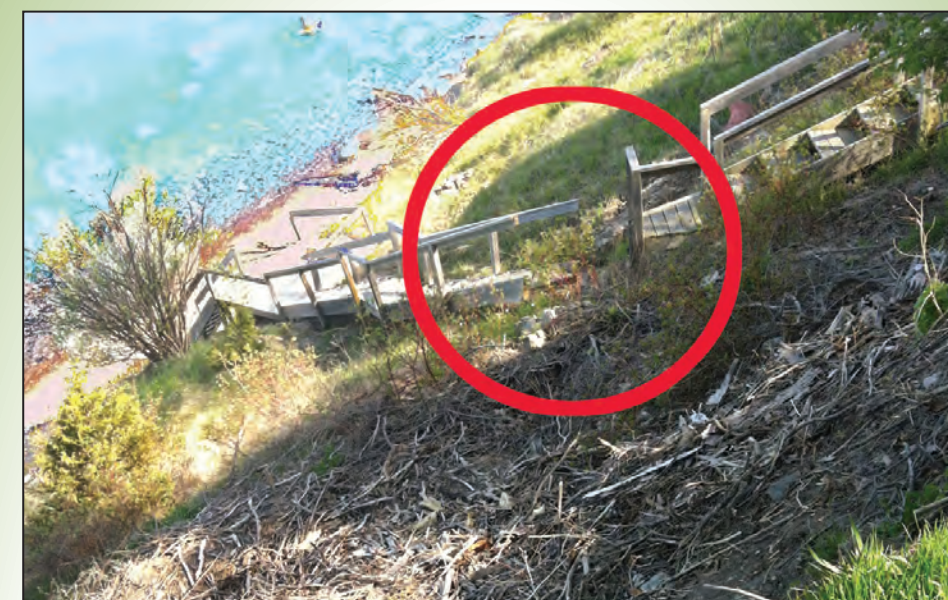
Slope instability indicators include displaced posts and fences, poles, monuments, guardrails, broken or displaced retaining walls, and stairs, among other indicators mentioned in this fact sheet. Please read the Recommended Management Practices panel inside.

- Displaced posts/fences, poles, monuments, guardrails, broken/displaced retaining walls, and stairs.

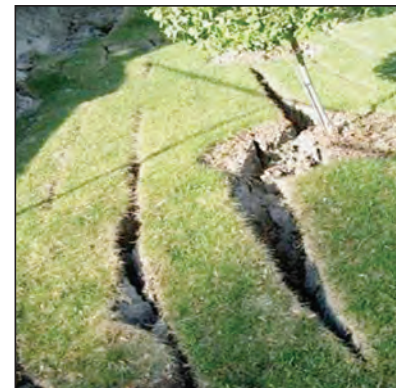
Irregular Slope Surfaces, Slumps, Scarps, Bumps, Bulges

- A presence of irregular slope surfaces such as slumps, scarps, bumps, bulges, etc. generally indicates a soil movement.
- Slumps and scarps result in an over-steepened (even near vertical) and bare zone at the 'head' or 'crown' where the sliding mass has separated from the slope.
- A slump or slide may also result in tension cracks above the slide.
