Ausable Bayfield Conservation Authority

Prepared by
Aqua Solutions 5 Inc.
Dr. Robin Davidson-Arnott
Dr. Ryan Mulligan
Planning Solutions Inc.
Terraprobe Inc.

## SHORELINE MANAGEMENT PLAN 2016 CONSULTANT RECOMMENDATION REPORT

AUSABLE BAYFIELD CONSERVATION AUTHORITY
AUGUST 2016

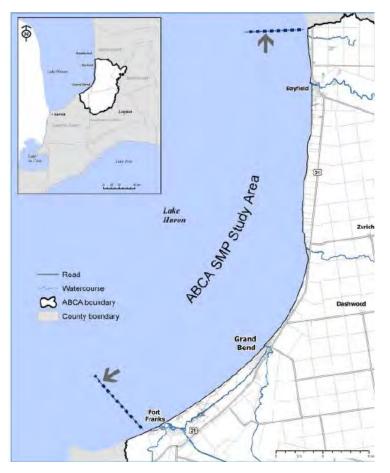
Figure 1.1: ABCA SMP Study Area

The study area for the 2016 Shoreline Management Plan Update is the shoreline area stretching from Port Franks in the south to Telephone Road north of Bayfield as identified in the following Figure 1.1:

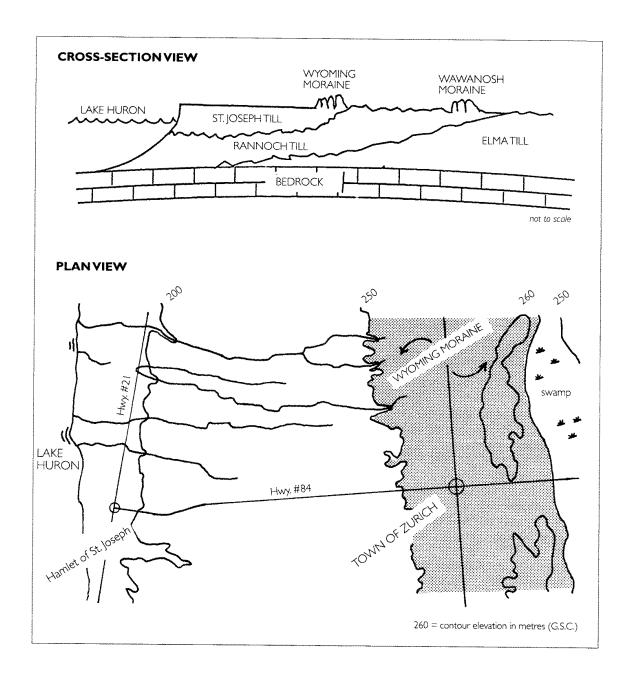
Figure 4.1: Cross-section and plan views of the glacial tills and their relation to bedrock in the ABCA area (from Reinders, 1989).

Bedrock near the shoreline is overlain by two glacial tills deposited by ice moving generally eastward out of the Lake Huron Basin towards the end of the last (Wisconsinan) glaciation on the order of 25-15 000 years ago. The Rannoch till, which overlies bedrock, is likely close to the surface along the shoreline in a few places (Figure 4.1). It is relatively stony and thus when exposed can form a rocky cover that is resistant to erosion by waves. It is possible that the two small promontories of Rocky Point and Dewey Point south of Bayfield (Figure 4.2) occur because of an outcrop of the Rannoch Till in the nearshore. The St. Joseph till forms the bluffs along the shoreline as well as outcropping in the nearshore out to water depths exceeding 6 m. It has a composition of about 86% silt and clay, with the remainder being sand, gravel and cobbles. It is relatively hard and strong because it was over consolidated by the weight of the ice during deposition and while the stone content is less than the Rannoch Till it can still lead to the formation of a lag cover of cobbles in places in the nearshore. Near Grand Bend the accumulation of sand buries the till in the nearshore and the shoreline becomes dominated by sandy beaches and dunes with modern dunes near the lake and older dunes related to post glacial lake levels behind them (Figure 4.2). Because of losses of sand inland over the dunes and offshore into deeper water the stability of the shoreline in this area depends on a continuing supply of sand from nearshore bluff and gulley erosion in the northern section.

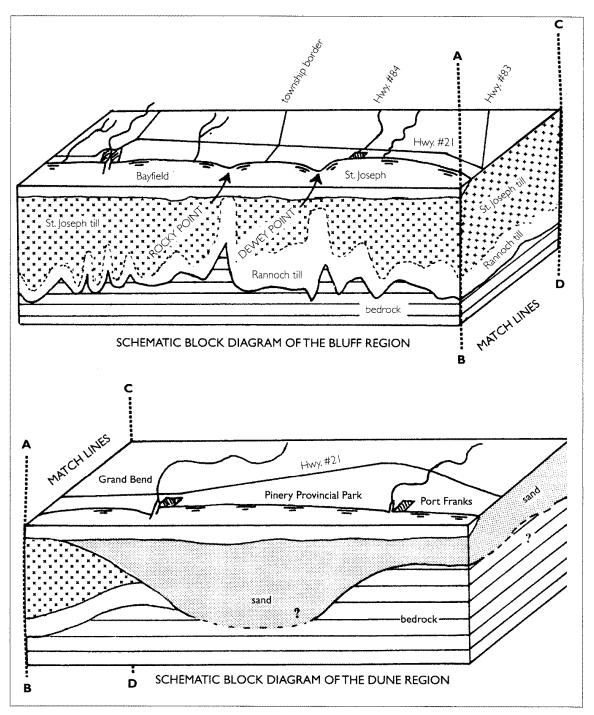
Figure 4.2: Schematic block diagrams of the northern cohesive bluff shoreline and southern sandy beach and dune shoreline within the ABCA jurisdiction (from Reinders, 1989)

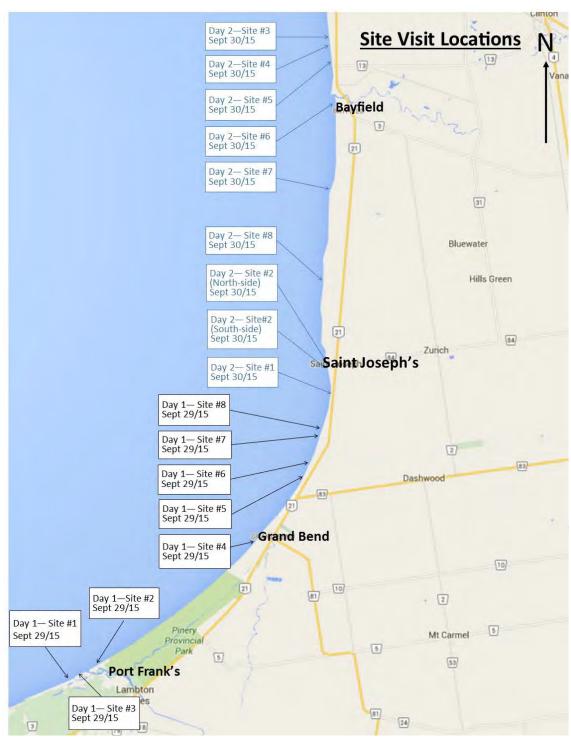
Figure 4.7: Site Visit Locations

Shoreline field observations were carried out over a two-day period in September (29<sup>th</sup> & 30<sup>th</sup>), 2015. At each site photographic records were captured, catalogued and provided to the ABCA. Please see the following map Figure 4.7 with the site locations that were visited.

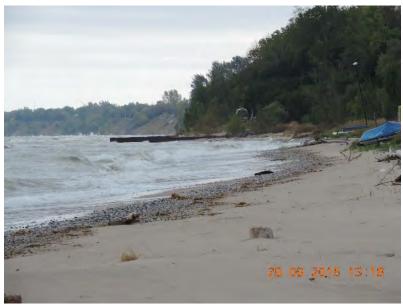
Dynamic Beach Transitioning to Erosion Area with Strucutres

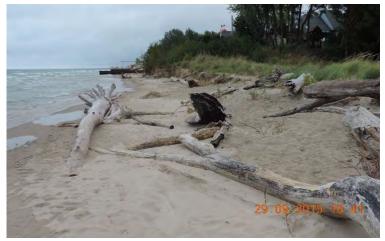
Transition zones from the Dynamic Beach to the Erosion Hazard areas.

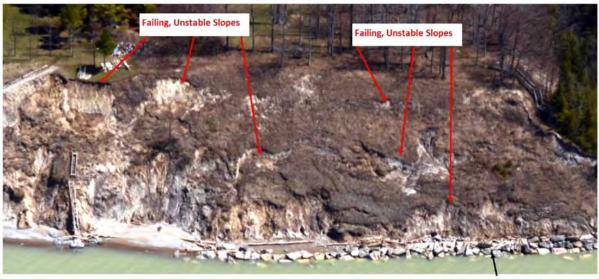
Protection Works along toe of slope

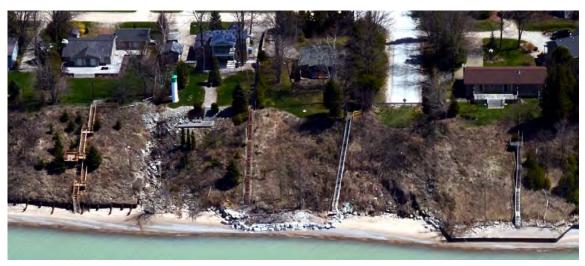
Lack of coordination and consistency of shoreline protection works between properties, and evidence of instability is indicated in the following photograph.

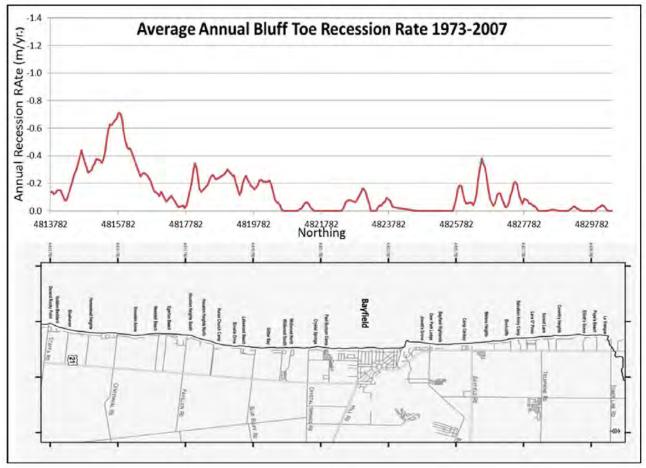
Figure 4.8 a) The ABCA northern section of the cohesive bluff shoreline

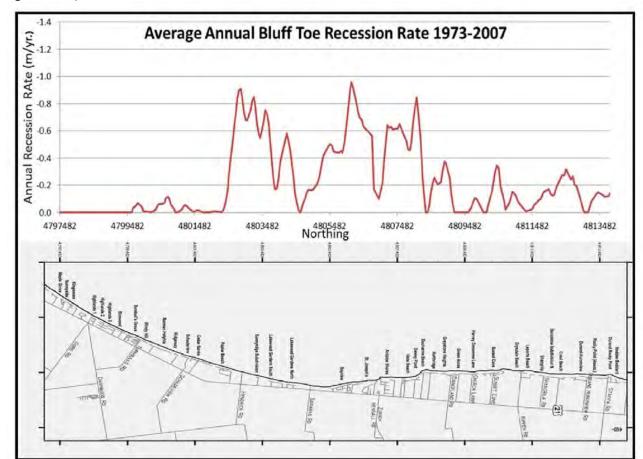
Figure 4.8 b) The ABCA southern section of the cohesive bluff shoreline

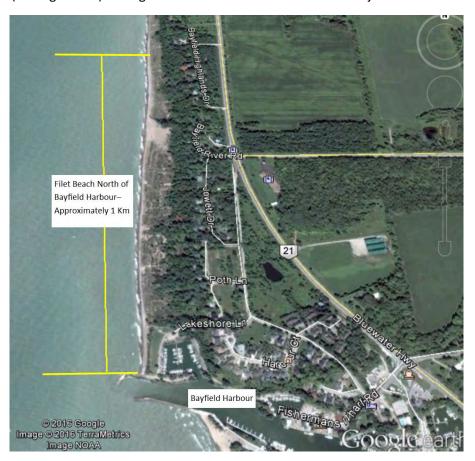
Figure 4.9: Filet Beach North of Bayfield Harbour

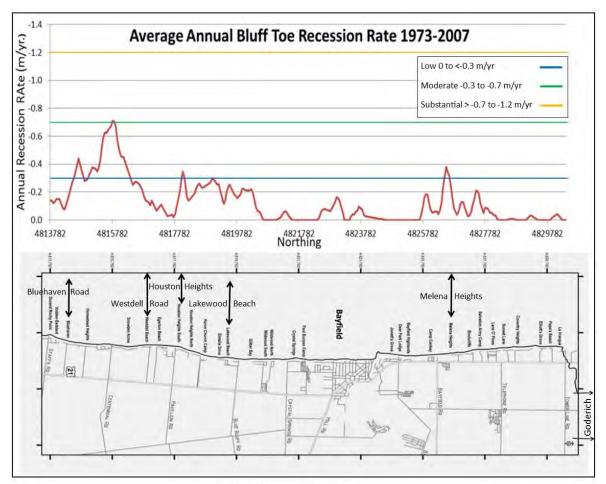
Figure 4.10 a): Northern Recession Rate Map – Average Annual Bluff Toe Recession Rates 1973 – 2007

Northern Recession Rate Map

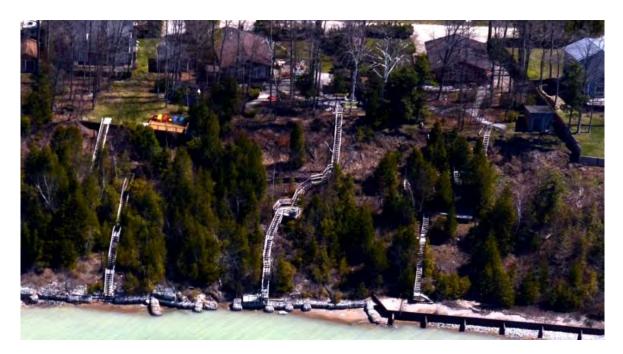
Homes are extremely close to an eroding shoreline and unstable bluff and a further geotechnical investigation has been recommended to qualify and quantify the safety issues, and the extent of these problems.

An increase in the erosion of the toe of slope areas is evident and as a result of this evidence, it was recommended to ABCA that further investigation be carried out to assess the level of risk that these buildings may be exposed to.

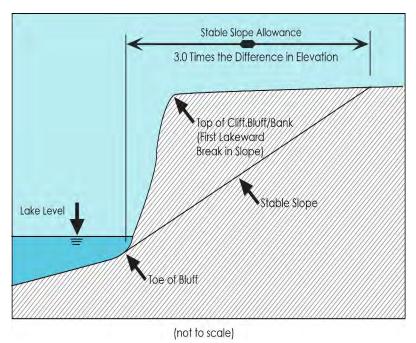
Figure 5.1: Stable Slope Allowance

Safety of 1.5 is required. Site specific modelling and analysis could establish a stable slope inclination steeper than the default value of 3 horizontal to 1 vertical (3:1), or approximately 18 degrees.

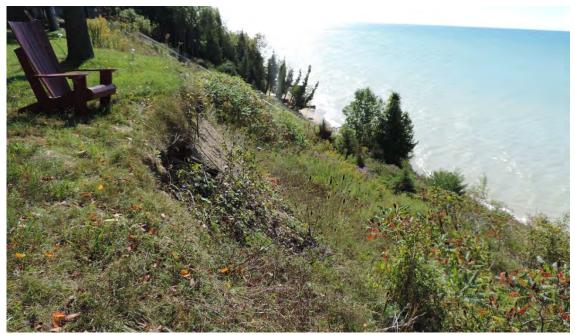
The top (crest) of Slope indicates the slope instability.

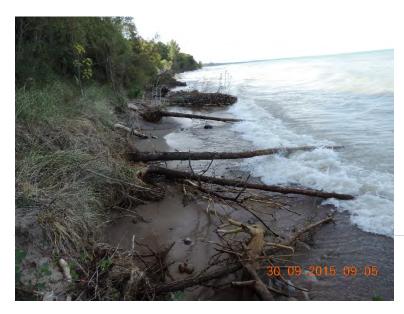
Presence of slumped material with fallen trees along the shoreline in the nearshore. Photograph taken during site reconnaissance September 30<sup>th</sup>, 2015.

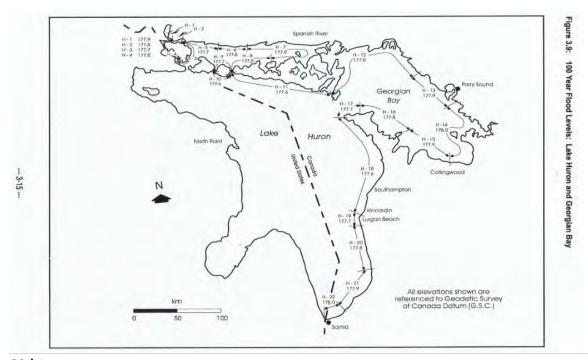
Figure 5.6: MNRF 100 year Flood Levels for Lake Huron

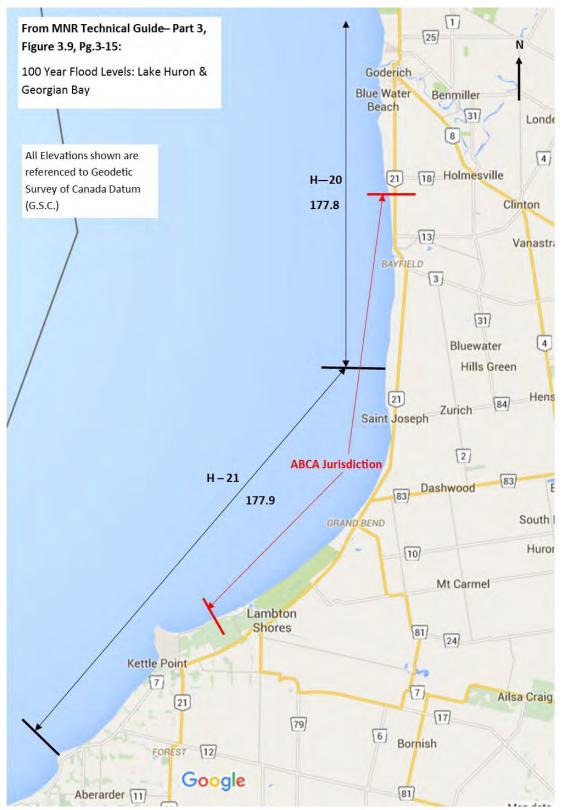
Figure 5.7: MNRF 100 year Flood Levels for ABCA area

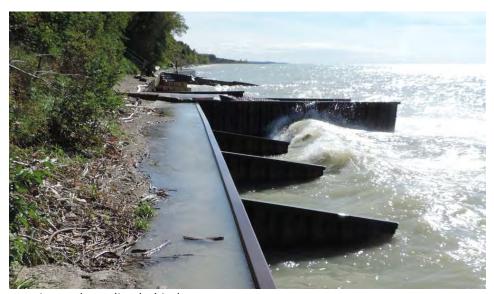
Wave Overtopping and ponding behind structures.

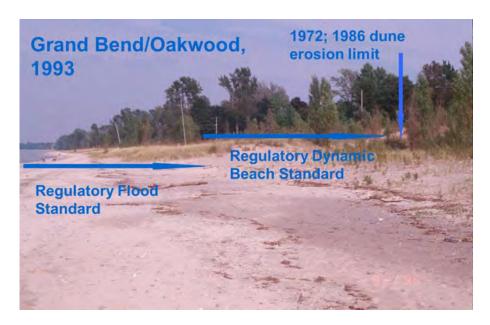
Figure 5.13: The test site at Oakwood used to determine the limit of wave erosion during major storms associated with periods of high lake level. Measurements here show that the maximum erosion is accommodated within a 30 m distance landward of the Regulatory Flood Standard. There is no long-term recession at this site.

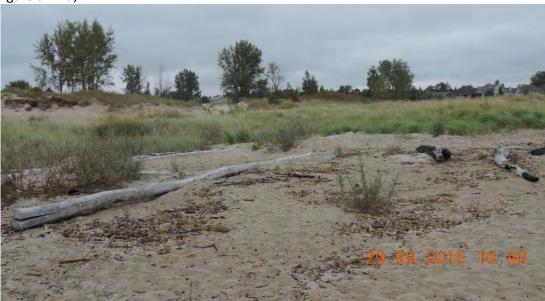
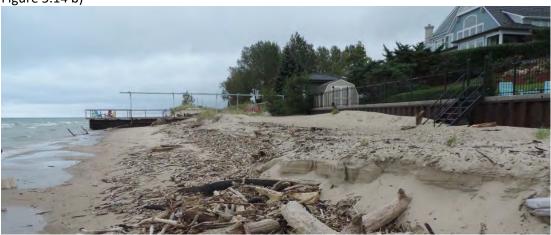
Figure 5.14 b)

Figure 5.14: Dynamic beach and development: a) development is located behind the foredune at this location permitting the beach and dune system to operate naturally and keeping structures out of the hazard zone; b) development is located within the hazard zone requiring the use of a seawall which restricts the beach width and prevents development of a natural sand dune.

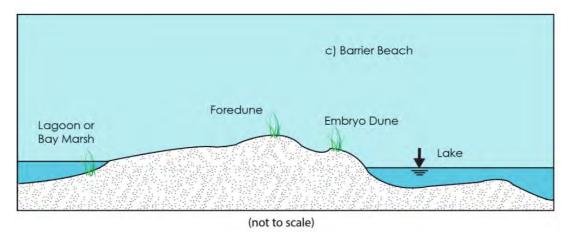
Figure 5.16: Schematic of the three main types of dynamic beach

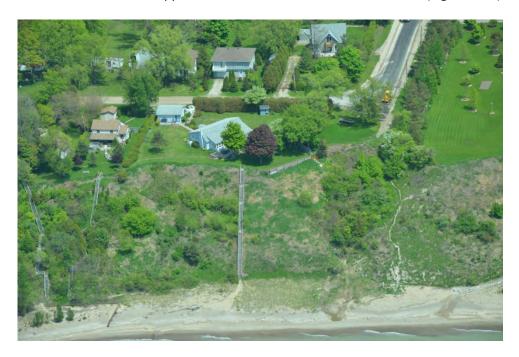
Figure 5.18: Oblique aerial photograph of a portion of the ABCA shoreline south of Bayfield showing a dynamic beach backed by an eroding cohesive bluff.

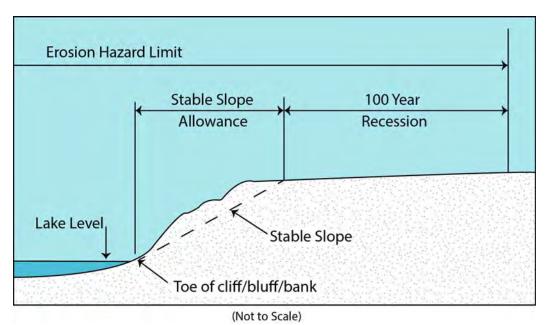
Figure 5.20: Erosion Hazard criteria must also be applied along with the Dynamic Beach Hazard (from MNR Technical Guide.

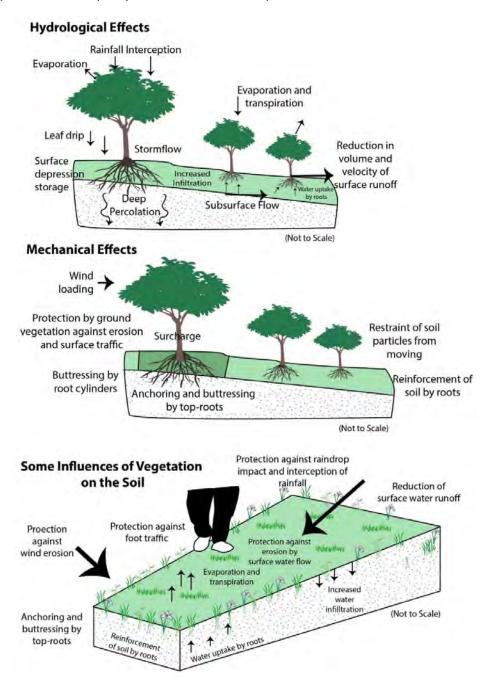
Figure 7.1 from MNRF Technical Guide Part 4: Erosion Hazards, Figure 4.13, The Importance in Vegetation Controlling Surface Erosion Pp. 4-17(2001).

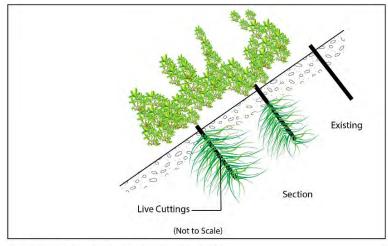
Figure 117 - Live Staking (from Gray and Sotir, 1996)

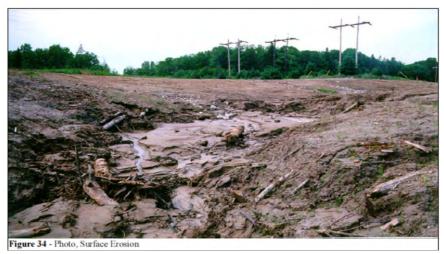
Figure 7.4: Surface Drainage Issues, From MNRF – Figure 34, Terraprobe, Geotechnical Principles for Stable Slopes (1997) Page 37

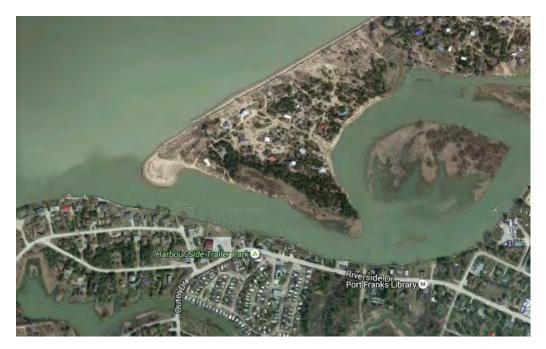
Figure 7.8: Development around the Mouth of the Ausable River

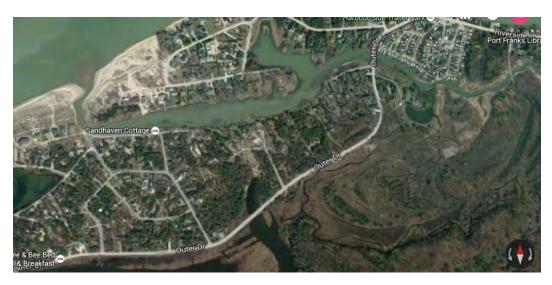
Figure 7.9: Development around Mouth of Mud Creek

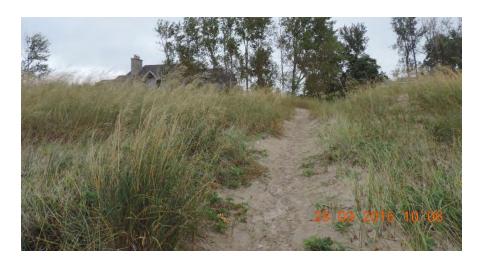
Figure 7.10: Setback of dwellings beyond the dynamic beach hazard limit has permitted the persistence of a well-vegetated foredune which provides protection to the area landward.

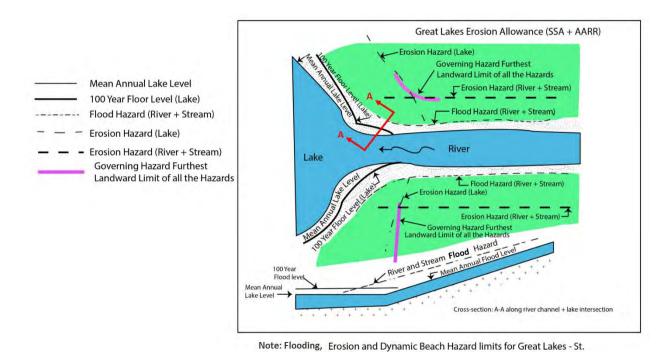
Figure 7.11: Overlap and Governing Hazard of furthest Landward Limit - Source MNRF Natural Hazard Training Manual. Page 53 (1997).

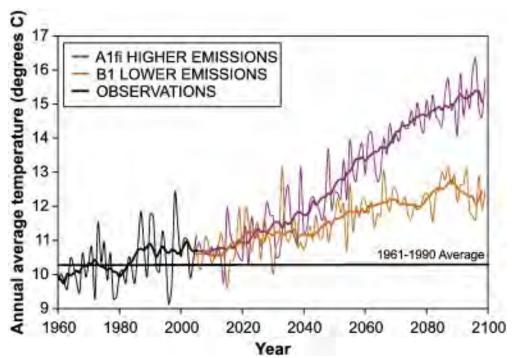
Figure 1: Observed and model-simulated historical and projected future annual average temperatures for Chicago, in degrees Celsius. Model simulations show the average of the GFDL 2.1, HadCM3, and PCM models for the SRES A1fi (higher) and B1 (lower) emission scenarios (after Hayhoe et al., 2012).

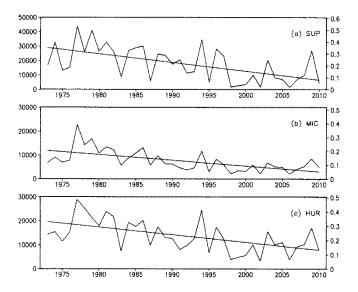
Figure 3: Annual mean lake ice area (km²) for Lakes Superior, Michigan and Huron for the period 1973-201 and least squares trend line (from Wang et al., 2012, Figure 5).

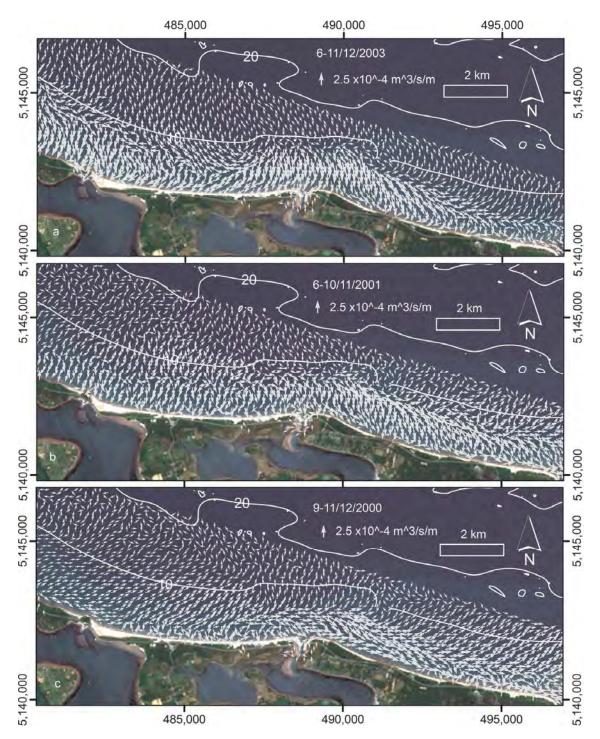
Figure 5: Example of the use of Delft3D hydrodynamic model to simulate sediment transport off the north coast of Prince Edward Island during open water conditions (Manson et al., 2016a). Shown are: a) mean bedload; b) suspended load; and c) total load transport with weighted mean transport directions during three fall storms. The arrows indicate the direction of transport and the length of the arrow is proportional to the mass of sediment transported.

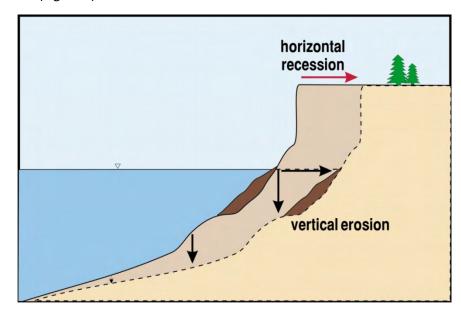
Figure 2: Equilibrium profile development on a cohesive bluff coast. Ongoing vertical erosion permits waves to continue to attack the wave toe as the bluff recedes and the two proceed in equilibrium (Davidson-Arnott and Ollerhead, 1995).

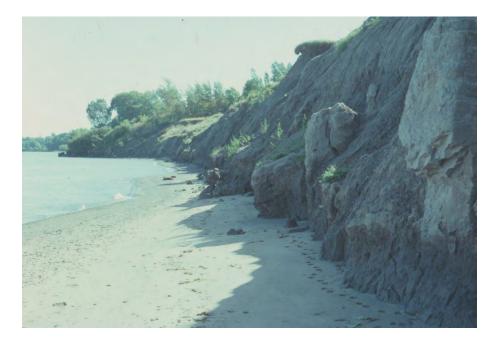
Figure 4: Weathering of till in cohesive bluffs, St. Catharines, Lake Ontario: a) bluff toe - wave erosion has removed weathered till in the right foreground and expansion cracks and fissures are just appearing. In the background small slumps have taken place in weathered material aided by snowmelt in the spring; b) drying of the surface layer in the summer produces a 'popcorn' surface of weathered silt and clay that is easily removed during heavy rains.

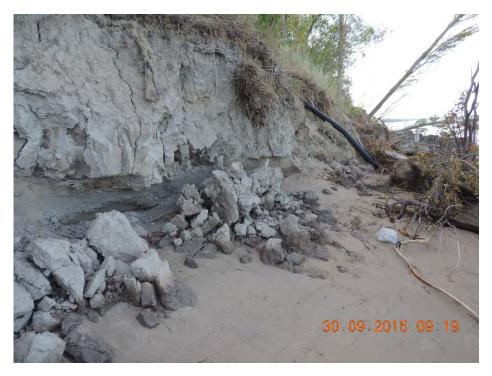
Figure 5: Desiccation cracks formed in a layer of weathered till leading to slumping of isolated blocks, ABCA shoreline

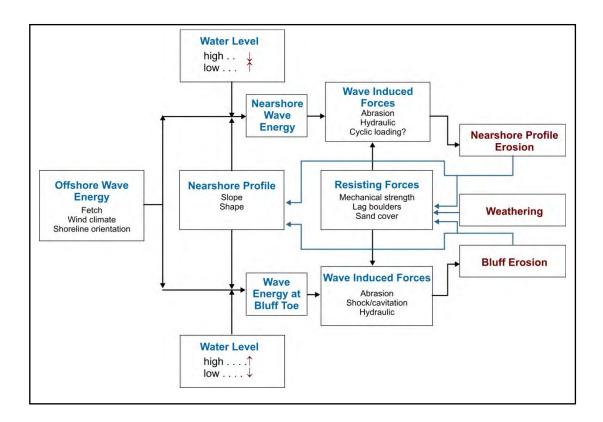
Figure 6: Processes controlling erosion of a cohesive coast. The upper and lower set of boxes relate to the 'assailing forces' on the nearshore profile (upper) and bluff toe (lower) while the centre part relates to the 'resisting forces'. Weathering reduces the mechanical strength of the till both on land and underwater. Note also that high lake level is associated with increased bluff toe erosion while increased underwater erosion occurs with low lake level. (Davidson-Arnott, 1990, 2010; after Sunamura, 1983).

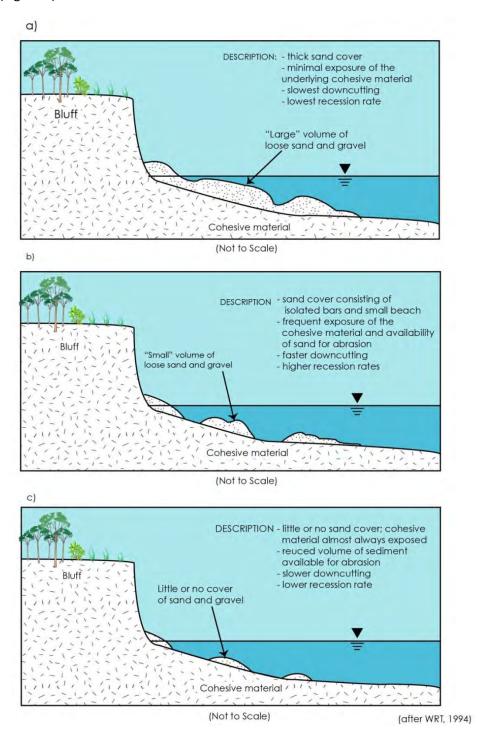
Figure 9: Schematic showing the effects of varying sand and gravel cover on exposure of till underwater (from MNR Technical Guide-Part 1: Figure A1.2.4 Cohesive Shores and the Role of Sand/Gravel Cover. Page A1-2-6 (2001)).

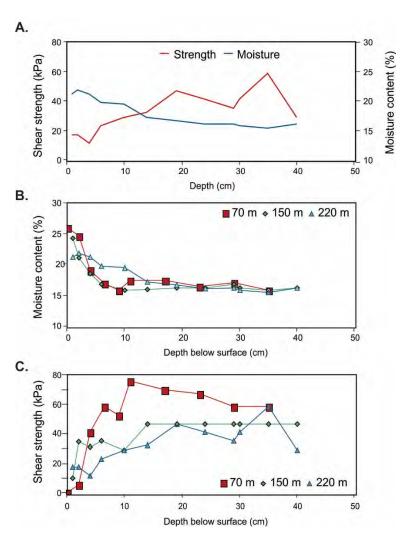
Figure 11: Variations in moisture content and shear strength within 5 cm diameter cores taken underwater in Lake Ontario at St. Catharines: a) variations in moisture content and shear strength in a single core taken 220 m offshore in a water depth of 4 m. Note that increasing moisture content towards the surface is associated with decreasing shear strength; b) variations in moisture content and c) shear strength in cores taken 70, 150 and 220 m offshore (water depth of 1.3, 3 and 4 metres). The softened layer is about 10 cm thick in shallow water, 15 cm at a depth of 3 m and up to 20 cm in water deeper than 4 m. (After Davidson-Arnott and Langham, 2000).

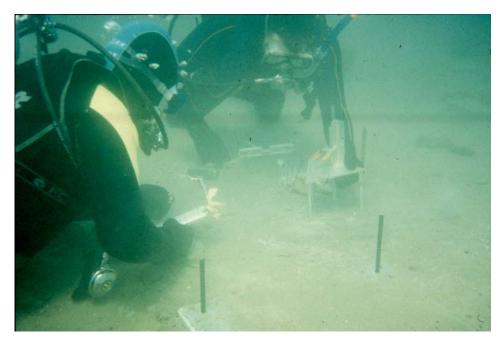
Figure 12: Measuring underwater erosion of in Lake Ontario at St. Catharines. The erosion station (centre right) consists of 3 metal pins hammered into the till and levelled. The MEM is positioned on the pins for each measurement and the distance to the bed in the middle of each side is measured using a 'foot' which slides in a tube and the distance to the till surface is measured against a vertical scale. The large pins in the foreground are holding in place one of the plates used to protect the surface from erosion and wave pressure fluctuations in order to assess the role of till softening over time (after Davidson-Arnott and Langham, 2000).

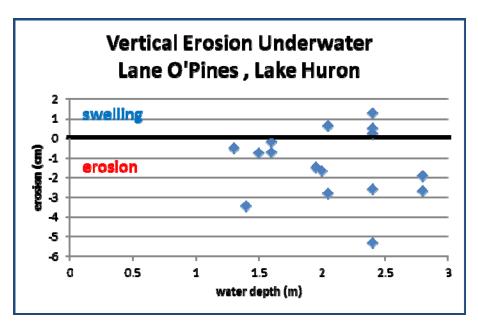
Figure 13: Annual measurements of vertical erosion of till near Lane O'Pines in 1993-4 and 1994-5. The erosion stations are located between 40 and 200 m offshore. Each measurement is an average of three points at that station. Erosion ranged from 0.2 cm/y to a maximum of 5.3 cm/y. Note that positive measurements were obtained on four occasions indicating expansion of the till surface.

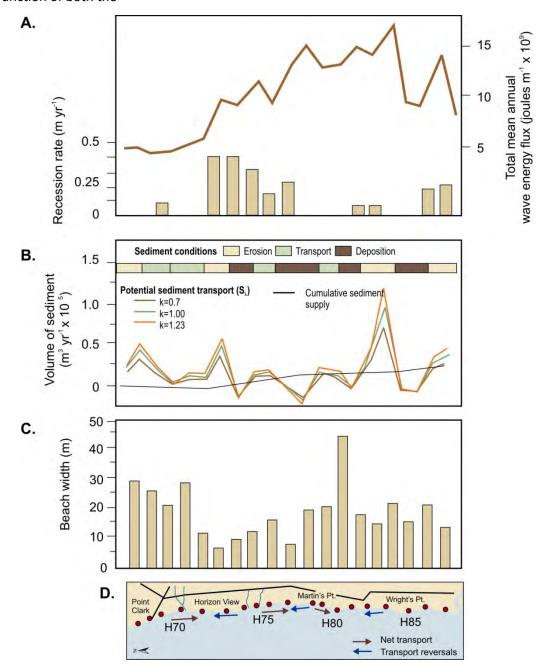
Figure 16: Comparison of modelling of littoral sediment transport with geomorphic indicators for a section of the Lake Huron shoreline: (a) plot of the spatial distribution of the mean annual bluff recession rate versus the mean annual total wave energy flux predicted from the model; (b) the alongshore distribution of potential sediment transport based on modelling and the available littoral sediment supply based on the bluff recession rate and bluff composition. Zones of potential erosion, transport and deposition are based on the alongshore transport gradient; (c) alongshore variations in beach width measured on one day; (d) map of the coastline between Pt. Clark and Goderich. The dots mark locations of calculations for model values and the numbered stations are sites of long-term bluff
