ARMSTRONG WEST EROSION CONTROL WORKS

2007-2008 Monitoring Report

September 2008

**Re: Armstrong West Erosion Control Works – 2008 Monitoring Program
TSH Project No. 54-22264**

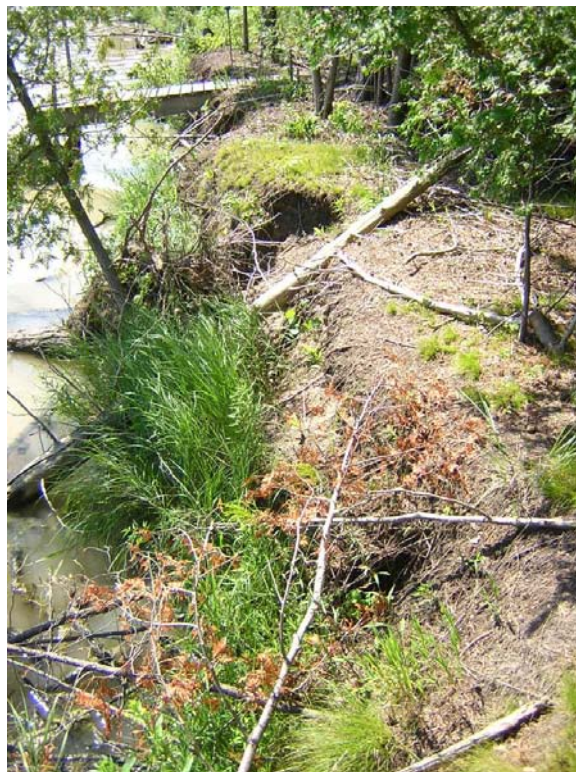
- An invasive vine was noted in a number of locations, most evident on Weirs C, E, and F and in each case has established itself on the upstream (north) side of the weirs. It has orange roots that are wrapping around and smothering other weeds and vegetation. New shoots are creeping across the rocks. It appears to have arrived within the past month or so. It is suspected to be Oriental Bittersweet (*Celastrus orbiculatus*) but not confirmed. **Figure 1** shows this vine on Weir C.

Figure 1 – Invasive vine on Weir C

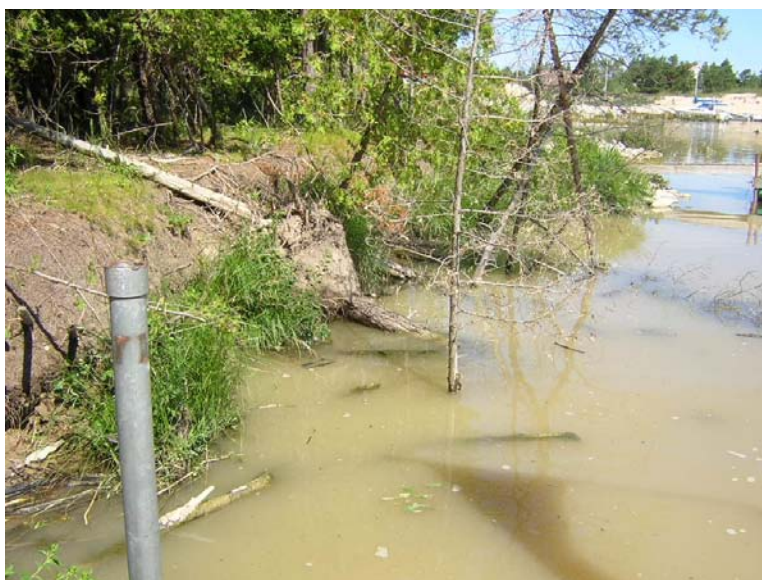
- **Figure 2** and **Figure 3** provide updated photos of the area of concern downstream (south) of the revetment that was noted during the December 2007 inspection. This area was suspected of excessive bank erosion, however it does not appear that the bank migration rate has accelerated beyond pre-construction conditions (i.e., greater than 0.5 m/year). Bank erosion and deep scour holes near the shoreline had been noted at this location for many years prior to construction.

Figure 2 – Potential Bank Erosion (approx. 35 m downstream (south) of Weir G, photo looking south)

- There appears to be recent scour of the river bank (approximate depth of 1.5-2m) downstream of the southern extent of the project, approximately 35 m south of weir G (see **Figure 1** on page 2 of this report). It is suggested that the monitoring plan be adapted to include semi-annual monitoring (spring and fall, initially) of the bank to confirm the bank migration rate. Note: Weir G was added to the initial/concept design to address potential erosion at this location and the rock revetment was extended as far south to the point where it was felt that the existing root structure would provide bank stability. If it is found that the bank migration rate here is significant, Weir G can be redesigned and modified (e.g., increase the weir length and/or upstream orientation angle) as an added control measure.

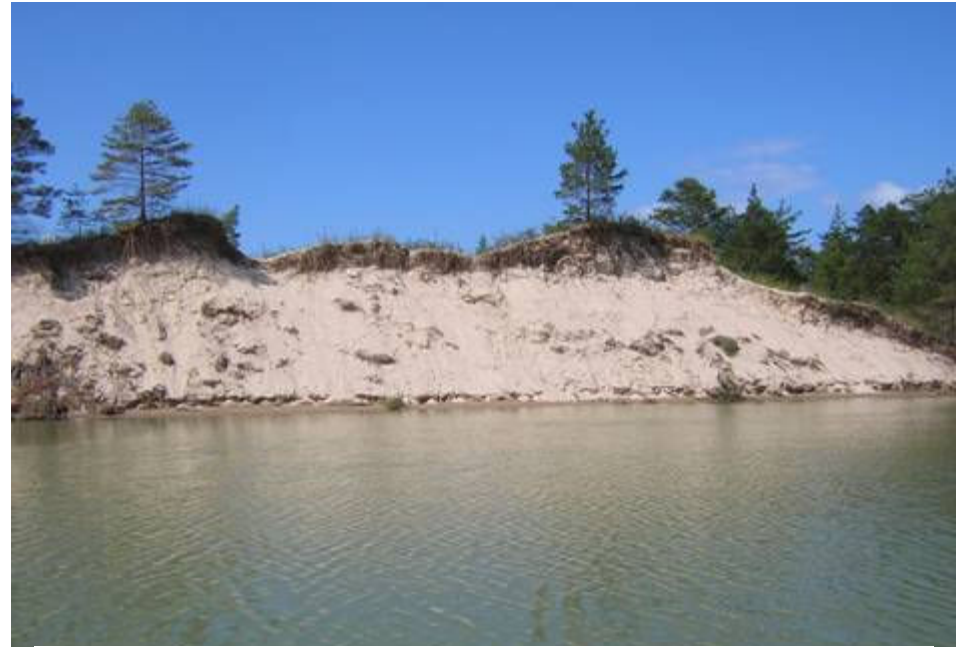
Photos E1 through E8 document pre-construction conditions and were taken in August 2005. These photos cover the length of the shoreline in the project site and indicate a highly unstable and eroding slope.

Photo E1 (23-Aug-05): Looking west at north end of project, proposed weir A.

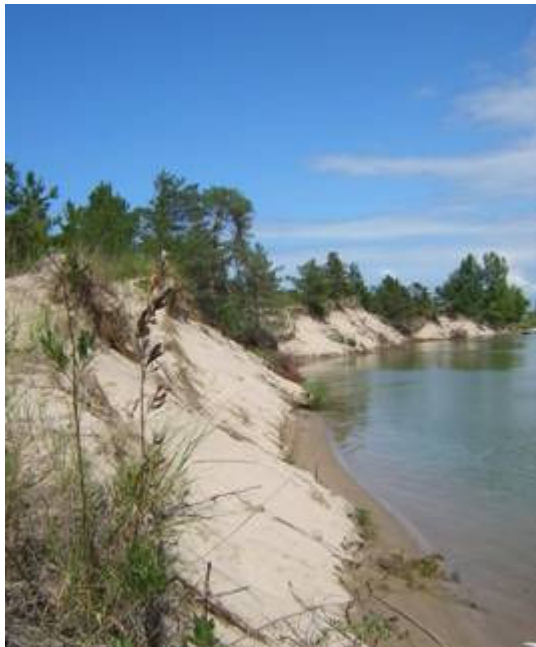
Photo E2 (23-Aug-05): Looking west between proposed weirs B and C.

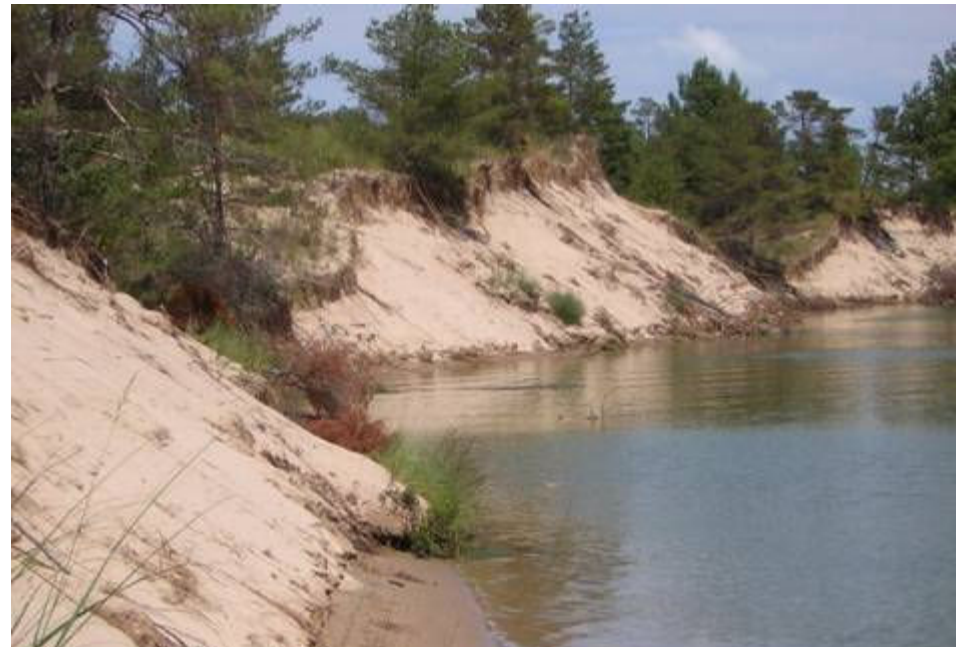
Photo E3 (23-Aug-05): Looking north from Smugglers Lane.

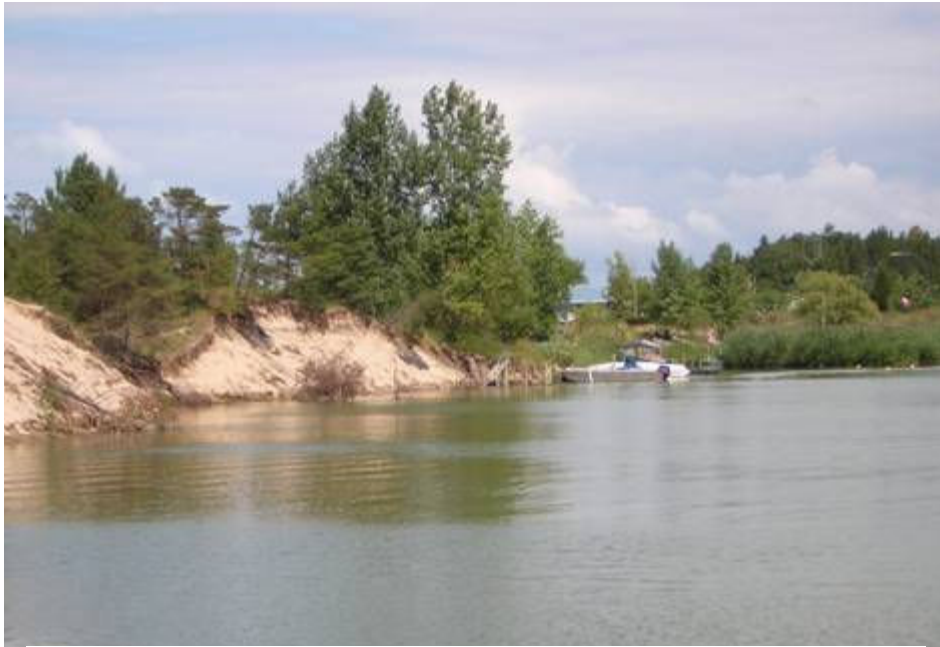
Photo E4 (23-Aug-05): Looking north from proposed weir D.

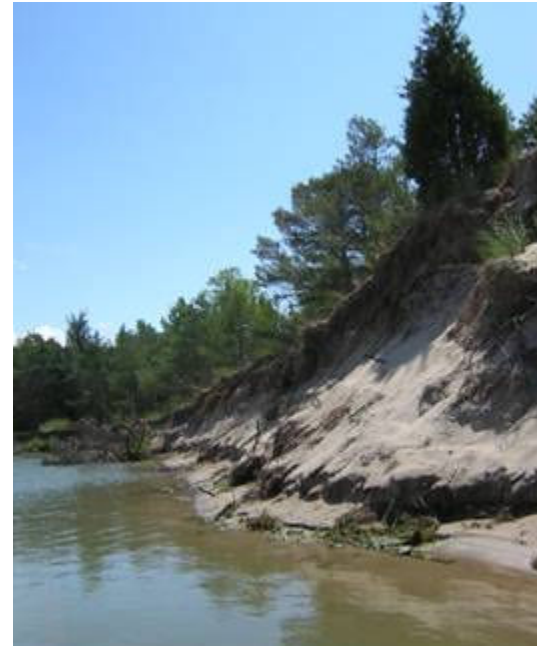
Photo E5 (23-Aug-05): Looking north from proposed weir D.

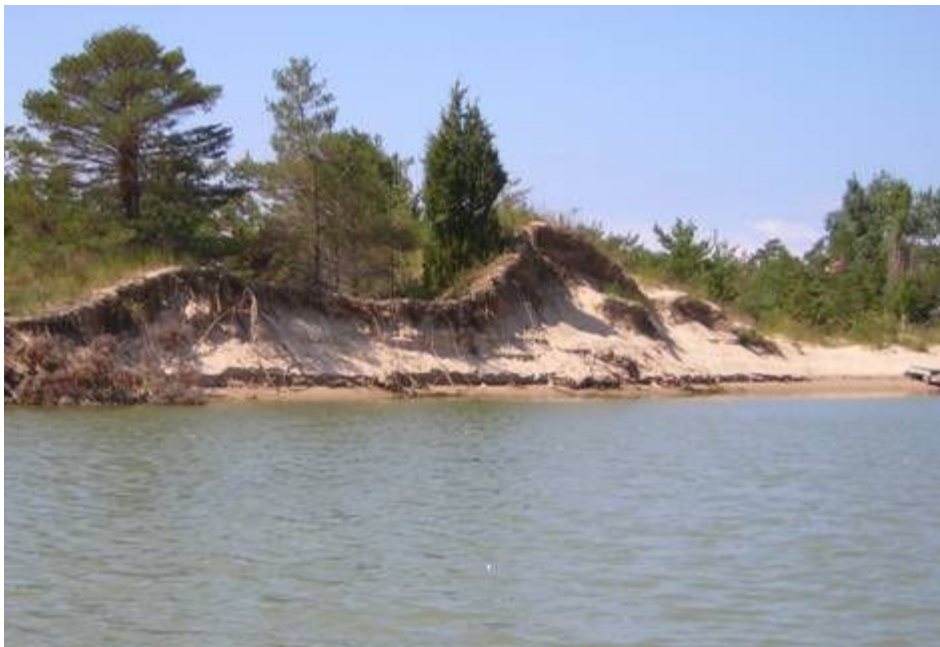
Photo E6 (23-Aug-05): Looking south from Smugglers Lane.

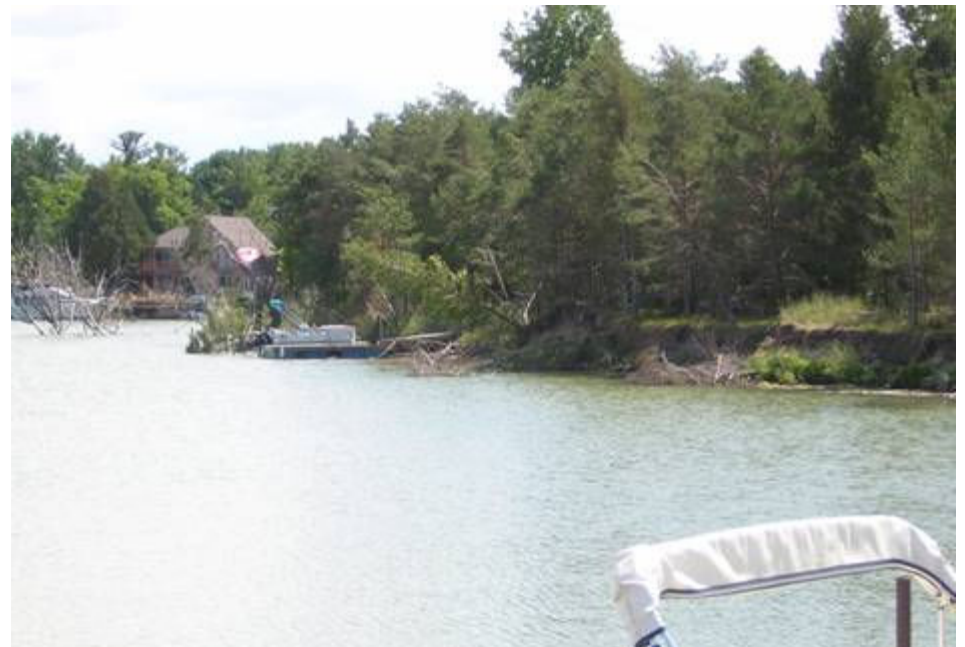
Photo E7 (23-Aug-05): Looking west from proposed weir E.

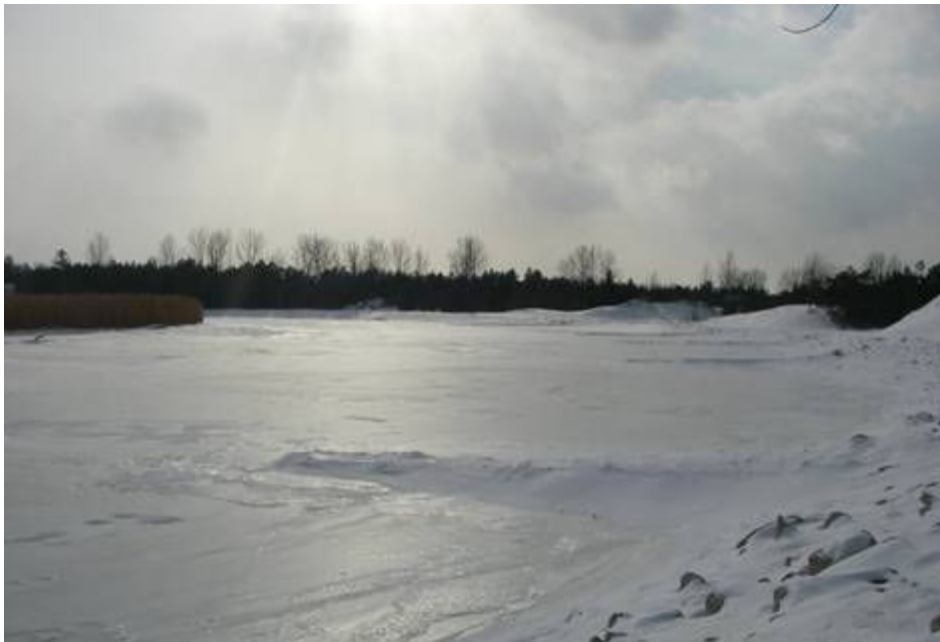
Photo P1 shows the project site during ice conditions in February 2007. Photos P2 through P6 show the shoreline and weirs following ice-out conditions in March 2007.

Photo P1 (3-Feb-07): Looking southwest from north end of revetment, weir A in foreground, weirs B to G in background.

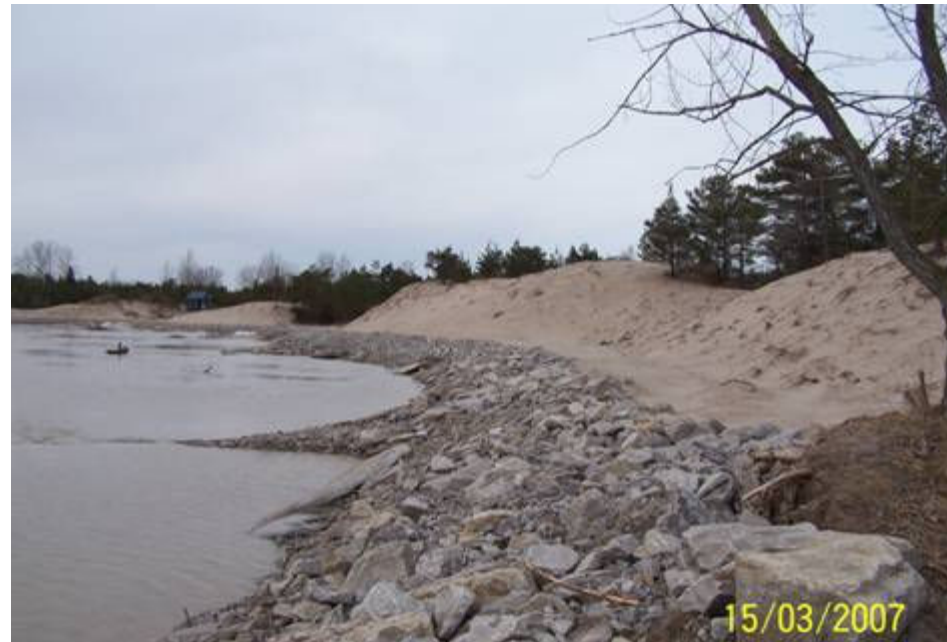
Photo P2 (15-Mar-07, ABCA): Looking southwest from north end of revetment.

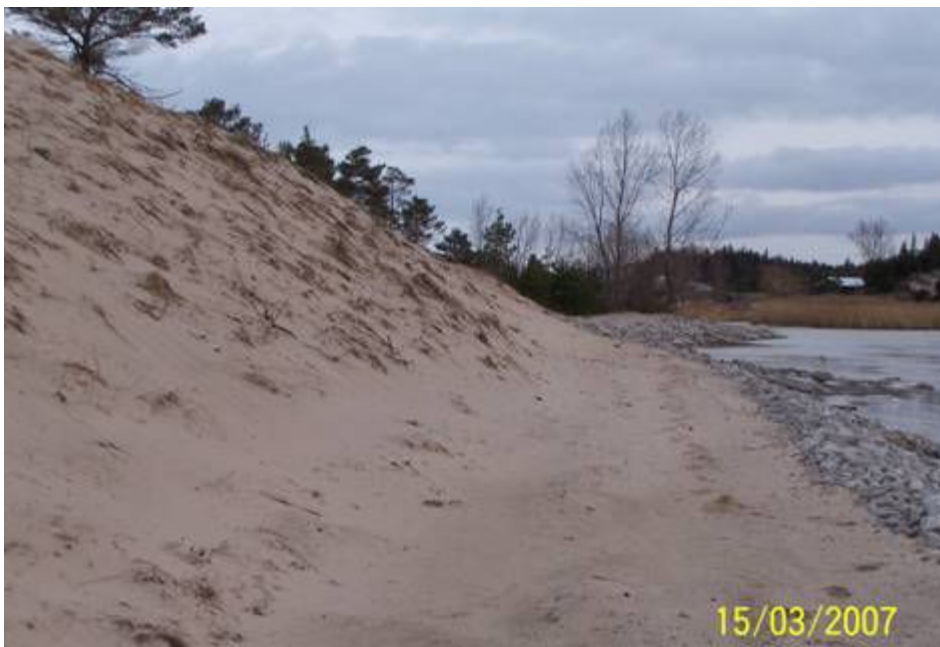
Photo P3 (15-Mar-07, ABCA): Looking northeast from weir C.

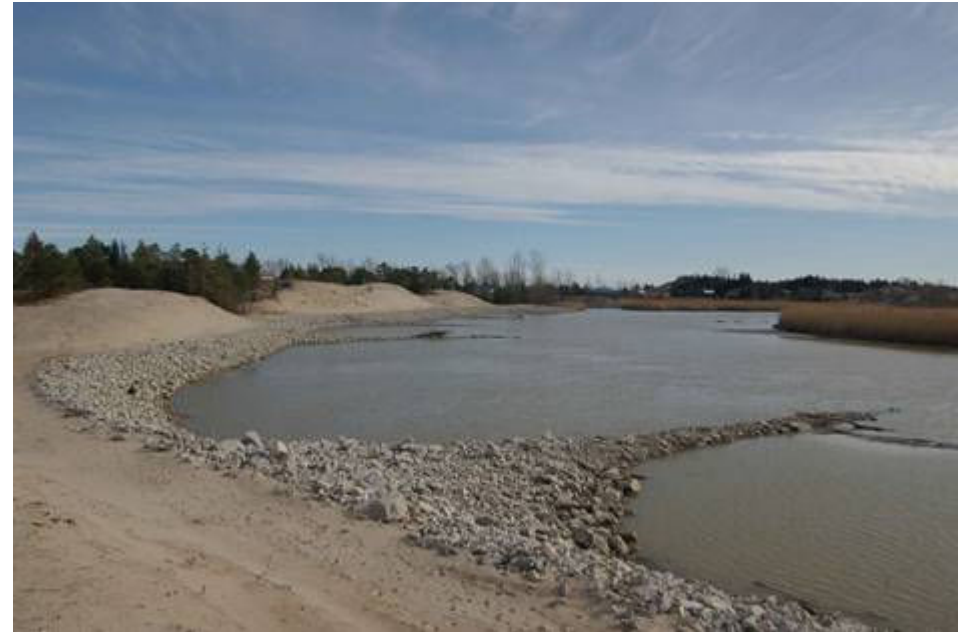
Photo P6 (28-Mar-07, ABCA): Looking north from Lot 22.

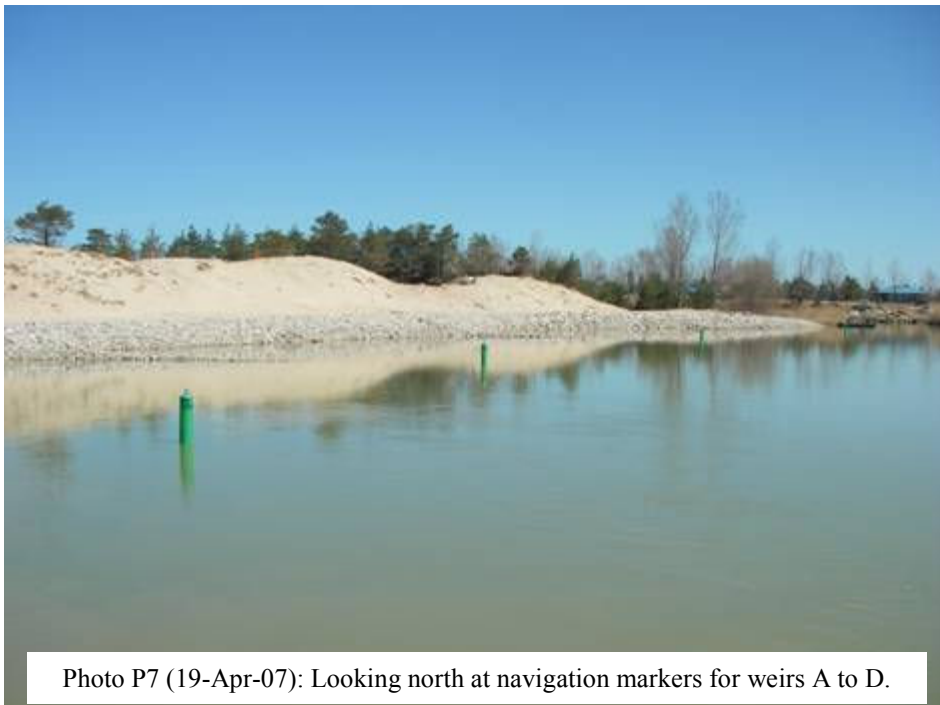
Photo P7 (19-Apr-07): Looking north at navigation markers for weirs A to D.

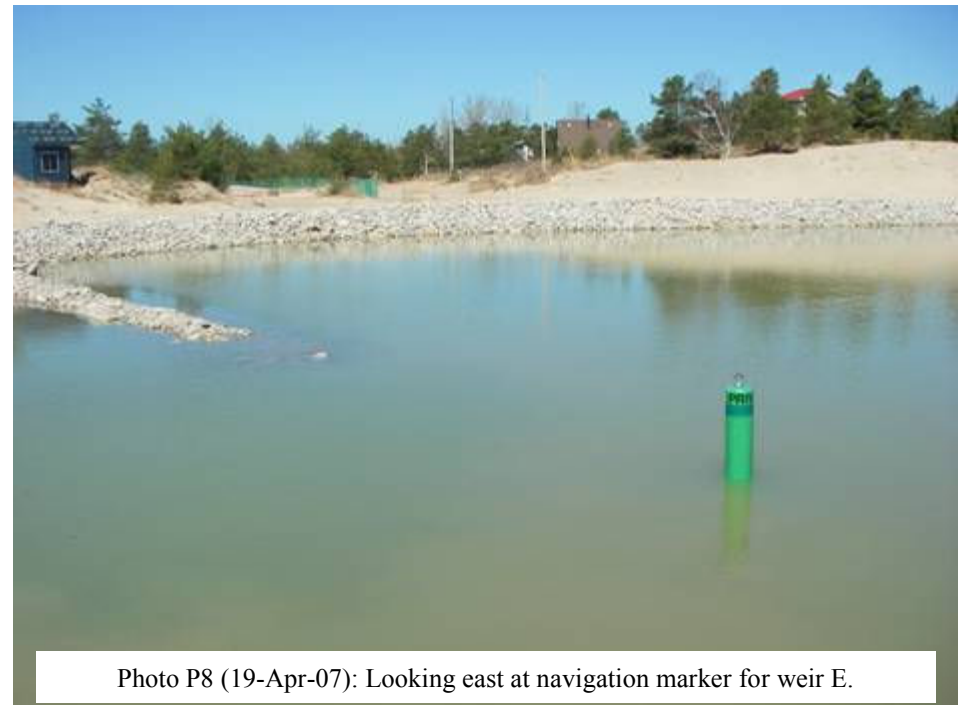
Photo P8 (19-Apr-07): Looking east at navigation marker for weir E.

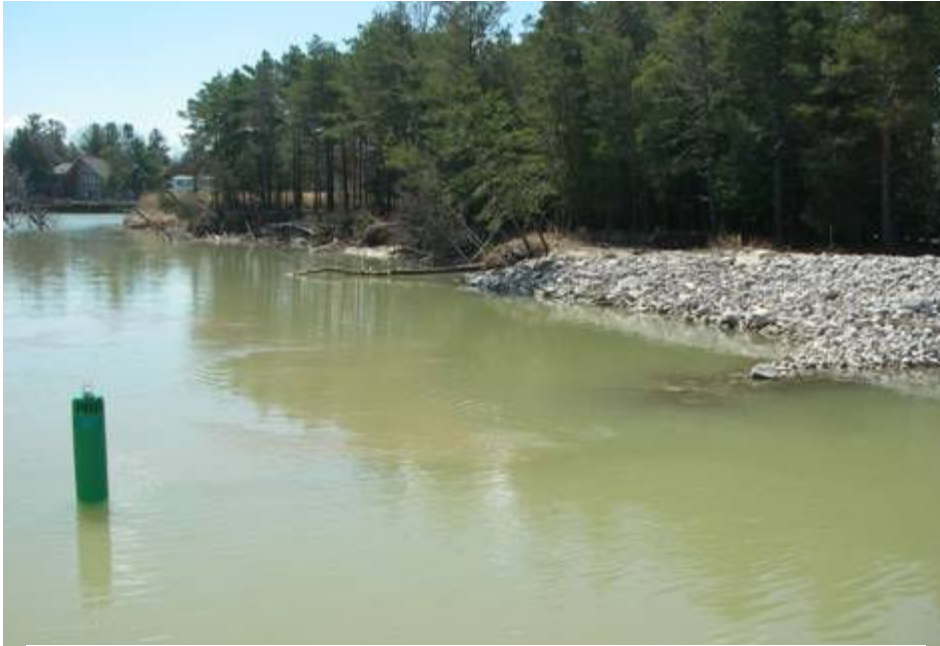
Photo P9 (19-Apr-07): Looking south at navigation marker for weir G.

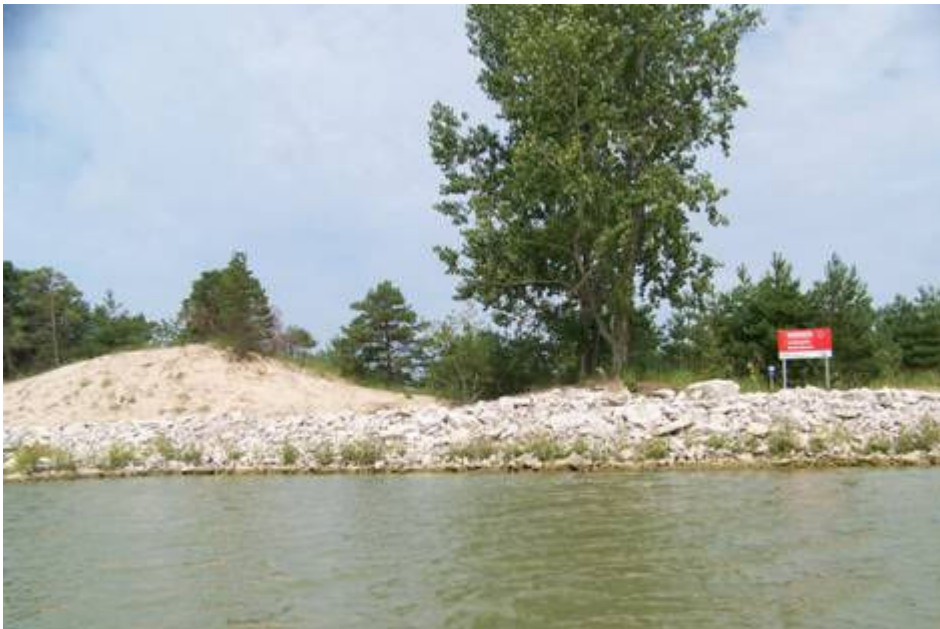
Photo P11 (10-Aug-07, ABCA): Looking northwest at north end of revetment, note vegetation along shoreline.

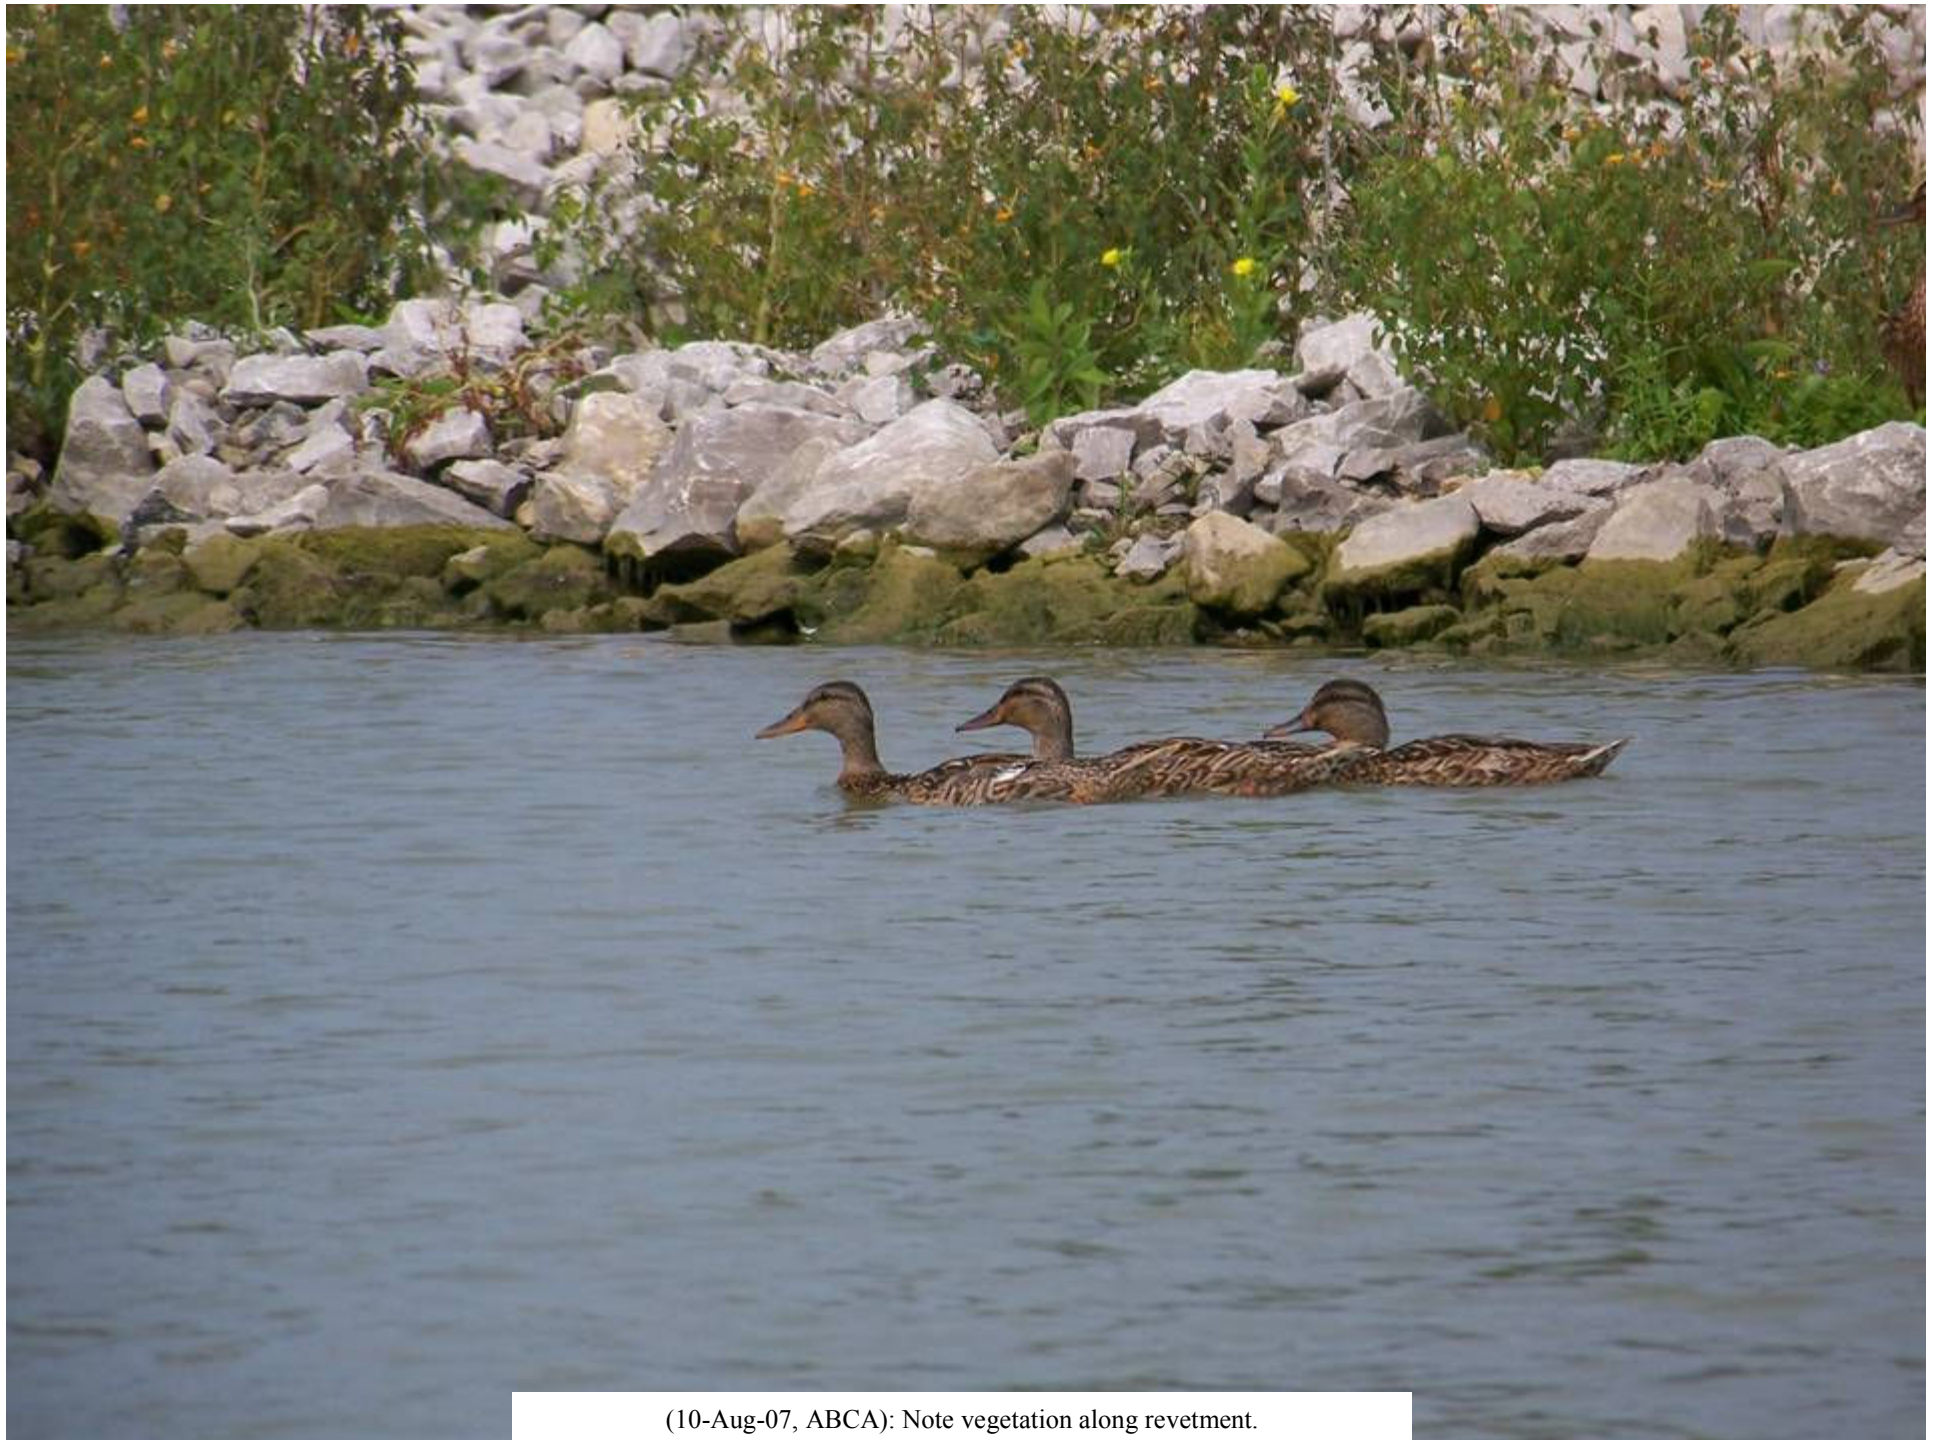
(10-Aug-07, ABCA): Note vegetation along revetment.

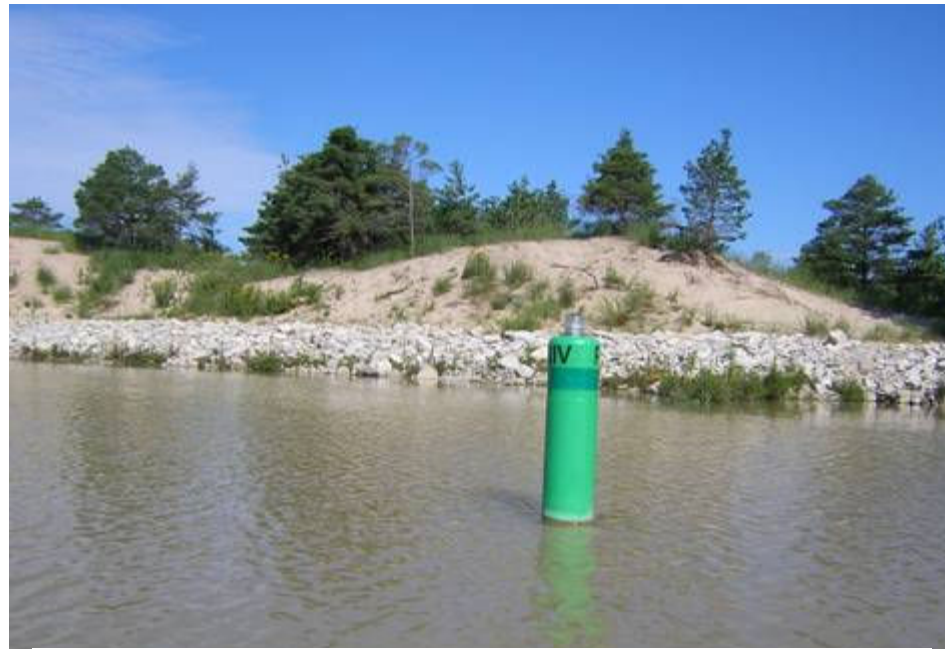
Photo P14 (25-Jul-08): Weir A (vegetated area on right).

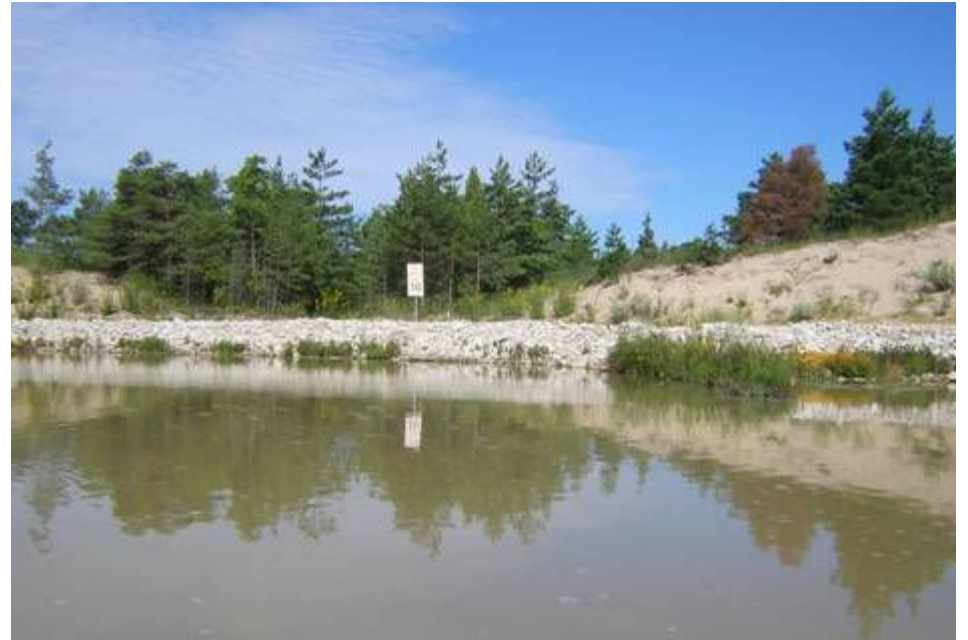
Photo P18 (25-Jul-08): Weir C (vegetated area on right).

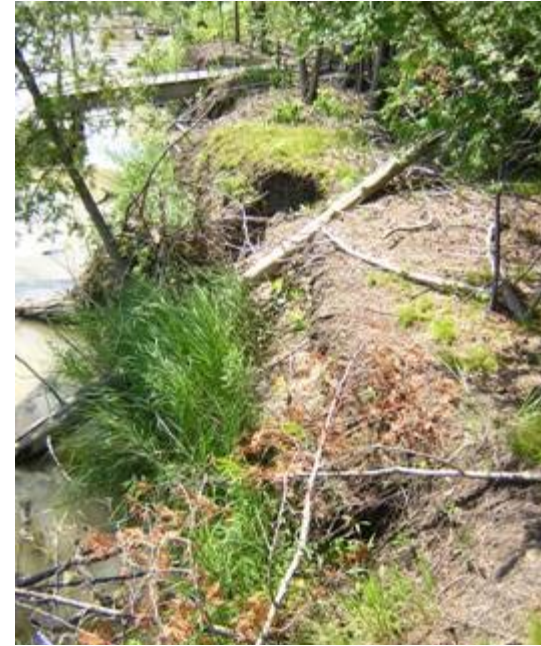
The final three photos highlight an area of concern downstream/south of the revetment. During the December 2007 inspection (see photo P45), there appeared to be excessive bank erosion at this location. However the July 2008 inspection (see photos P43 and P44) did not indicate the bank migration rate has accelerated beyond pre-construction conditions (i.e., greater than 0.5 m/year). Bank erosion and deep scour holes near the shoreline had been noted at this location for many years prior to construction.

Photo P43 (25-Jul-08): Bank erosion downstream/south of southern end of revetment.

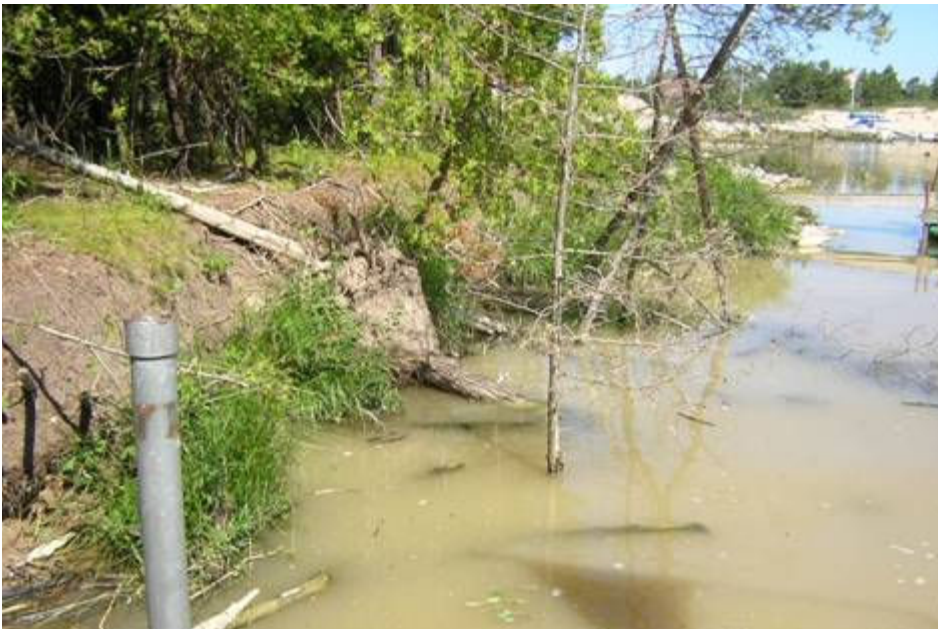
Photo P44 (25-Jul-08): Bank erosion downstream/south of southern end of revetment.

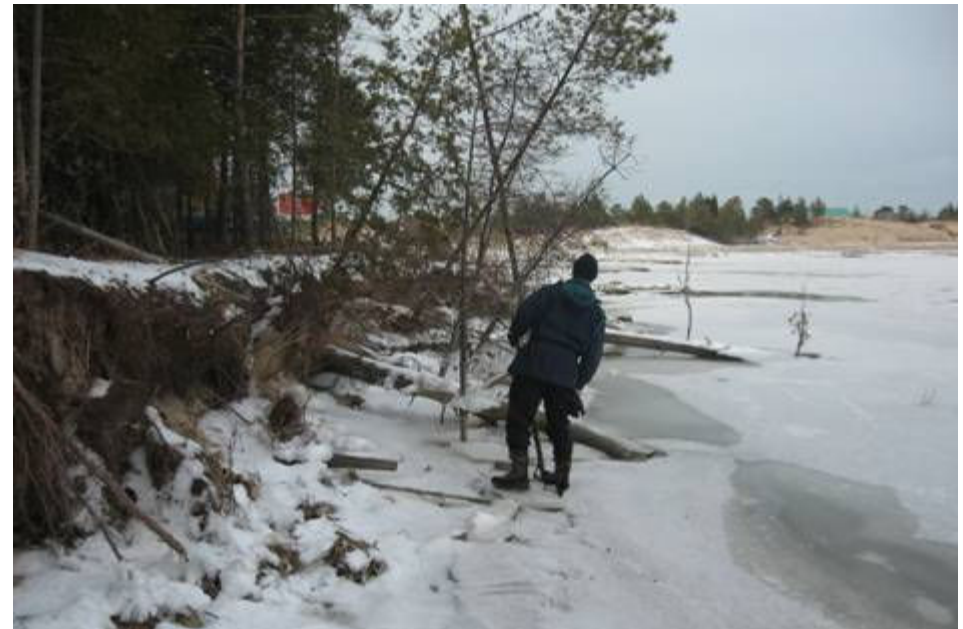
Photo P45 (13-Dec-07): Bank erosion downstream/south of southern end of revetment.
